CAMPAIGN BULLETIN

Automatic Transmission Dealer Inventory

Reference: PC564
Date: April 28, 2017

PC564 – TITAN XD (A61G, 4WD) MULTI-POINT INSPECTION

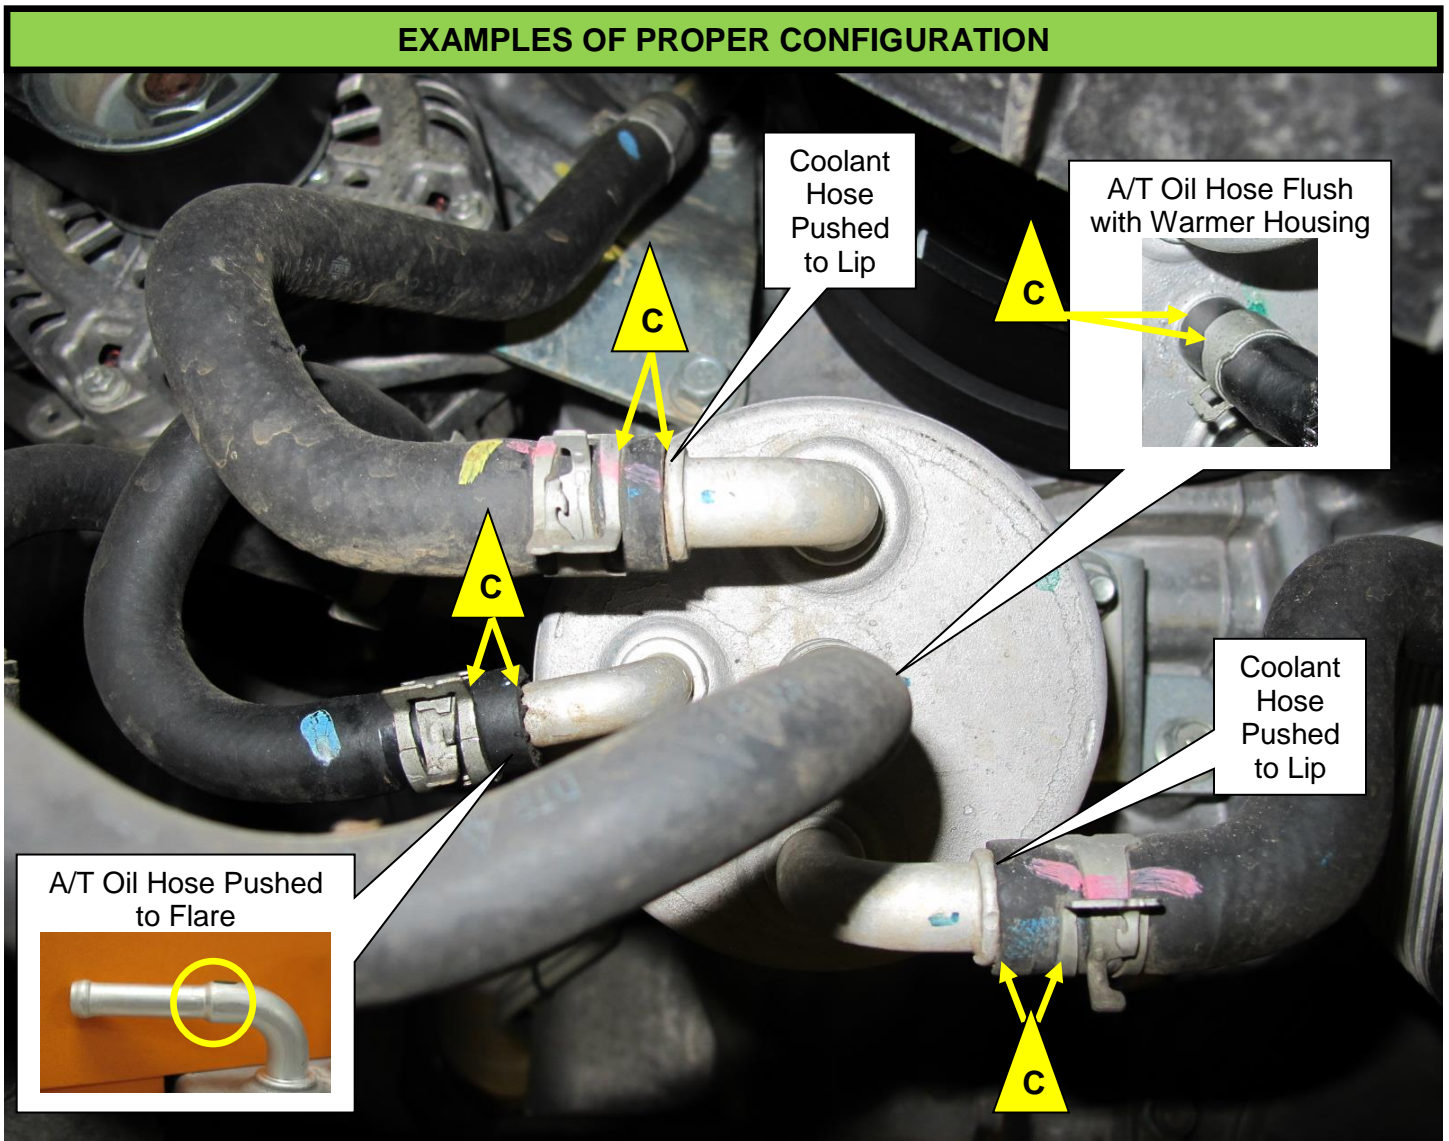
Figure 6

6. Inspect **four** A/T Warmer Hoses for proper configuration (Figure 6).

A. Straight tube hose placement: hose pushed all the way until flush with warmer housing.

B. Bent tube hose placement: hose pushed all the way to stop/lip or outward flare.

C. Clamp placement

; clamp located 5MM +or- 2MM (1/8th to 1/4 inch) from end of hose.

8. CORRECT ANY HOSES NOT PROPERLY INSTALLED, REFERENCE STEP 6 (FIGURE 6).

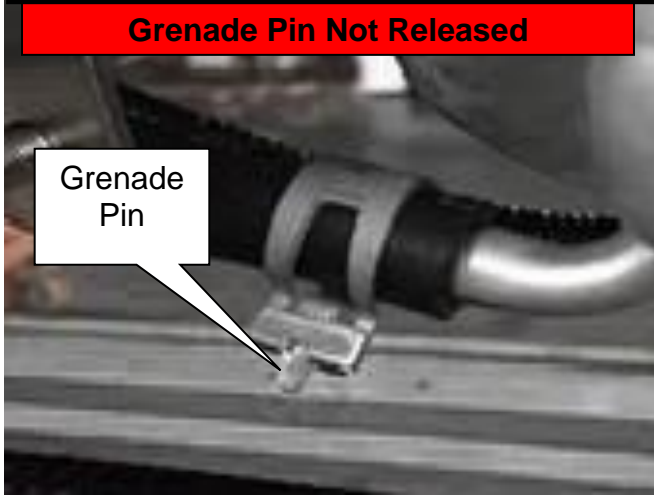
Figure 7

Grenade Pin Not Released

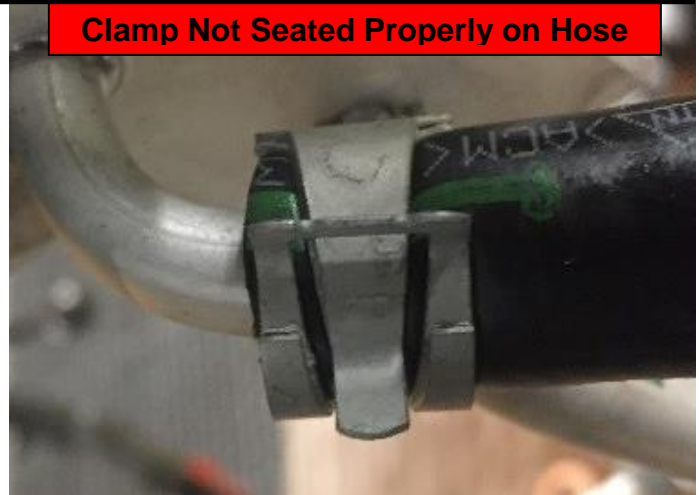
Figure 8

Clamp Not Seated Properly on Hose

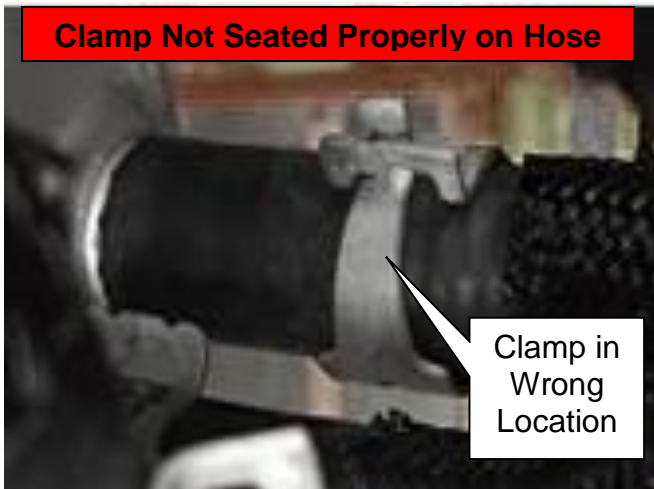
Figure 9

Clamp Not Seated Properly on Hose

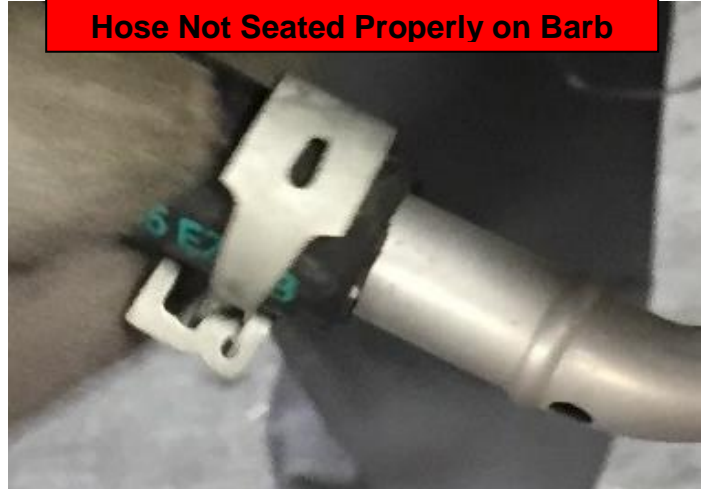
Figure 10

Hose Not Seated Properly on Barb

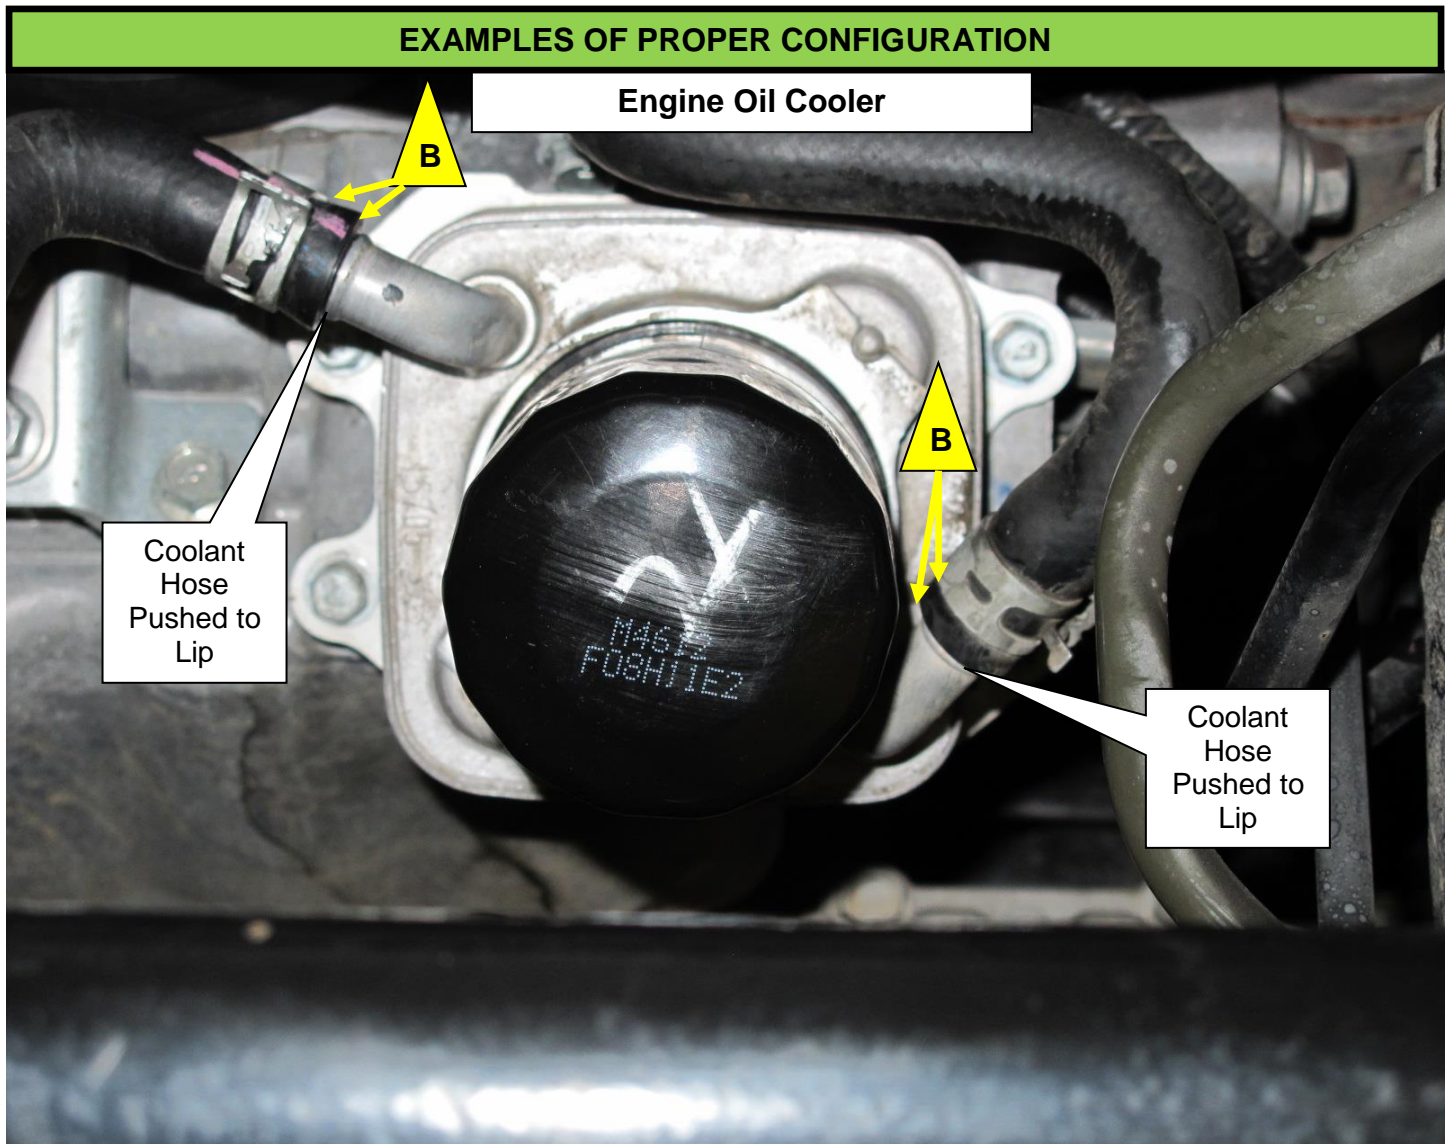
Figure 11

9. Inspect **two** engine oil cooler hoses for proper configuration (Figure 11).

A. Bent tube hose placement: hose pushed to the lip on the oil cooler pipe.

B. Clamp placement **B**: clamp located 7MM +or- 2MM or approximately (3/16 to 3/8 inch) from the end of the hose.

11. CORRECT ANY ENGINE OIL COOLER HOSES NOT PROPERLY INSTALLED, REFERENCE STEP 9 (FIGURE 11).

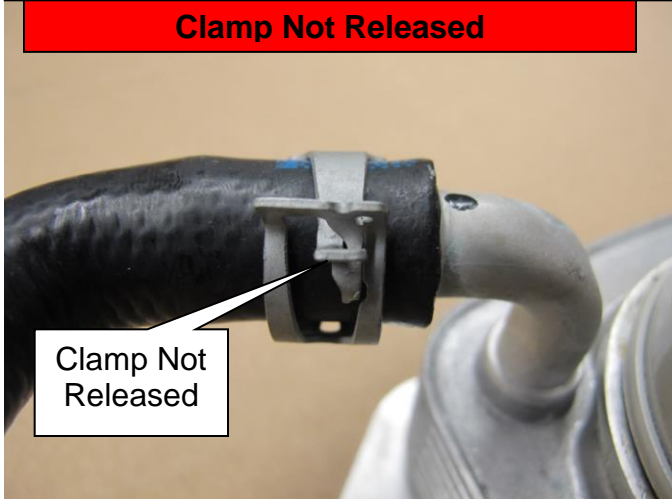
Figure 12

Clamp Not Released

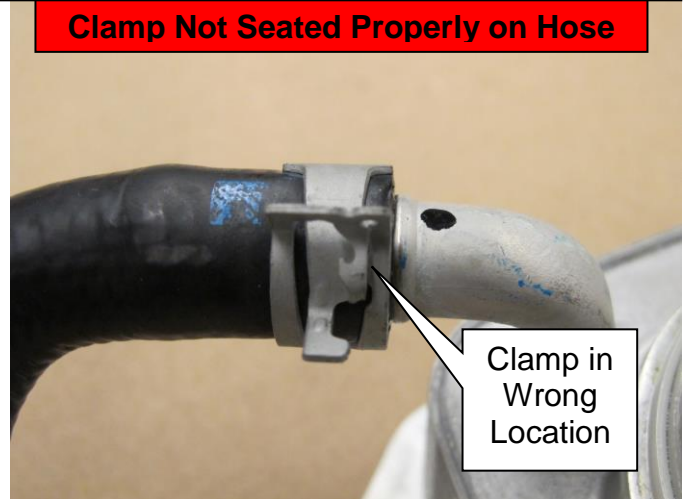
Figure 13

Clamp Not Seated Properly on Hose

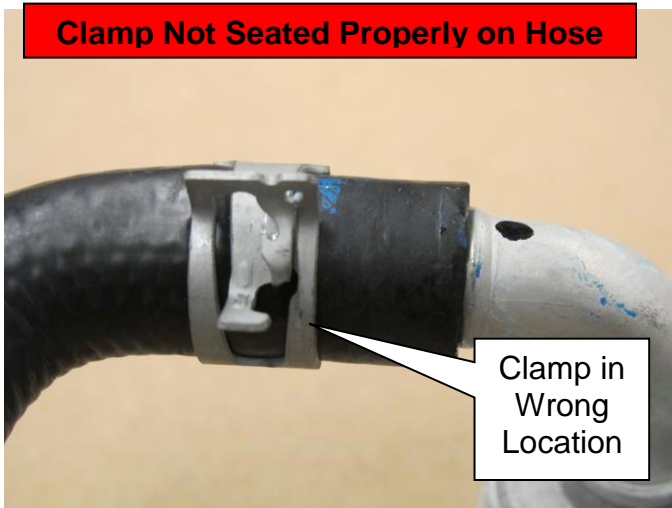
Figure 14

Clamp Not Seated Properly on Hose

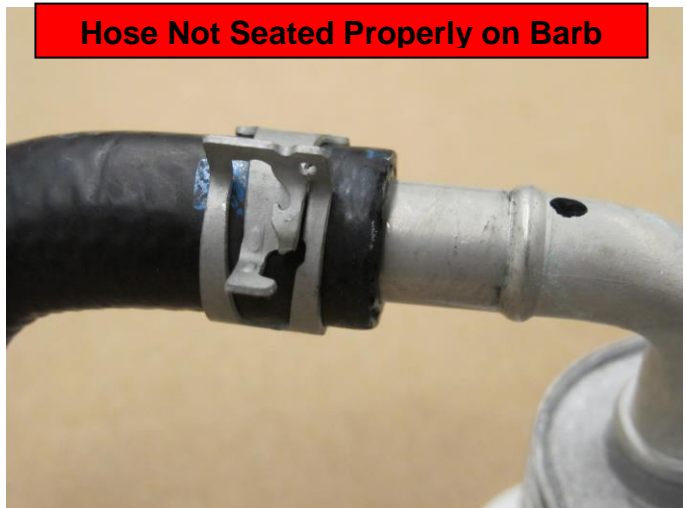
Figure 15

Hose Not Seated Properly on Barb

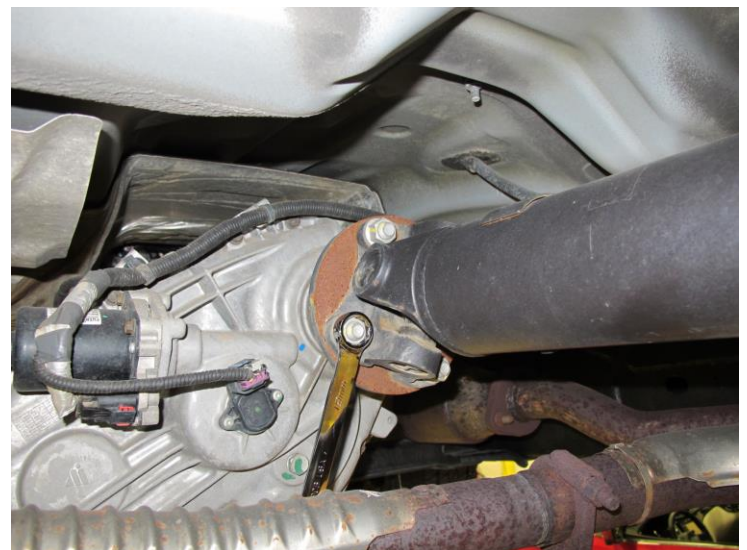
Figure 2

2. Using a suitable tool apply LIGHT to MODERATE force to one of the 19MM bolts, repeat on the other bolts (Figure 2).

A. If **any** of the bolts move (NOT the prop shaft) **replace all 4** of the rear prop shaft bolts and nuts, (see Parts Information).

- Torque NEW Rear Prop Shaft bolts and nuts:
105N·m (77 ft-lb)

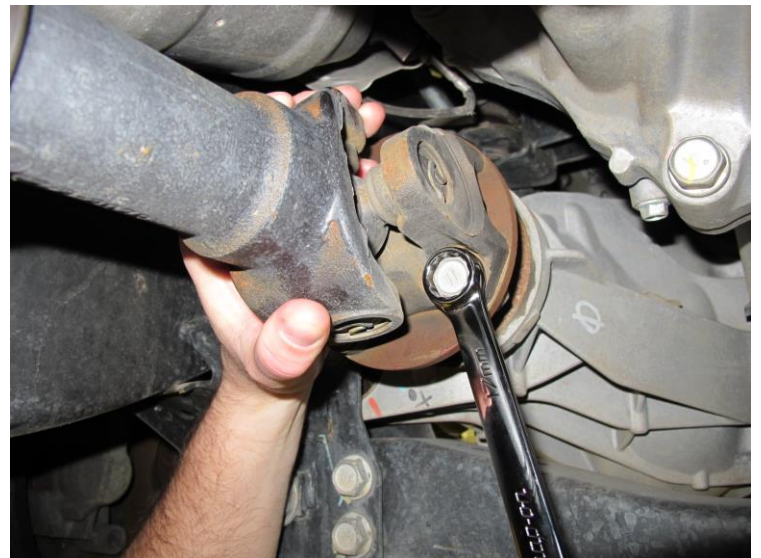
Figure 2

2. Place a 17MM box end wrench on one of the inside nuts, while holding the Prop Shaft in place apply LIGHT to MODERATE force, repeat on the other bolts. (Figure 2):
 - A. If **any** of the bolts move (NOT the prop shaft) **replace all 4** of the front prop shaft bolts and nuts, (see Parts Information).
 - Torque NEW Front Prop Shaft bolts and nuts:
80N·m (59 ft-lb)
 - B. If bolts do not move (are tight) go to Inspection 4.

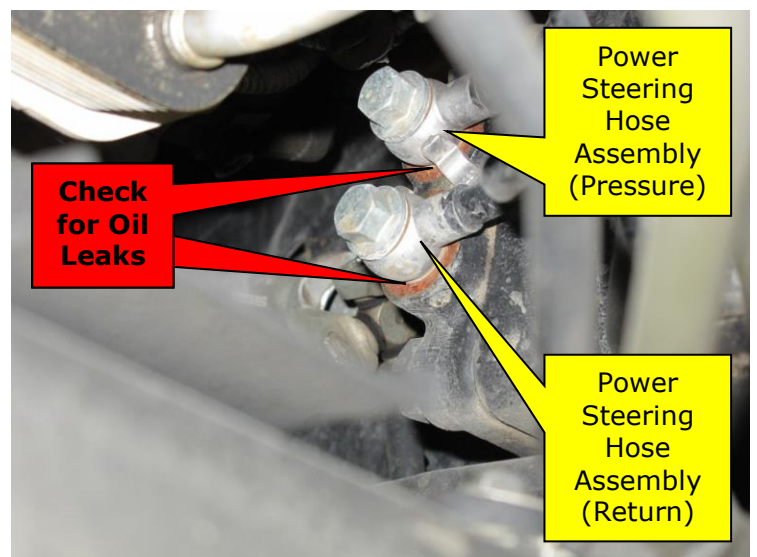
Figure 3

2. Inspect for **LEAKS** between the Steering Gear Box and Power Steering Hose Assembly (Pressure) and Power Steering Hose Assembly (Return) connections. (Figure 3).

- If **NO LEAK** found, inspection is complete, proceed to step 12 to install front under cover.
- If **LEAK** found, proceed to step 3.
