CAMPAIGN BULLETIN

Automatic Transmission Dealer Inventory

Reference: PC565
Date: April 28, 2017

PC565 – TITAN XD (A61D, 2WD) MULTI-POINT INSPECTION

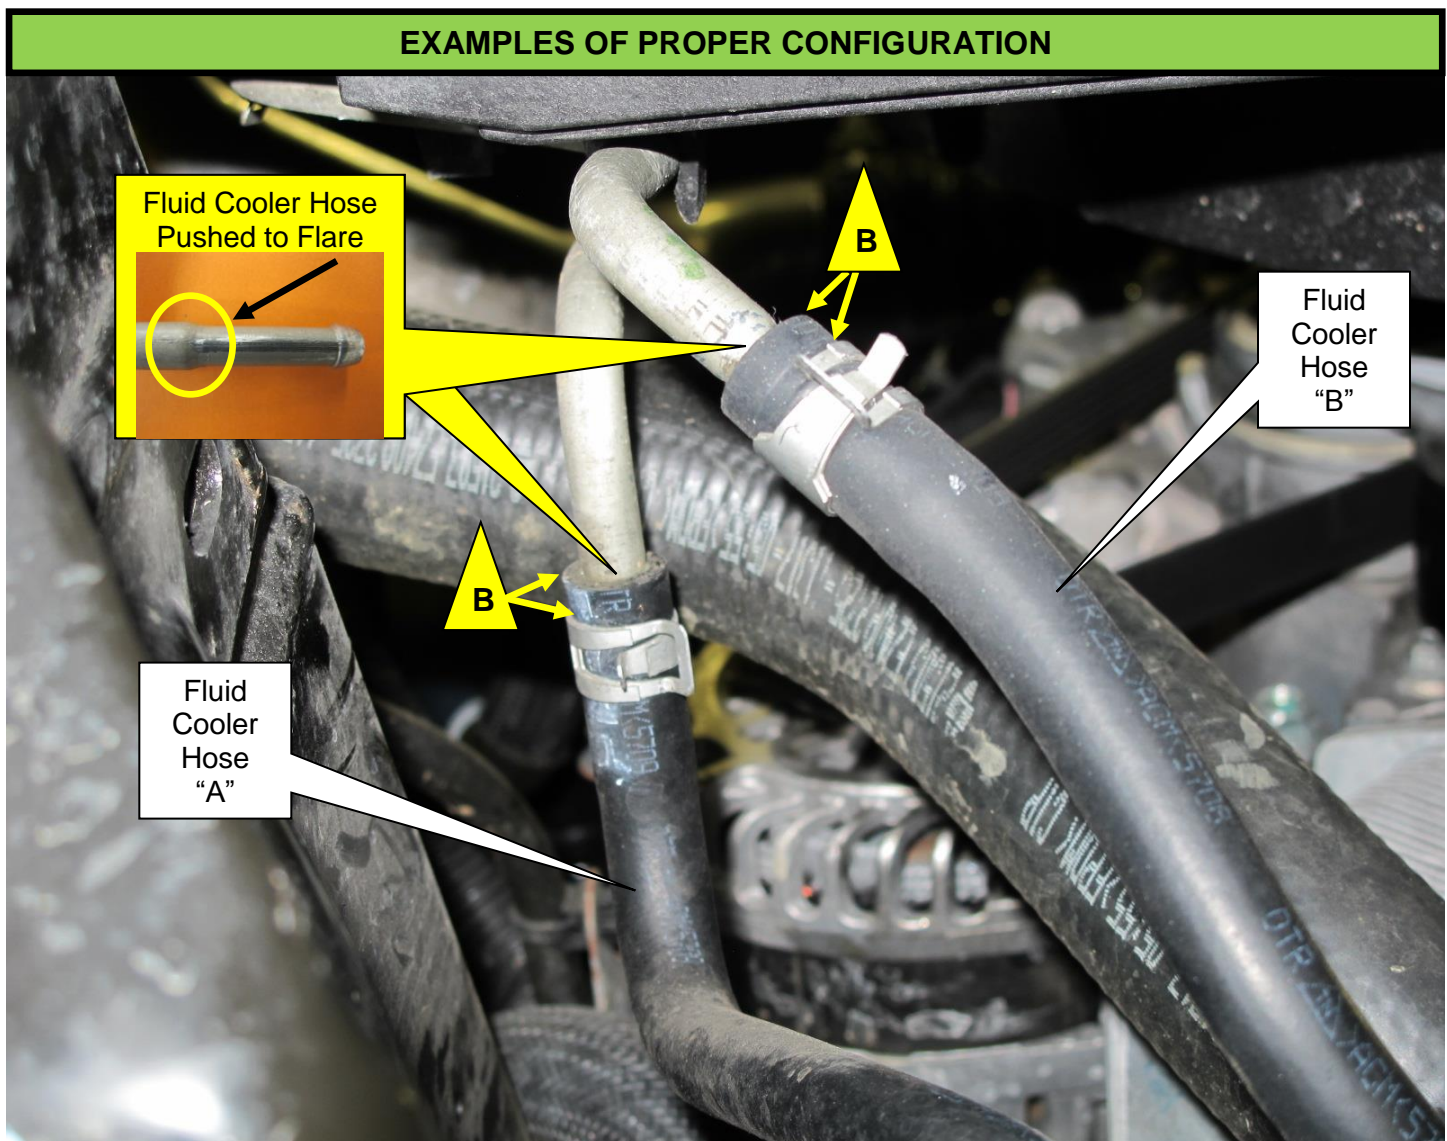
Figure 5

6. Inspect A/T Fluid Cooler Hose "A" and "B" connections for proper configuration (Figure 5).

A. A/T Fluid Cooler hose placement: Hose pushed all the way to flare.

B. Clamp placement **B**; clamp located 5MM to 9MM or approximately (3/16 to 3/8 inch) from end of hose.

8. CORRECT ANY HOSES NOT PROPERLY INSTALLED, REFERENCE STEP 6 (FIGURE 5).

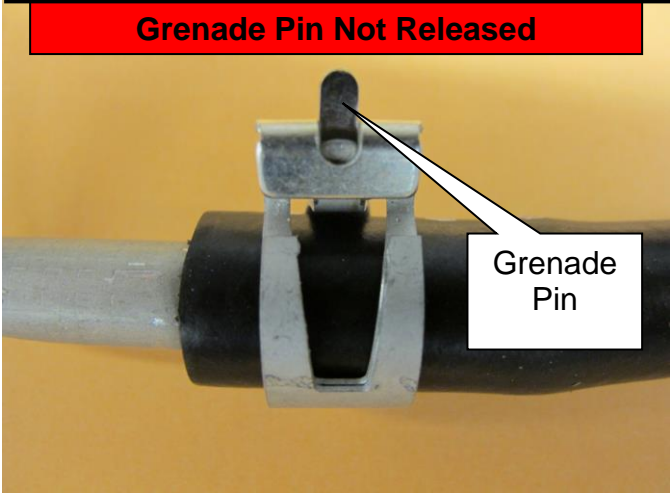
Figure 6

- Grenade pin not released (Figure 6).
- Clamp not seated properly on hose (Too close to the end of the hose) (Figure 7).
- Clamp not seated properly on hose (Too close to barb lip) (Figure 8).
- Hose placement not correct (Check hose insertion length) (Figure 9).

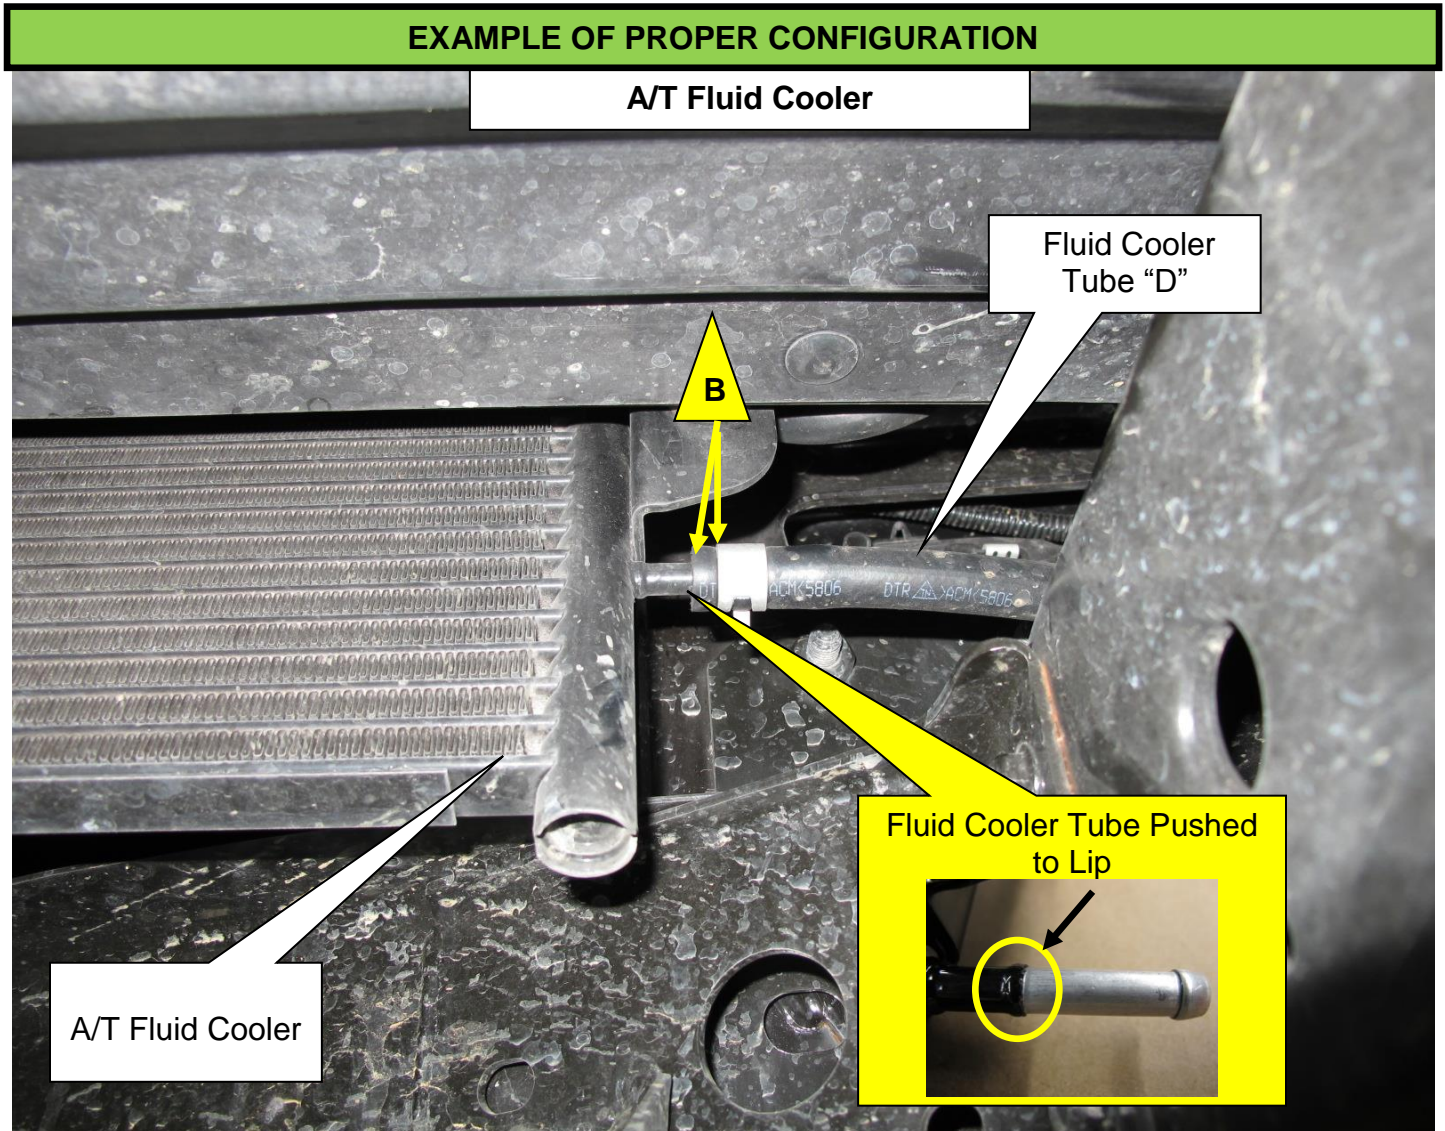
Figure 12

11. Inspect fluid cooler tube "D" for proper configuration (Figure 12).

A. A/T Fluid Cooler hose placement: Fluid cooler tube pushed to lip.

B. Clamp placement **B**: clamp located 5MM to 9MM or approximately (3/16 to 3/8 inch) from end of hose.

13. CORRECT A/T FLUID COOLER HOSE IF NOT PROPERLY INSTALLED, REFERENCE STEP 11 (FIGURE 12).

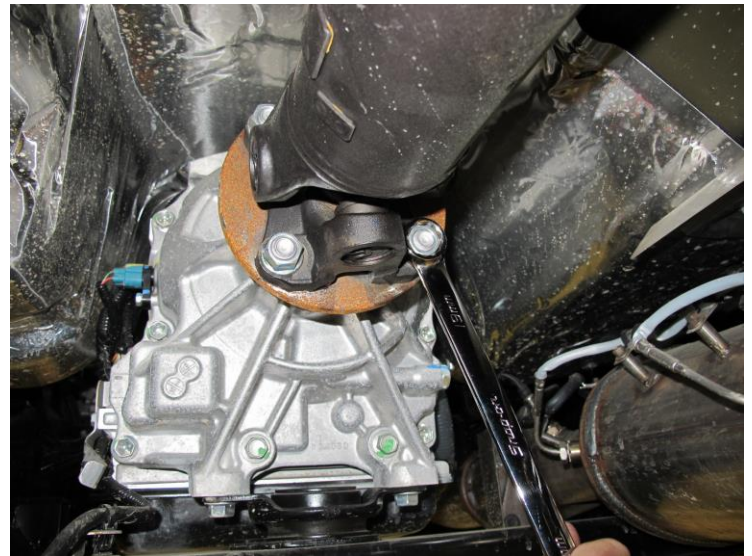
Figure 2

2. Using a suitable tool apply LIGHT to MODERATE force to one of the 19MM nuts, repeat on the other nuts (Figure 2).

A. If **any** of the nuts move (NOT the prop shaft) **replace all 4** of the rear prop shaft bolts and nuts, (see Parts Information below).

- Torque NEW Rear Prop Shaft bolts and nuts:
105N·m (77 ft-lb)
