CAMPAIGN BULLETIN

Automatic Transmission Dealer Inventory

Reference: PC566
Date: April 28, 2017

PC566 – TITAN XD (A61D, 4WD) MULTI-POINT INSPECTION

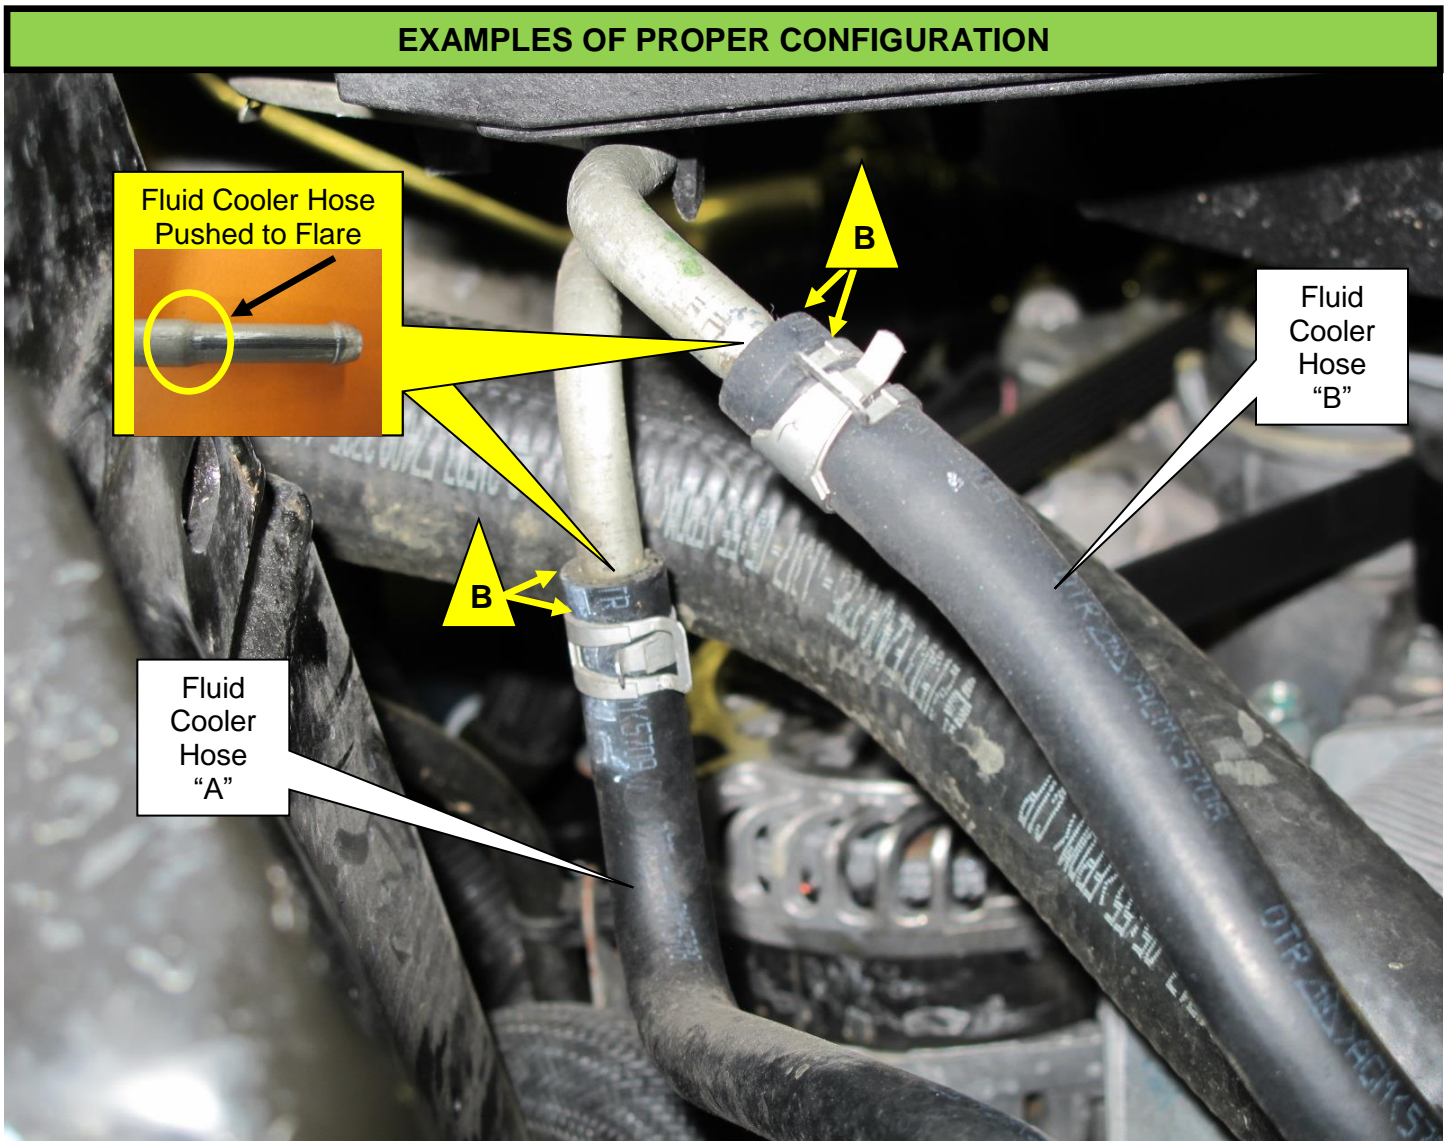
Figure 6

6. Inspect A/T Fluid Cooler Hose "A" and "B" connections for proper configuration (Figure 6).

A. A/T Fluid Cooler hose placement: Hose pushed all the way to flare.

B. Clamp placement **B**; clamp located 5MM to 9MM or approximately (3/16 to 3/8 inch) from end of hose.

8. CORRECT ANY HOSES NOT PROPERLY INSTALLED, REFERENCE STEP 6 (FIGURE 6).

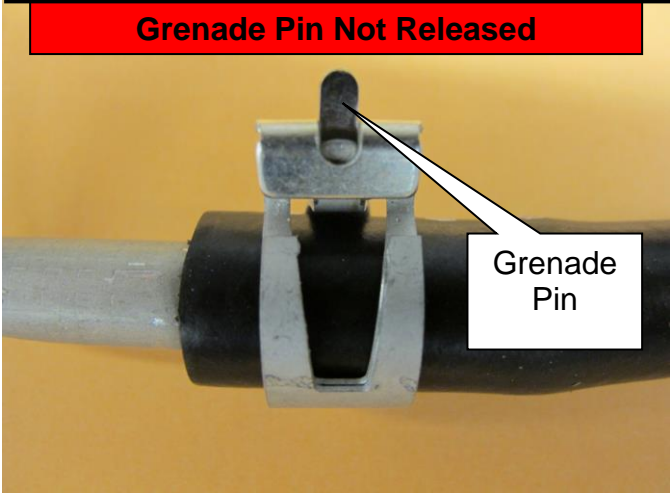
Figure 7

- Grenade pin not released (Figure 7).
- Clamp not seated properly on hose (Too close to the end of the hose) (Figure 8).
- Clamp not seated properly on hose (Too close to barb lip) (Figure 9).
- Hose placement not correct (Check hose insertion length) (Figure 10).

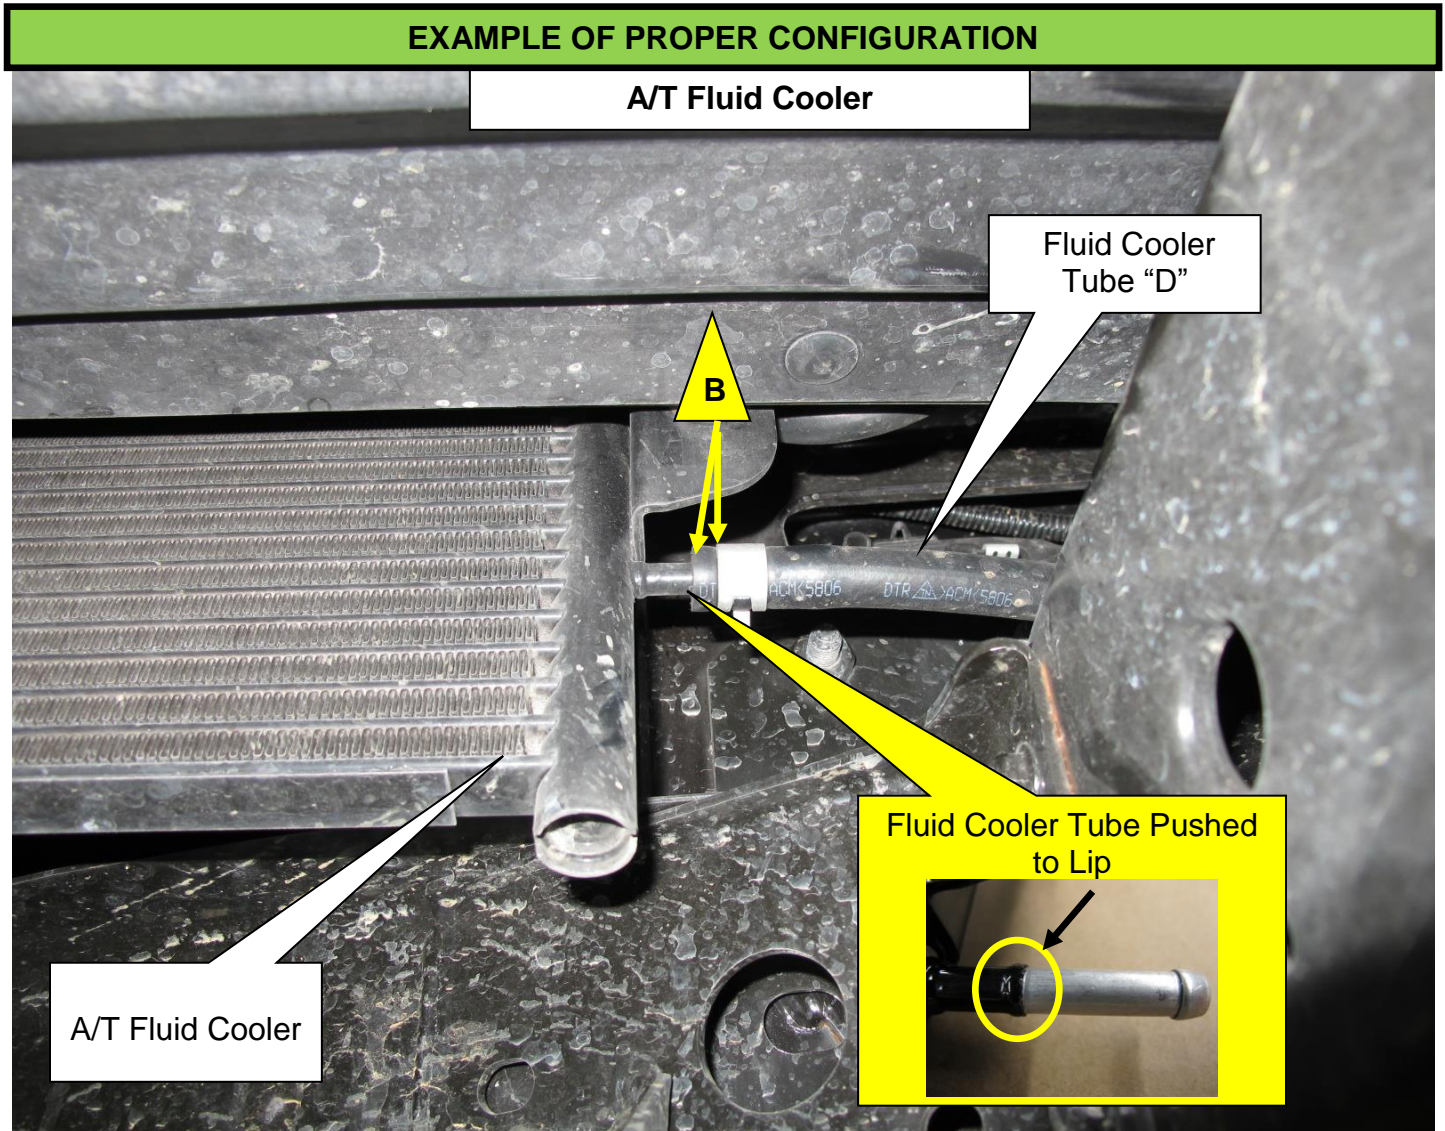
Figure 13

11. Inspect fluid cooler tube "D" for proper configuration (Figure 13).

A. A/T Fluid Cooler hose placement: Fluid cooler tube pushed to lip.

B. Clamp placement **B**: clamp located 5MM to 9MM or approximately (3/16 to 3/8 inch) from end of hose.

13. CORRECT A/T FLUID COOLER HOSE IF NOT PROPERLY INSTALLED, REFERENCE STEP 11 (FIGURE 13).

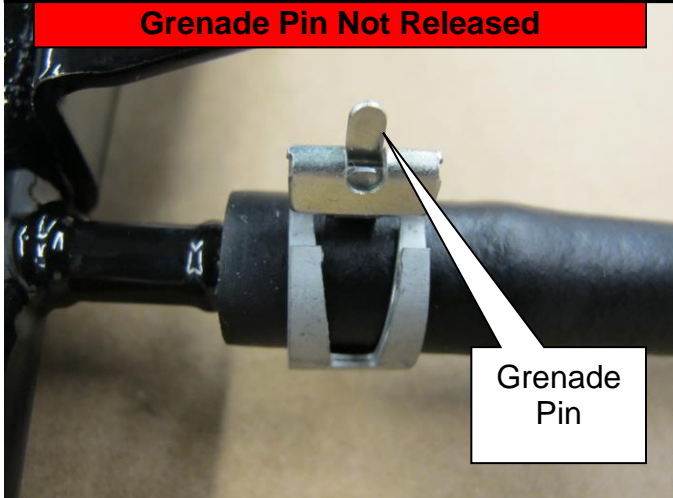
Figure 14

- Grenade pin not released (Figure 14).
- Clamp not seated properly on hose (Too close to the end of the hose) (Figure 15).
- Clamp not seated properly on hose (Too close to barb lip) (Figure 16).
- Hose not seated properly on barb (Check hose insertion length) (Figure 17).

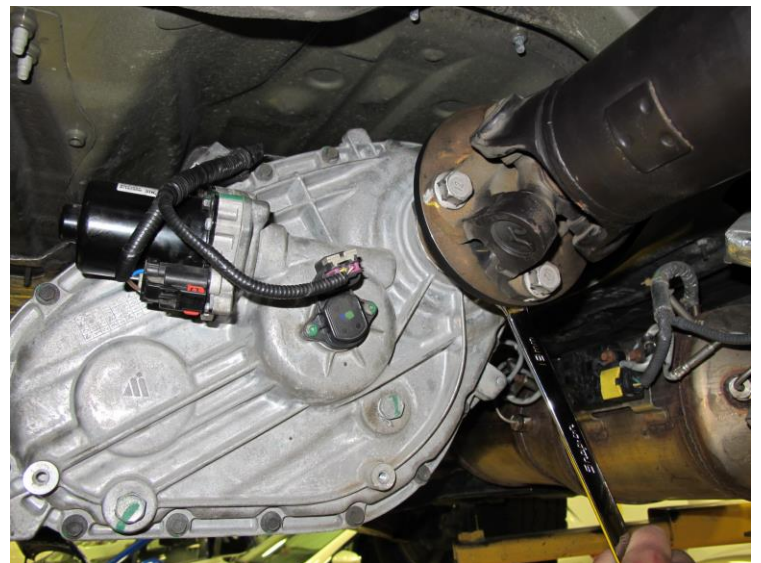
Figure 2

2. Using a suitable tool apply LIGHT to MODERATE force to one of the 19MM nuts, repeat on the other nuts (Figure 2).
 - A. If **any** of the nuts move (NOT the prop shaft) **replace all 4** of the rear prop shaft bolts and nuts, (see Parts Information below).
 - Torque NEW Rear Prop Shaft bolts and nuts:
105N·m (77 ft-lb)
 - B. If nuts do not move (are tight) go to inspection 3.

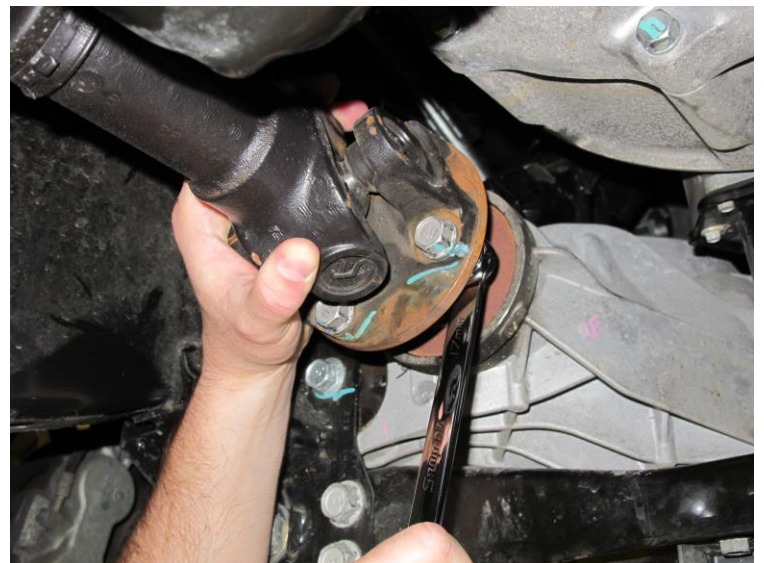
Figure 2

2. Place a 17MM box end wrench on one of the inside nuts, while holding the Prop Shaft in place apply LIGHT to MODERATE force, repeat on the other bolts. (Figure 2):
 - A. If **any** of the nuts move (NOT the prop shaft) **replace all 4** of the front prop shaft bolts and nuts, (see Parts Information below).
 - Torque NEW Front Prop Shaft bolts and nuts:
80N·m (59 ft-lb)
 - B. If nuts do not move (are tight) go to Inspection 4.
3. Once Inspection is complete and all bolts have been checked for torque and/or replaced, move to Inspection 4.

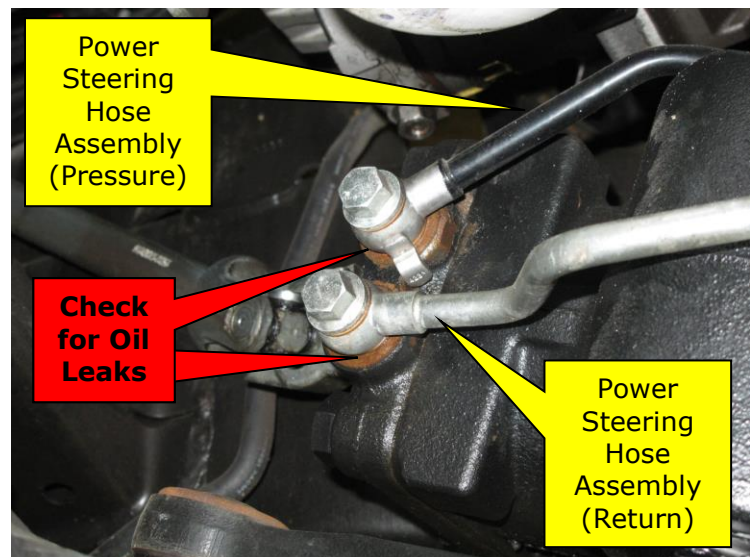
Figure 3

2. Inspect for **LEAKS** between the Steering Gear Box and Power Steering Hose Assembly (Pressure) and Power Steering Hose Assembly (Return) eye bolt connections (Figure 3).

- If **NO LEAK** found, inspection is complete, proceed to step 13 to install front under cover.
- If **LEAK** found, proceed to step 3.
