GROUP CLI	MODEL 2017MY Sorento (UMa)
	NUMBER 037	DATE January 2017
TECHNICAL SERVICE BULLETIN		
SUBJECT: SERVICE ACTION: DRIVER'S SIDE HVAC TEMPERATURE OPTIMIZATION (SA274)

This issue number is SA274

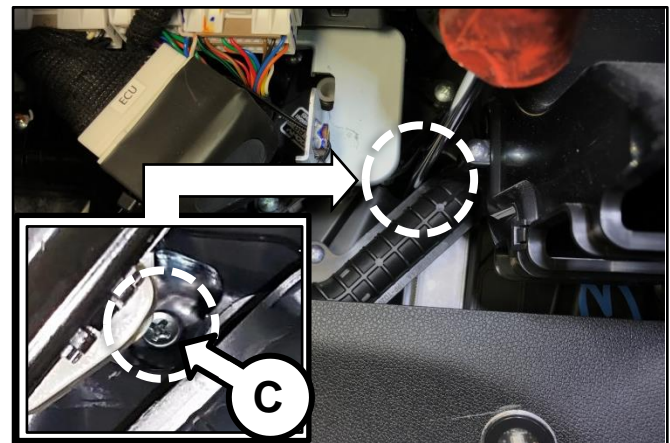
This bulletin provides information related to the Heating Ventilation and Air Conditioning (HVAC) system on some 2017MY Sorento vehicles equipped with Dual Air Temperature Control (DATC) produced from August 1, 2016 to December 18, 2016, which may experience poor heater performance on the driver's side due to a binding mix door. Follow the procedure below to repair and/or prevent the door from binding. Before conducting the procedure, verify that the vehicle is included in the list of affected VINs.

3. Insert a 12" Phillips screwdriver into the opening and turn the screw (C) 90° degrees counter-clockwise to enhance the mix door fitment.
