GROUP ELE	MODEL 2016-2017MY Sorento (UMa)
	NUMBER 115	DATE January 2017
TECHNICAL SERVICE BULLETIN		
SUBJECT: AVN 4.0 SOFTWARE UPDATE FOR "BLUETOOTH PHONEBOOK DOWNLOADS AT EVERY VEHICLE START"

This bulletin provides the procedure for updating the AVN 4.0 (Audio/Video/Navigation) software on some Sorento (UMa) vehicles that frequently display a 'Priority phone pop-up' or 'Phonebook download pop-up' at vehicle startup. Additionally, voice guidance that the phonebook is downloading is heard and the customer is unable to stop or skip the voice guidance. This concern typically happens when more than one (1) phone has been paired. Follow the procedure outlined in this bulletin to improve the AVN 4.0 logic.

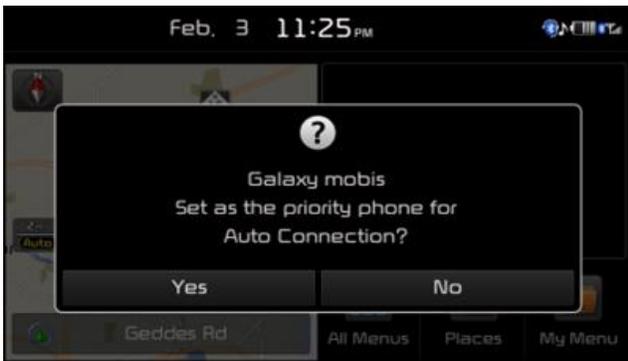
Priority phone pop-up message

The two (2) images above should only appear when pairing a new phone, not each time the ignition is turned on.

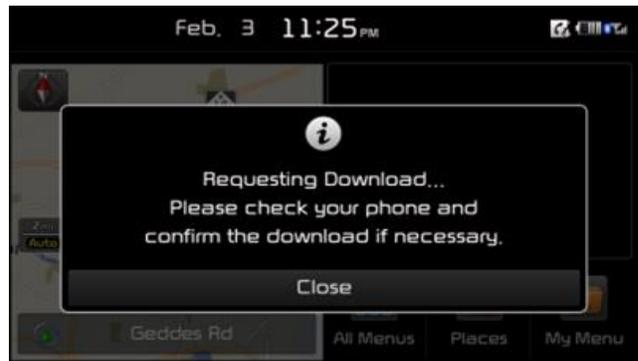
Phonebook download pop-up message
