GROUP ELE	MODEL 2015MY K900 (KH)
	NUMBER 122	DATE January 2017
TECHNICAL SERVICE BULLETIN		
SUBJECT: PREMIUM NAVIGATION UNIT SOFTWARE UPGRADE

This bulletin provides the procedure for upgrading the navigation system software of some 2015MY K900 (KH) vehicles, produced from January 2, 2014 through March 17, 2015, to resolve concerns related to “Application Error” messages on the navigation screen and system reboots or blank screen concerns.

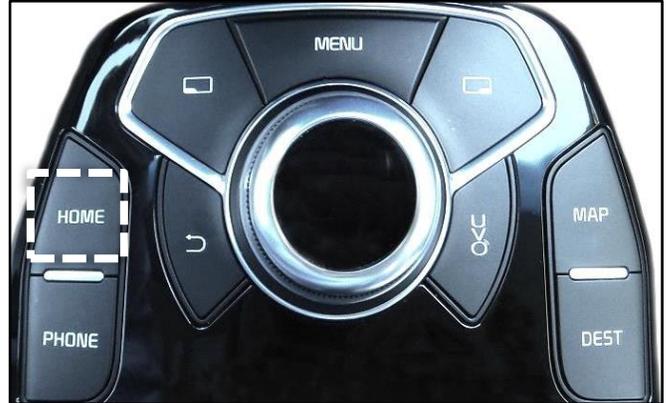
1. Press the **HOME** button on the controller.

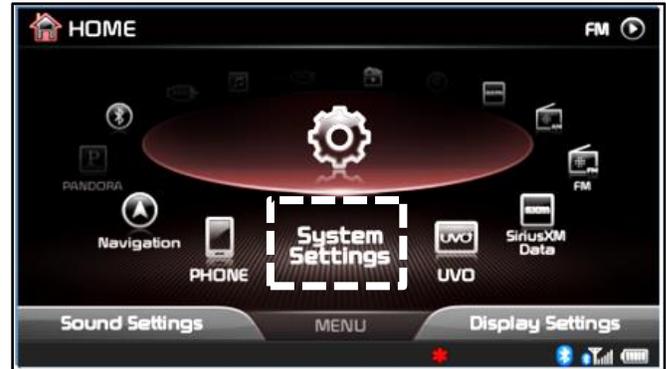
2. Using the controller knob, select **System Settings** on the screen.

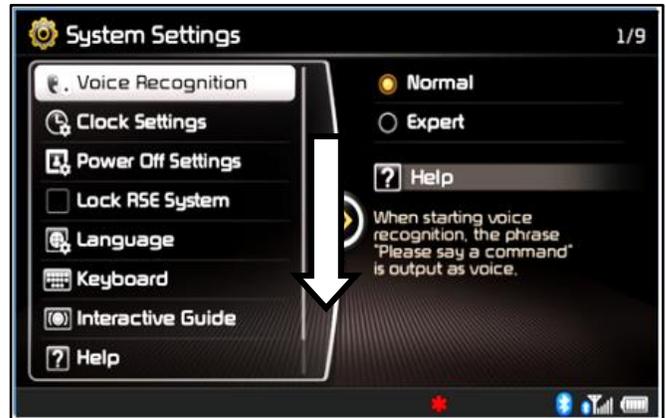
3. Scroll down and select **System Update**.

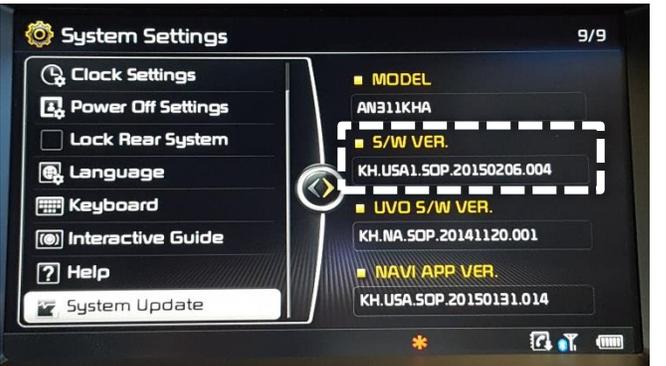
4. Record the current software version.

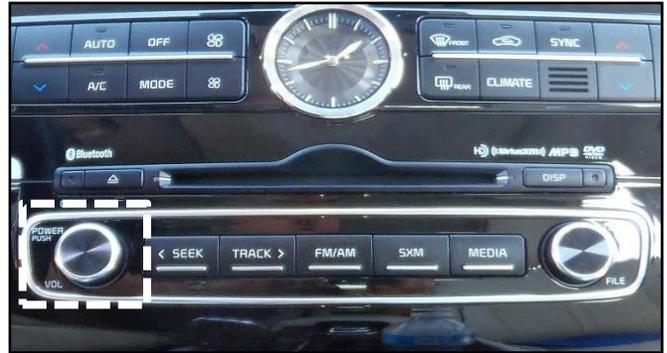
4. After inserting the AUM USB connector into the USB port of the vehicle, ensure the head unit is ON.

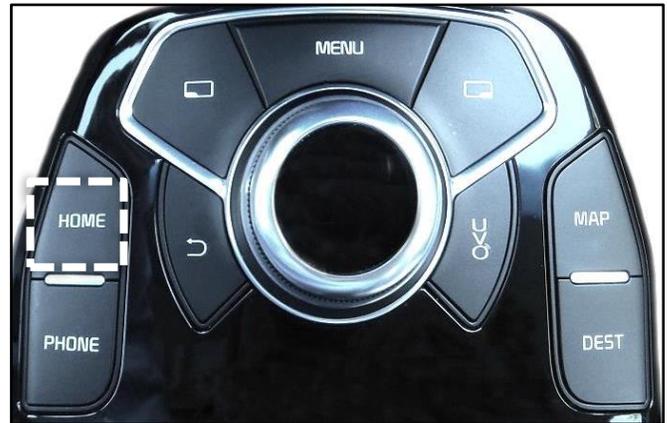
5. Press the **HOME** button on the controller.

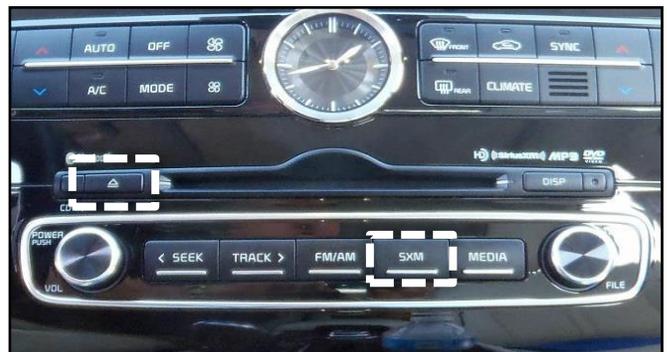
6. Press and hold the CD EJECT button (⏏) on the center stack and then press the SXM button four (4) times in a quick succession.

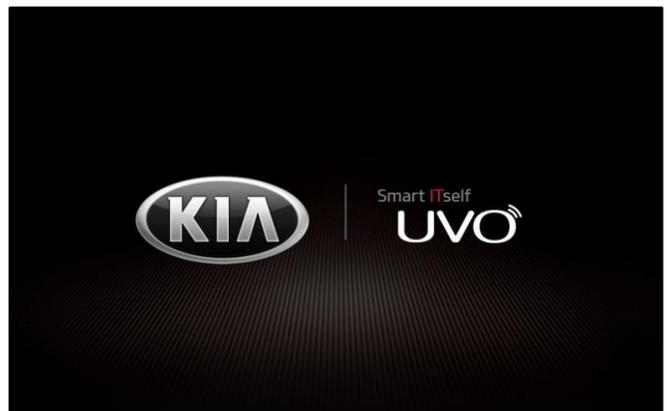
7. The system will restart automatically and then the update will begin.

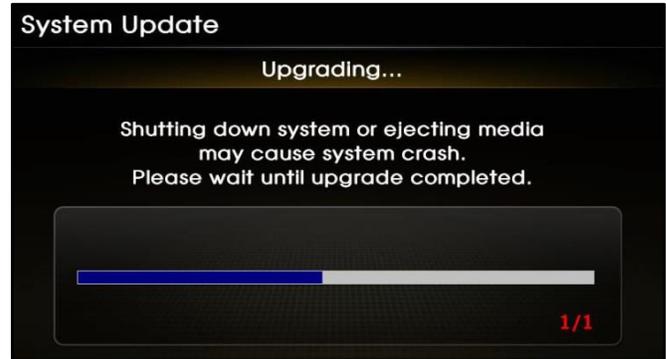
8. The progress bar will display, as shown.

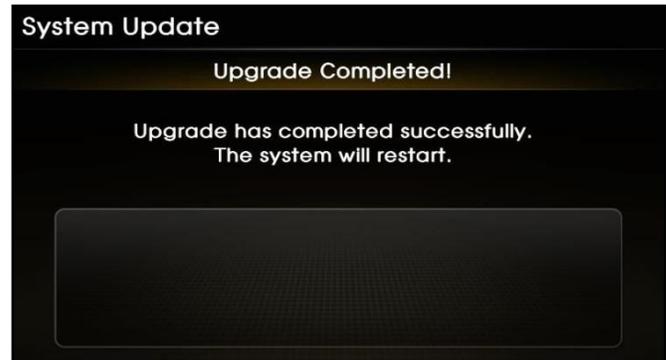
9. When the update is complete, the system will automatically start.
