MODEL
2016MY
Sorento (UMa)

NUMBER
123

TECHNICAL SERVICE BULLETIN

SUBJECT: DARK BACK-UP CAMERA DISPLAY ON
UVO eSERVICES (UVO 2.0)

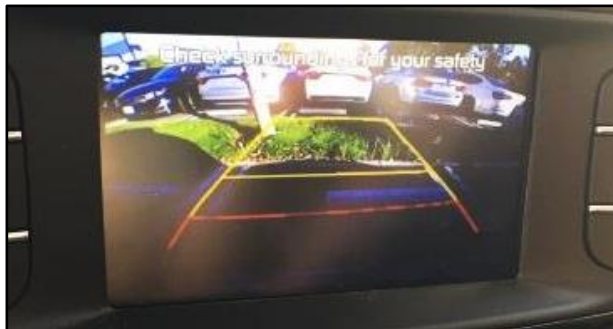
This bulletin provides the procedure to upgrade the UVO 2.0 software on some 2016MY Sorento (UMa) vehicles, produced from October 27, 2014 to April 26, 2016, which may experience a “dark” back-up camera display in situations in which there is partial shade and bright sunlight causing high contrast. This may occur when backing out of a garage or when parked under trees and is dependent upon the sun position in the sky. Follow the procedure outlined in this bulletin to improve the brightness of the back-up camera.

Camera Display Before Update

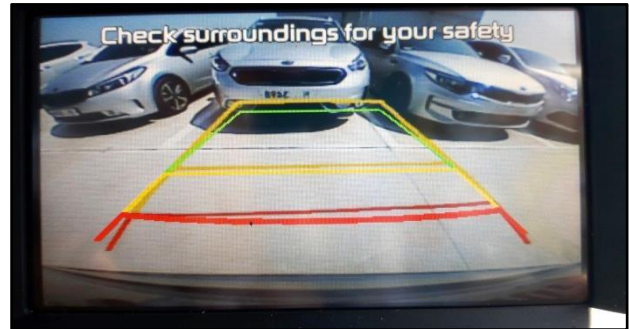
Camera Display After Update
