| | GROUP ELE | MODEL 2014-2015MY Forte Koup (YD) |
| | NUMBER 125 | DATE January 2017 |
| TECHNICAL SERVICE BULLETIN | | |
| SUBJECT: OUTSIDE REAR COMBINATION LED LAMP ASSEMBLY REPLACEMENT | | |

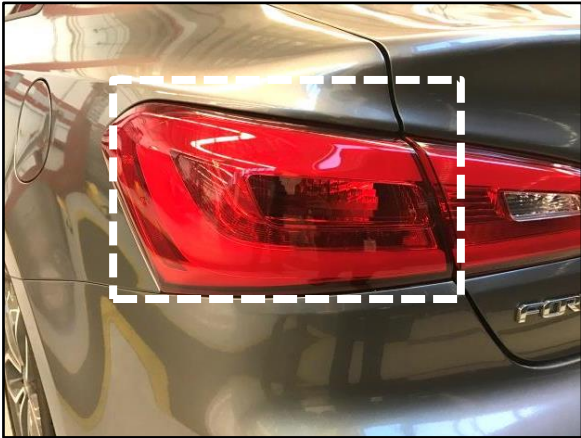
Outside Left Rear Combination Lamp

This bulletin provides the procedure to replace the outside rear combination lamp(s) (LED type) on some 2014-2015MY Forte Koup (YD) vehicles, produced from October 14, 2013 to July 1, 2014, which may experience an intermittently inoperative LED portion of the outside rear combination lamp due to a poor solder joint on the printed circuit board. Follow the procedure outlined in this bulletin to replace the outside rear combination lamp(s) with the inoperative LED portion(s), then inspect the LOT No. of the other outside rear combination lamp by following the inspection procedure on page 3 of this bulletin and replace the lamp if necessary.

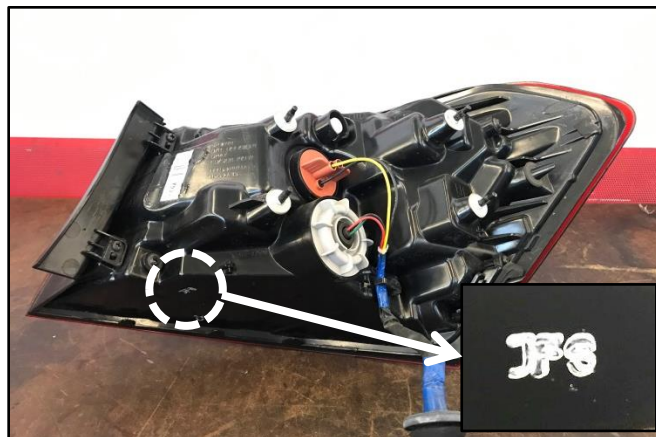
Note: If LOT No. is “JGB” (stamped on the bottom of the lamp assembly), the production date is July 2, 2014; therefore, no further action is required. If the production date is on or before July 1, 2014, LOT No. “JGA”, replacement of the outside rear combination lamp is required.

1. Repeat steps 1 to 5 of the service procedure on page 2 to remove the outside rear combination lamp.
2. Locate the LOT number on the bottom of lamp and verify the production date of the lamp by referring to the LOT number identification table on page 4.

3. If the LOT number of the lamp is on or before JGA (July 1, 2014), replace the lamp with the improved part. Reinstall all removed components in the reverse order of removal.

If the LOT number of the lamp is on or after JGB (July 2, 2014), no further action is required. Reinstall all removed components in the reverse order of removal.
