KIN	GROUP FUE NUMBER	MODEL 2014-2015MY Sorento (XMa) DATE	
033 January 2017 TECHNICAL SERVICE BULLETIN				
SUBJECT:	FILL LEVEL LIMIT	VALVE REPLACE	EMENT

This bulletin provides information related to the fill level limit valve (FLLV) replacement on some Sorento (XMa) vehicles, produced from December 17, 2012 to December 11, 2014, which may exhibit a Malfunction Indicator Light (MIL) illuminated in the Electronic Control Module (ECM) with system-related DTC: P0455. To correct this concern, follow the procedure outlined in this bulletin. Replacement of fuel tank is not necessary.

FILL LEVEL LIMIT VALVE REPLACEMENT

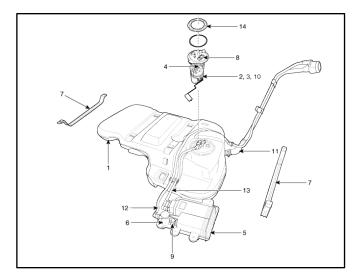
The <u>green</u>-colored FLLV shown is for demonstration purposes only. Color of removed FLLV may vary.
