MODEL
2015MY
Sedona (YP)

NUMBER
PS466

REPETITIVE KNOCKING NOISE EMANATING FROM ONE OR BOTH FRONT STRUTS

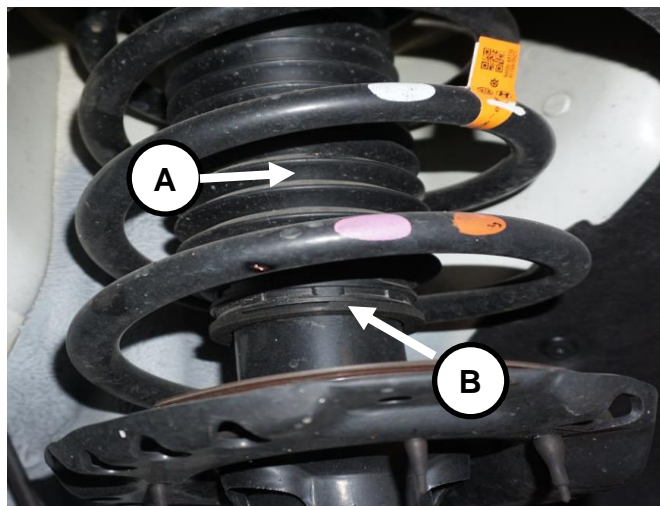
On some 2015MY Sedona's produced between July 21, 2014 through September 21, 2014, customers may complain of a repetitive knocking noise emanating from the front strut or suspension areas of the vehicle. This noise is more noticeable during a parking lot maneuver at slow speeds, especially over speed bumps.

1. Place the vehicle on the lift.
2. Locate the strut bellows (A) and striker cap (B).
