GROUP <b>BOD</b>	MODEL <b>2014-2015MY Soul (PS)</b>
	NUMBER <b>133</b>	DATE <b>March 2017</b>
<b>TECHNICAL SERVICE BULLETIN</b>		
<b>SUBJECT: INSTRUMENT PANEL PAD NOISE REPAIR</b>

## INSTRUMENT PANEL PAD NOISE REPAIR

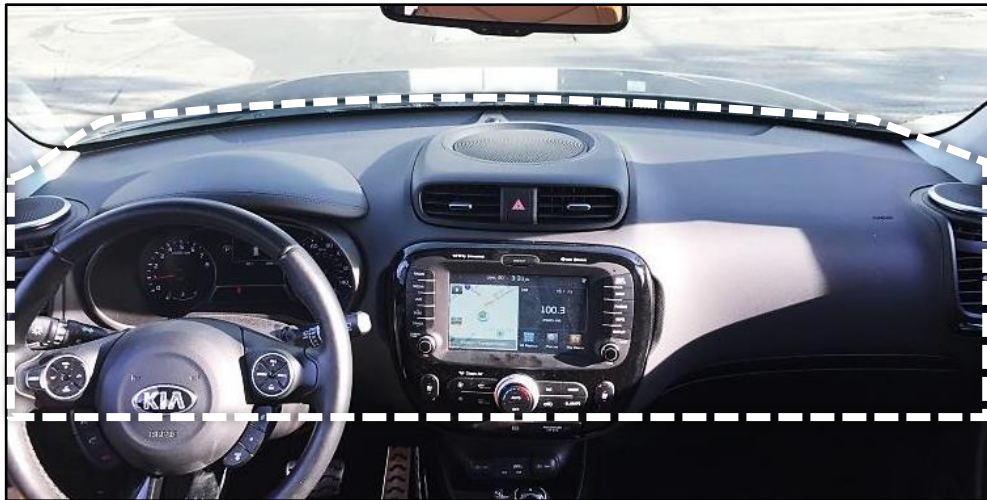
Instrument Panel

This bulletin provides information relating to some 2014-2015MY Soul (PS) vehicles, produced from July 21, 2013 to February 14, 2015, which may experience a rattle sound from the upper area of the instrument panel during turns or while driving over bumps or rough roads. This sound may be more prevalent during cold temperatures. Follow the procedure outlined in this bulletin to correct the concern.
