MODEL
2017MY Sportage
(QL)

NUMBER
035

TECHNICAL SERVICE BULLETIN

SUBJECT: A/C EVAPORATOR CORE REPLACEMENT

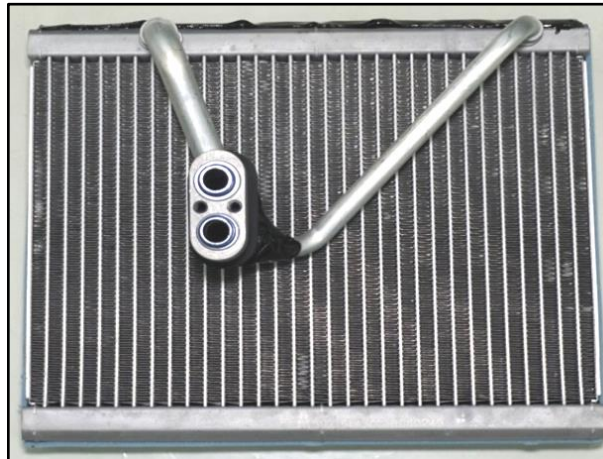
This bulletin provides information about the A/C evaporator core replacement on certain 2017MY Sportage (QL) vehicles, produced between December 10, 2015 and December 12, 2016, which may exhibit poor A/C performance due to a refrigerant leak caused by a defective tube weld at the A/C evaporator core. To correct this condition, follow the procedure outlined in this bulletin.
