GROUP ELE	MODEL 2017MY Forte (YDm)
NUMBER 124 (Rev 2, 03/07/2017)	DATE January 2017

TECHNICAL SERVICE BULLETIN

SUBJECT: SERVICE ACTION: SOFTWARE UPGRADE FOR AUDIO POWER ON IMPROVEMENT (SA264A)

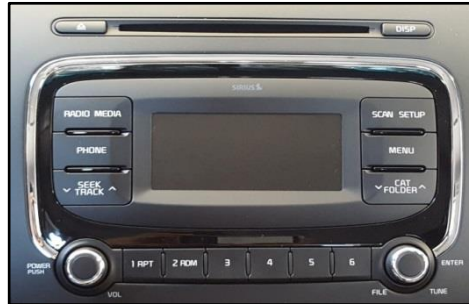
This bulletin provides the procedure to upgrade the Base Audio Gen 3.0 Type A software on some 2017 Forte (YDm) vehicles, produced from May 16, 2016 to November 24, 2016, which may experience an intermittent power-on concern after vehicle ignition is switched on and an error message: “Park the vehicle first to operate Bluetooth setting” while the gear shifter is in “Park” position. Follow the procedure outlined in this bulletin to correct the concern. Before conducting the procedure, verify that the vehicle is included in the list of affected VINs.
