GROUP ELE	MODEL 2016MY Optima (JFa)
	NUMBER 130	DATE March 2017
<b>TECHNICAL SERVICE BULLETIN</b>		
<b>SUBJECT: SERVICE ACTION: ANTENNA INSPECTION AND/OR REPLACEMENT (SA272)</b>

## ANTENNA INSPECTION AND/OR REPLACEMENT (SA272)

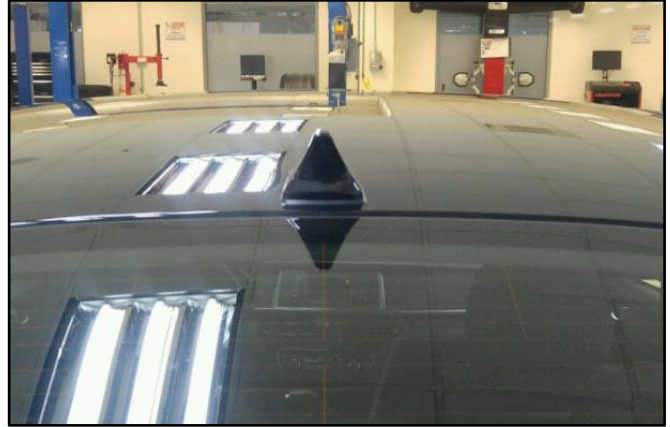
1. With medium force, push the antenna from side to side to verify that the antenna cap is not broken. If a cracking noise is heard or if the cap comes loose, replacement of the antenna assembly is necessary. If cap is found to be structurally sound, no further action is required.
