GROUP ENG	MODEL 2017MY Optima (JF HEV/PHEV)
NUMBER 166	DATE April 2017

TECHNICAL SERVICE BULLETIN

SUBJECT: SERVICE ACTION: HYBRID STARTER GENERATOR (HSG)
PULLEY NUT INSPECTION AND/OR HSG REPLACEMENT (SA289)

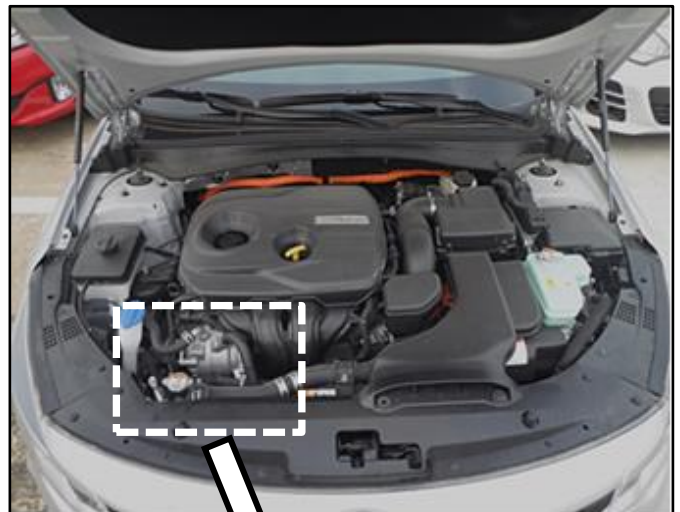
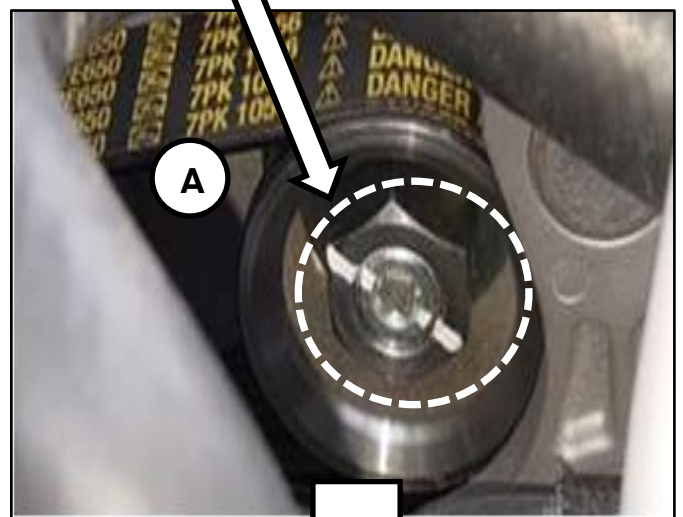
- If the mileage is less than **6,500 miles**, replace the HSG assembly, regardless of the paint mark on the HSG pulley (A). (Refer to the [“Replacement Procedure”](#) on page 3.)

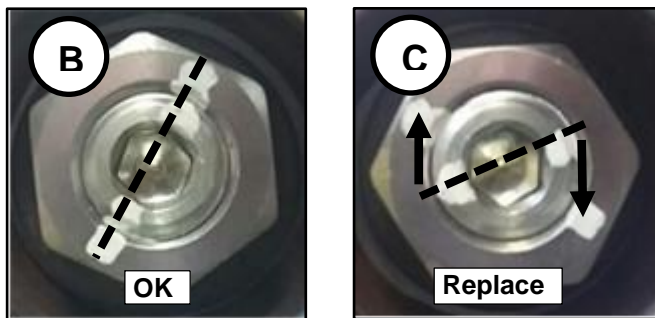
Inspection criteria if vehicle odometer is over 6,500 miles

- If the mileage is more than 6,500 miles,
 - If the paint mark is aligned (B), no further action is required, or
 - If the paint mark is **not** 100% aligned (C), replace the HSG assembly. (Refer to the [“Replacement Procedure”](#) below.)
