GROUP <b>Service Campaign</b>	MODEL <b>2014MY Soul (PS)</b>
	NUMBER <b>SC144</b>	DATE <b>March 2017</b>
<b>VOLUNTARY SERVICE CAMPAIGN</b>		
<b>SUBJECT:                   DRIVESHAFT HUB NUT (LH/RH)                                   REPLACEMENT (SC144)</b>

## DRIVESHAFT HUB NUT (LH/RH) REPLACEMENT (SC144)

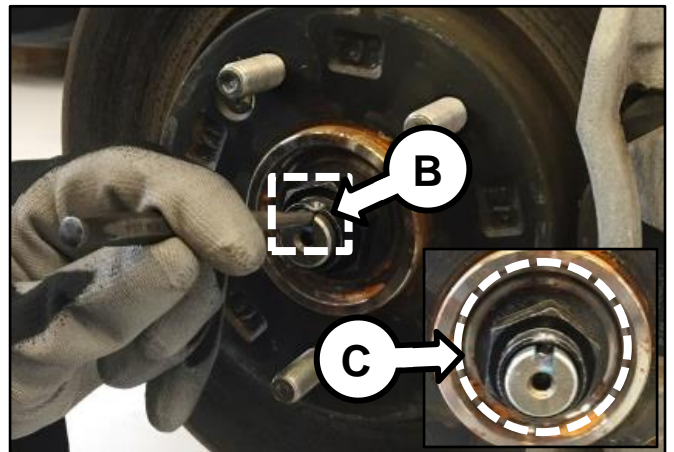
This bulletin provides information on some 2014MY Soul (PS) vehicles, produced from July 21, 2013 through May 26, 2014, which may exhibit loosening of the driveshaft hub nut while driving. A loose hub nut can damage the axle bearing, eventually resulting in bearing noise and wheel vibration while driving. To correct this concern, follow the procedure outlined in this bulletin to replace both left and right front axle driveshaft hub nuts. Before conducting the procedure, verify that the vehicle is included in the list of affected VINs.

3. Using a chisel or other similar tool and hammer, completely release both front left and right driveshaft hub nut stakings (B) then remove and discard the driveshaft hub nuts (C).

**Make sure the driveshaft threads are cleaned and free of debris before proceeding to the next step.**

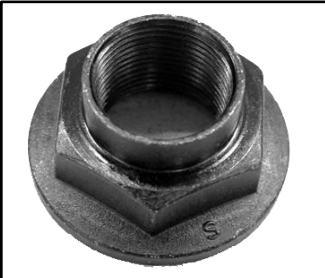
Improved driveshaft hub nut collar is thicker and threaded at the staking section
