GROUP  
**Electrical**

MODEL  
**2014-2015MY  
Optima (QF)**

NUMBER  
**PS464 (Rev 1, 5/1/2017)**

**SUBJECT: NO COMMUNICATION WITH BLIND SPOT DETECTION AFTER COLLISION REPAIRS**

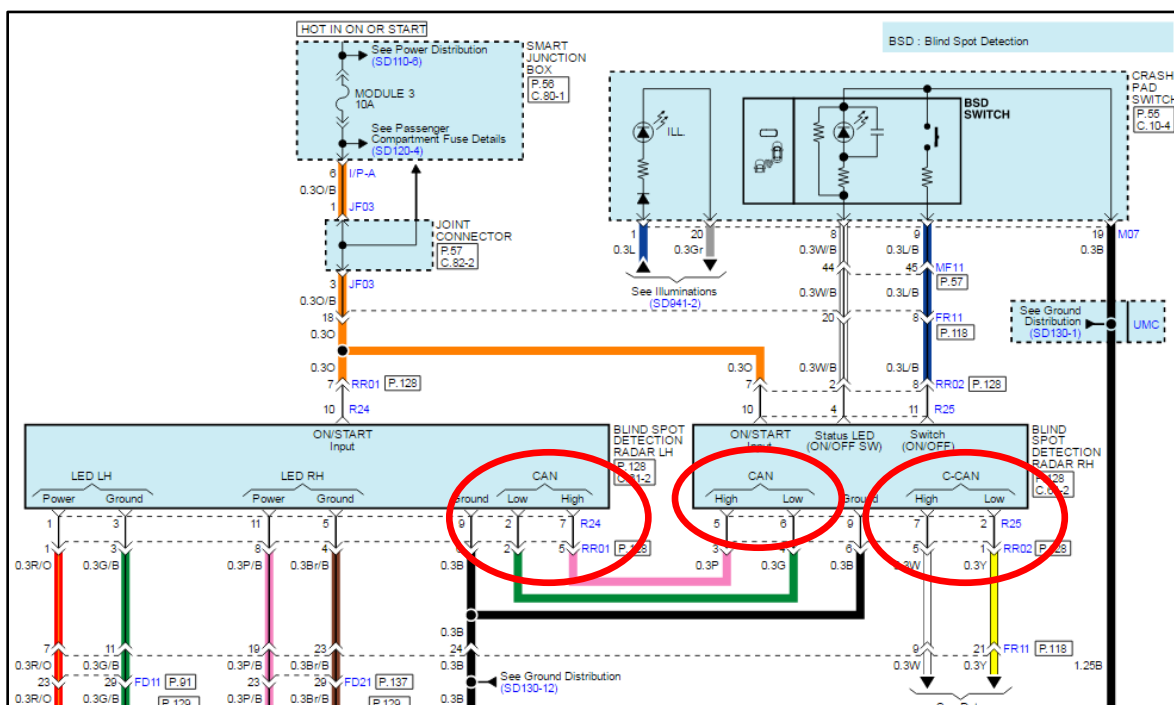
This Pitstop provides information relating to 2014-2015MY Optima (QF) vehicles with Blind Spot Detection (BSD), which may exhibit a “Check BSD System” message and no communication with the BSD system after collision repairs. This concern is commonly caused by the rear bumper harness installed backwards.

The master BSD module, located at the right side of the rear bumper, is the only BSD module that communicates on the C-CAN. The slave module (left side of bumper) communicates to the master module via local network CAN. The master (RR02) and slave (RR01) module connectors are physically identical and may be mistakenly swapped.

To confirm correct installation of the harness, verify that the yellow and white wires of the master (RR02) module connector are at pins 1 (yellow) and 5 (white). See diagram below.

It is important to note that the BSD system calibration must be performed after any rear collision repairs. Failure to do so can result in improper BSD system operation.
