GROUP BOD	MODEL 2017MY Sorento (UMa)
	NUMBER 169 (Rev 1, 05/15/2017)	DATE May 2017
TECHNICAL SERVICE BULLETIN		
SUBJECT: SERVICE ACTION: PANORAMIC SUNSHADE ROLLER GUIDE ADJUSTMENT (SA291)

SUBJECT: PANORAMIC SUNSHADE ROLLER GUIDE ADJUSTMENT (SA291)

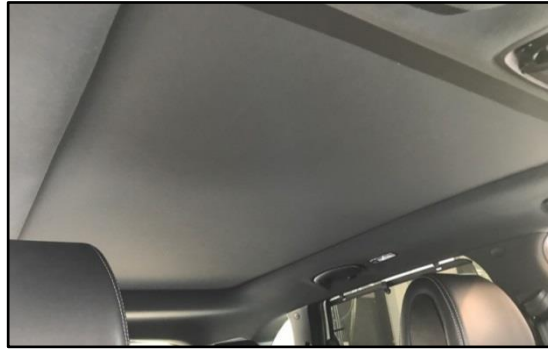
This bulletin provides the procedure to adjust the panoramic sunshade roller guide on some 2017MY Sorento (UMa) vehicles, produced from November 16, 2016 to February 3, 2017, which may experience a slow sunshade operation or squeak noise when the sunshade is reaching the closed position. The concern is caused by interference of the sunshade to the roller guides. Follow the procedure outlined in this bulletin to adjust the sunshade roller guide. Sunroof assembly replacement is not required to repair this condition. Before conducting the procedure, verify that the vehicle is included in the list of affected VINs.
