GROUP BOD	MODEL 2016MY Sorento (UMa)
	NUMBER 125 (Rev 1, 02/27/2017)	DATE August 2016
TECHNICAL SERVICE BULLETIN		
SUBJECT: PANORAMIC SUNROOF SLOW TO CLOSE AND/OR ABNORMAL NOISE WHEN CLOSING

This bulletin provides the procedure to repair a panoramic sunroof that exhibits a slow to close condition and/or abnormal noise when closing, on some 2016MY Sorento (UMa) vehicles produced from October 27, 2014 through January 23, 2016. Follow the procedure in this bulletin to clean, lubricate, and replace the rear tilt levers to correct the concern. Do NOT replace the sunroof assembly for this concern.

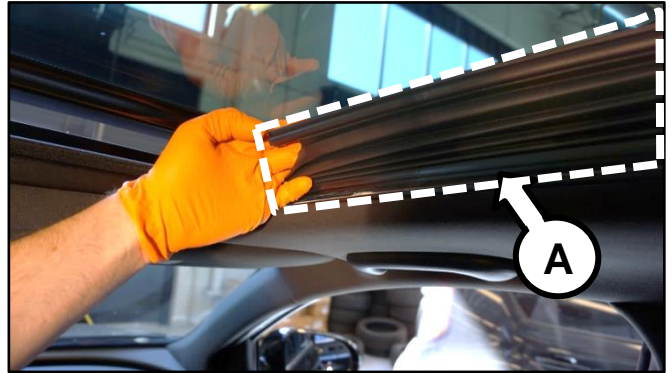
2. With the panoramic sunroof roller blind retracted, carefully remove the accordion covers (A) on the right and left side.

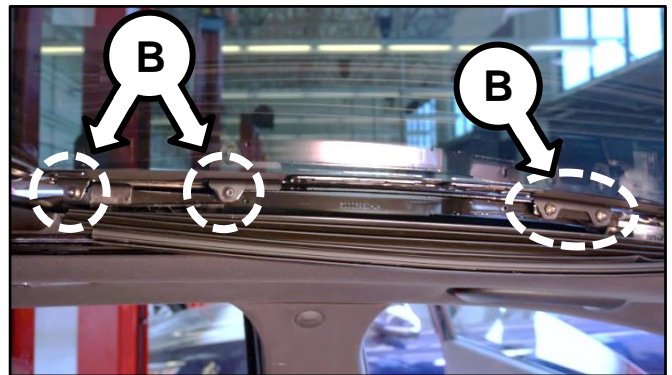
3. Using a T25 Torx® socket, remove the four (4) screws (B) on the right and left side.

Use caution not to scratch or damage the glass during removal of the screws.

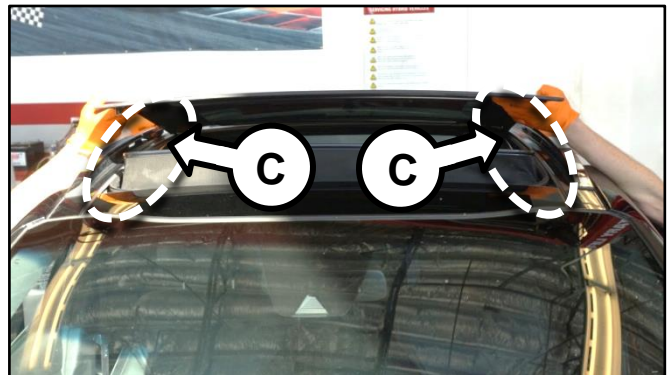
4. With the assistance of another person, remove the panoramic sunroof glass by sliding the glass towards the front of the vehicle until the sliders are out of the tracks (C).

Use caution not to scratch, damage, or break the glass during removal.

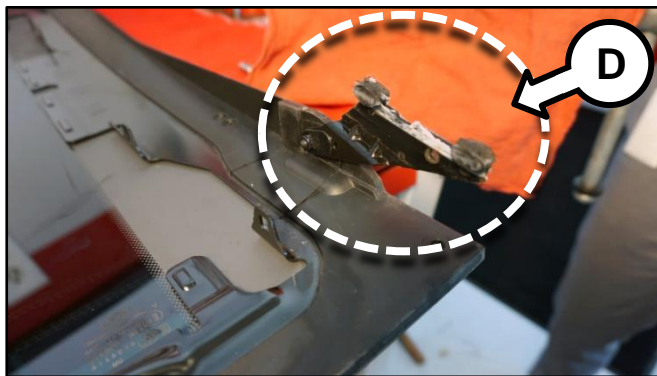
5. Lay the glass on a soft, flat, protected surface with the tilt levers (D) facing up.

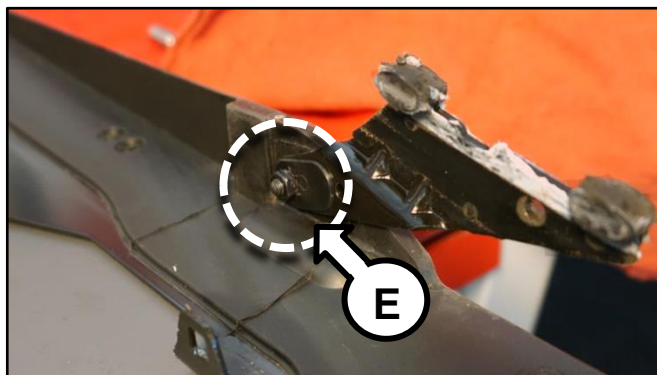
6. Using an 8mm socket, remove the nuts securing the tilt levers on both sides (E). Replace the tilt levers with new parts and tighten the nuts to the specified torque.

72 ~ 96 in·ft (8 ~ 11 N·m)

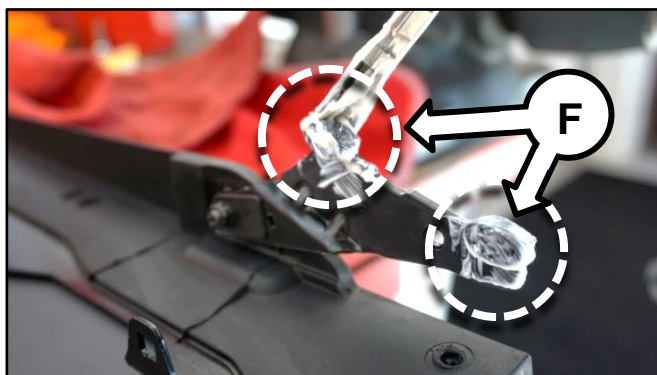
7. Lightly coat the tilt lever shoes (F) using the specified lubricant.

Failure to use the lubricant specified on page 7 of this bulletin may result in an ineffective or repeat repair.

Do not use Kia Dampening Grease (P/N UM011-CHA052), as it is not compatible with the grease used by the factory.

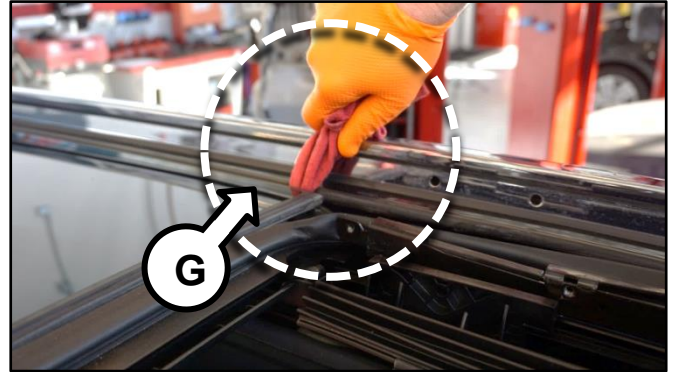
8. Using a non-marring trim panel tool and a clean shop towel, clean the rear guide rails (G) on both sides until there are no foreign materials present on the rag.

Use a non-marring trim removal tool (Such as Snap-on® Part Number PBN5 or equivalent) to avoid damaging roof seals.

Failure to thoroughly remove any old grease or foreign material from the guides may result in an ineffective or repeat repair.

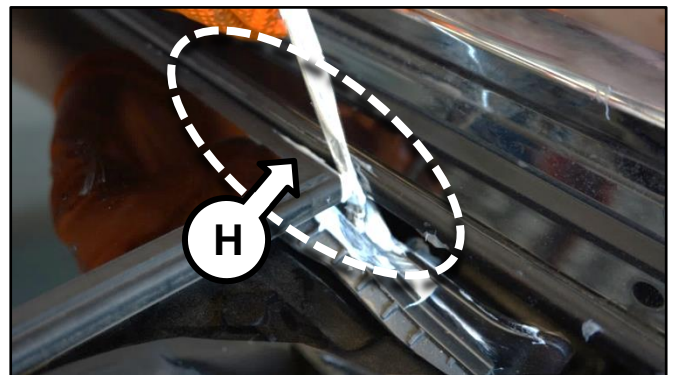
9. Using a clean brush, apply a sufficient amount of the specified lubricant to the entire length of both rear tracks (H).

(Approx. 15 grams of lubricant per track)

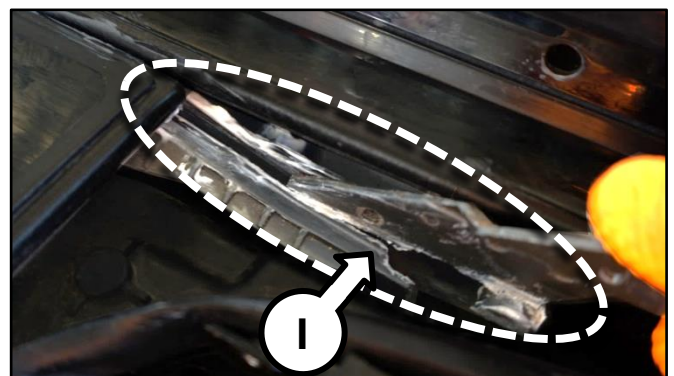
10. With the assistance of another person, carefully reinstall the panoramic sunroof glass by inserting the tilt levers into the guide rail (I).

Ensure both tilt lever shoes are completely inserted or damage to the glass and/or sunroof assembly may result.

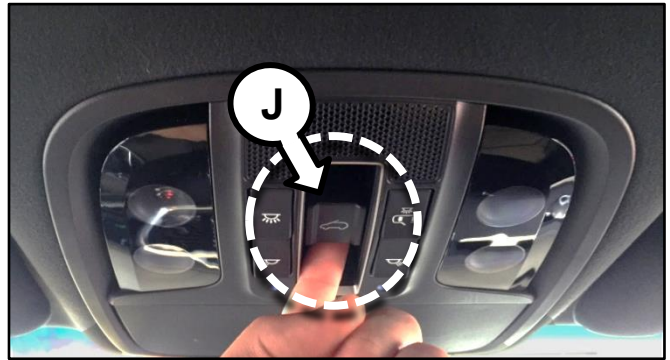
1. Turn the ignition key to the ON position, and then close the panoramic sunroof completely and release the switch.
2. Press and hold the CLOSE button (J) for 10-15 seconds until the sunroof fully closes then retracts slightly. The sunroof operates as follows:

3. Press and hold the CLOSE button until the sunroof glass operates as follows:
