| | GROUP ELE | MODEL 2017MY Forte (YDm) |
| | NUMBER 124 (Rev 1, 02/23/2017) | DATE January 2017 |
| TECHNICAL SERVICE BULLETIN | | |
| SUBJECT: SERVICE ACTION: SOFTWARE UPGRADE FOR AUDIO POWER ON IMPROVEMENT (SA264A) | | |

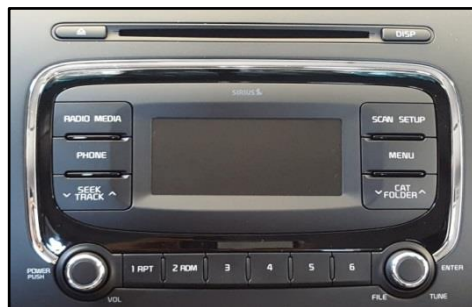
This bulletin provides the procedure to upgrade the Base Audio Gen 3.0 Type A software on some 2017 Forte (YDm) vehicles, produced from May 16, 2016 to November 24, 2016, which may experience an intermittent power-on concern after vehicle ignition is switched on and an error message: "Park the vehicle first to operate Bluetooth setting" while the gear shifter is in "Park" position. Follow the procedure outlined in this bulletin to correct the concern. Before conducting the procedure, verify that the vehicle is included in the list of affected VINs.
