Campaign Number	Revision Level	Date	Group Number
C1794	C	21-MAR-2017	
Expiration Date (U.S. and Canada)		Expiration Date (International)	
02-JUN-2017		02-JUN-2017

## Warranty Field Campaign

# ISX15 CM2350 Fuel Pump Tappet Campaign

Fuel Pump - Plunger and Tappet Roller Inspection and Repair

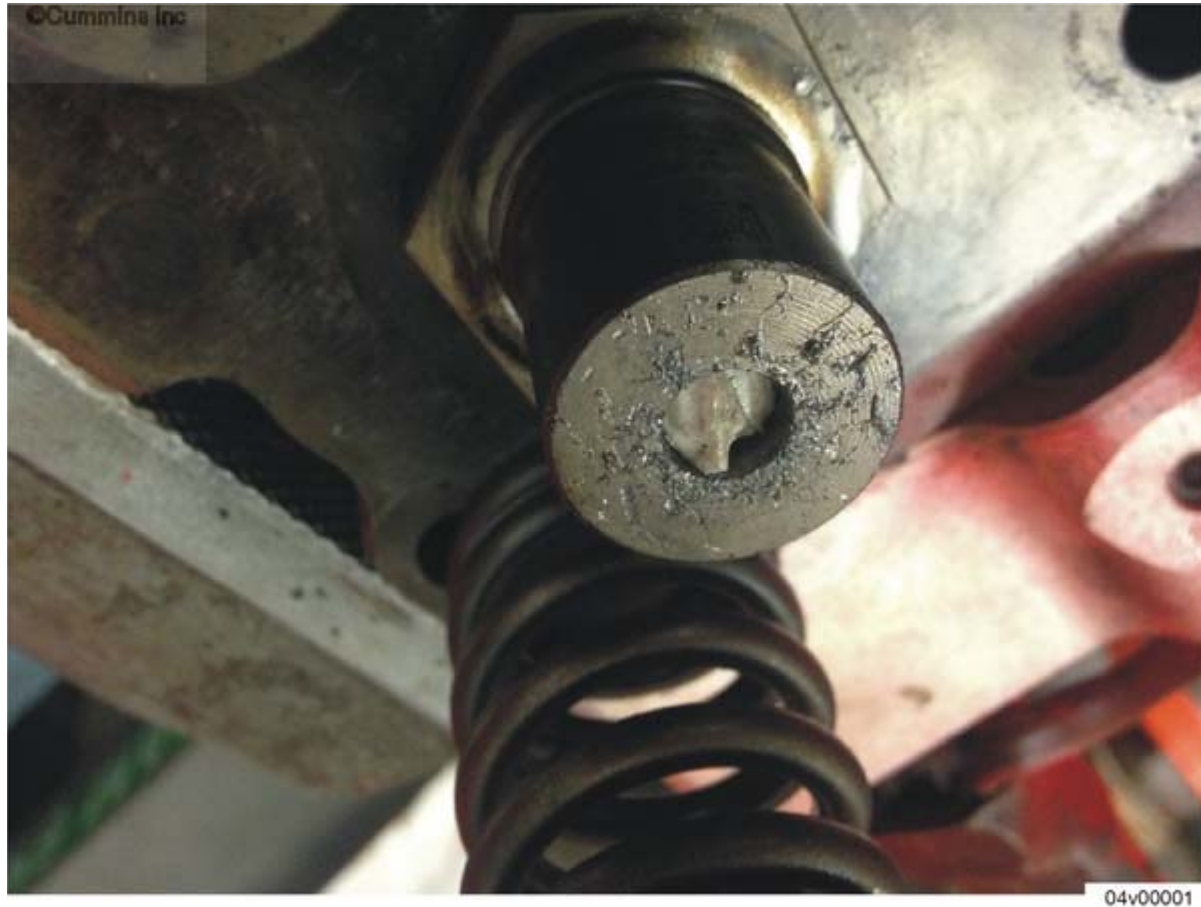
Figure 1, Fractured Fuel Pump Ceramic Pumping Plunger.

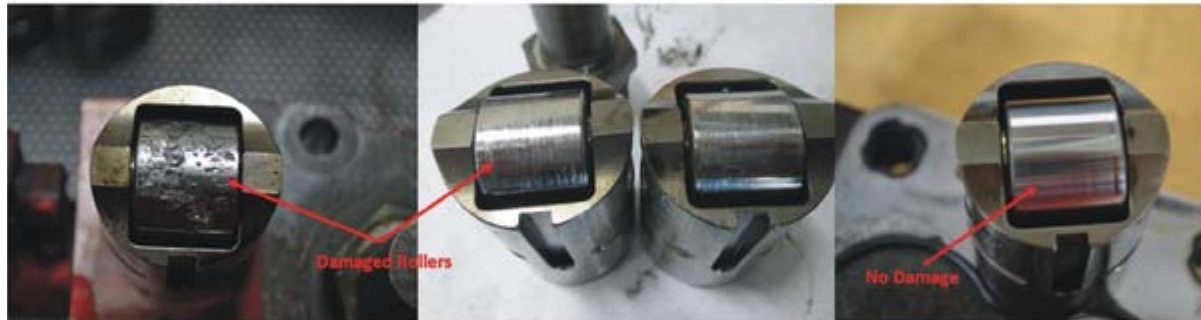
04v00002

Figure 2, Fuel Pump Tappet Roller Assemblies.

Inspect and verify the condition of the fuel pump tappet rollers. Reference Figure 2 above and Procedure 005-227 in Table 3 below.

Scenario 1: The fuel pump tappet rollers are damaged:

- Remove, cut open, and inspect the lubricating oil filter for debris. See Procedure 007-083 in Table 3.
- Connect INSITE™ electronic service tool to the service tool data link and review any logged fault codes.
- Reference Table 1 below for repair direction.

Scenario 2: The fuel pump tappet rollers are **not** damaged:

- Connect INSITE™ electronic service tool to the service tool data link and review any logged fault codes.
- Reference Table 1 below for repair direction.
