| TRP Number | Revision Level | Date | Group Number |
|---|---|---|---|
| T1830 | B | 07-MAR-2017 | |

# ISX15 CM2350 Cracked DOC Inlet Scoop Flange TRP

| TSB160099 |

Cracked Aftertreatment Diesel Oxidation Catalyst (DOC) Inlet Flange: Peterbilt™ and Kenworth™ Chassis

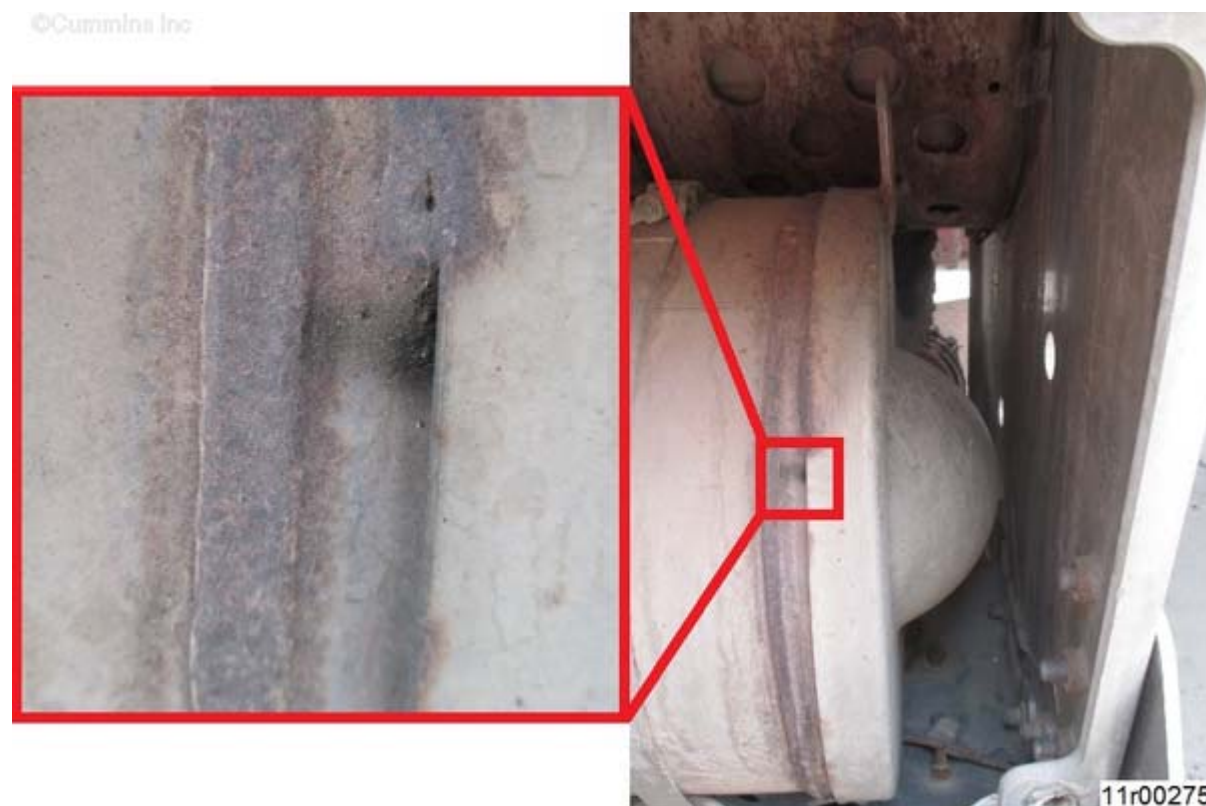
The aftertreatment diesel oxidation catalyst (DOC) inlet flange on “side-in” aftertreatment DOC configurations can fracture and allow exhaust soot to escape.

Inspect the aftertreatment DOC inlet flange area around the weld. Signs of exhaust soot from the weld area indicates an internal crack of the aftertreatment DOC. See Figure 1 below.

Figure 1, Exhaust Soot from Crack in Aftertreatment DOC Inlet Weld.

Replace the aftertreatment DOC if exhaust soot residuals are found escaping between the welds on the aftertreatment DOC inlet flange.
