TSB170002
-----------

## Technical Service Bulletin

Injector Sleeve Seal Leakage Causing Fuel and Coolant Cross-Contamination

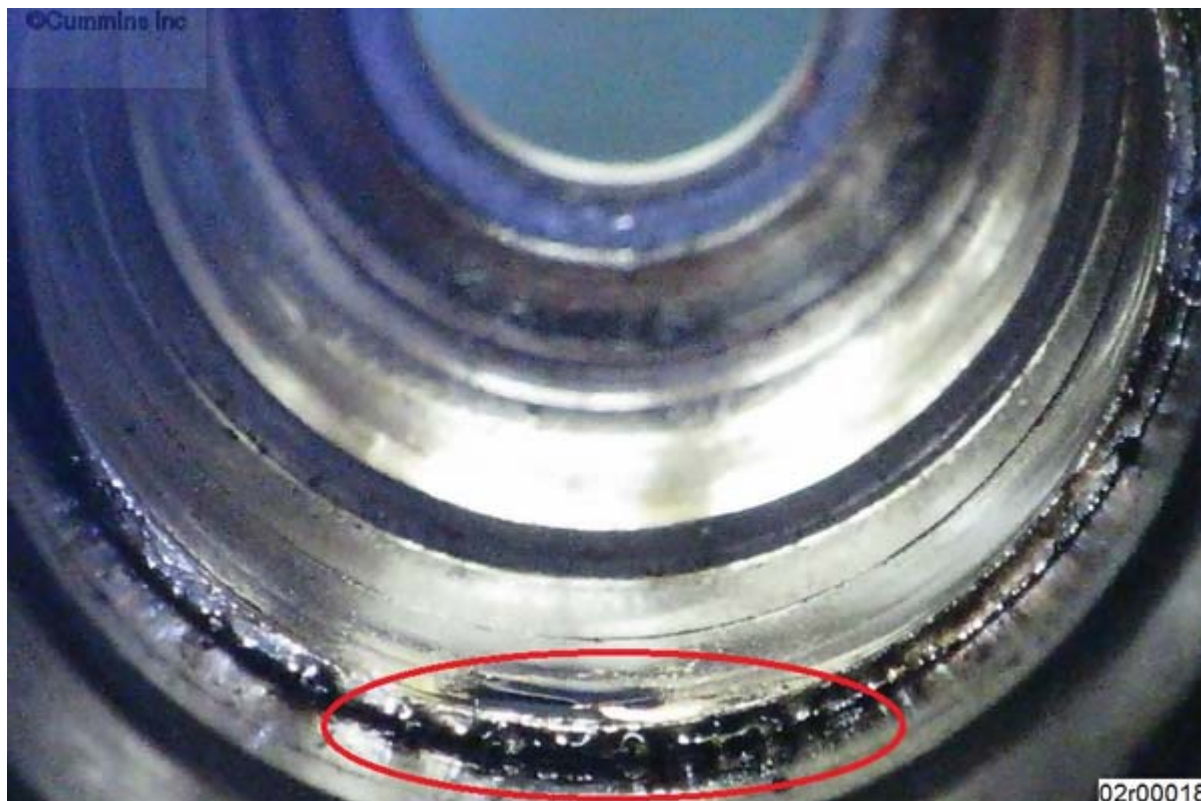
- Shrinkage of injector sleeve seal material can create a leak path between cylinder head cooling jacket and injector bore.

Figure 1, Small Amount of Coolant Leakage Past Injector Sleeve.

- Cylinder head assemblies are **not** to be replaced if injector sleeve is found leaking.
- If leaking injector sleeve is root cause of coolant or fuel cross-contamination, install retaining ring, Part Number 4312298 in all six injector sleeves. See Service Instructions and Service Parts Availability Sections below.
- Even if **only** one injector sleeve is found leaking, retaining rings **must** be installed in all six injector sleeves.
- Installation of a retaining ring is a onetime repair **only**. If an injector sleeve is found to be leaking again and a retaining ring was previously installed, Service Manual Procedure 002-014 in Section 2 will direct further investigation of cylinder head to better understand severity of fuel or coolant leak or causes besides sleeve seal material being compromised.

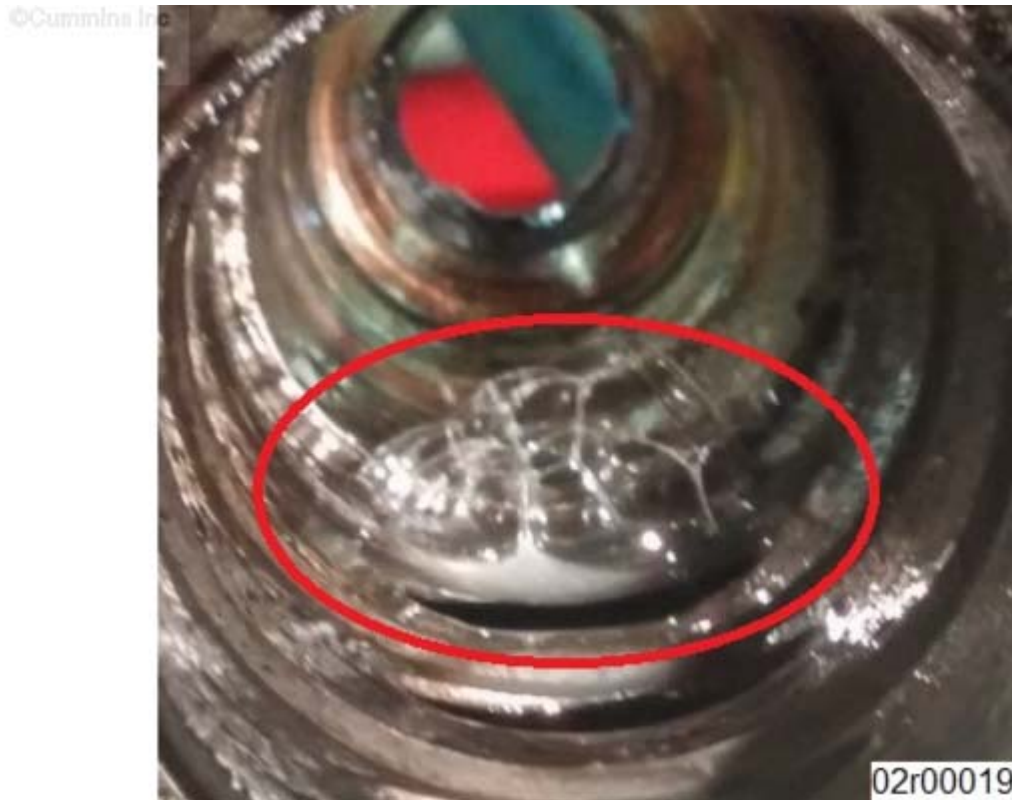
Figure 2, Large Amount of Coolant Leakage Past Injector Sleeve.
