| TSB170024 |

Air Compressor Malfunction Caused by Water Ingestion from Charge Air Cooler

- B6.7 CM2350 B121B
- ISB6.7 CM2350 B101

- Durastar
- CE Series School Bus

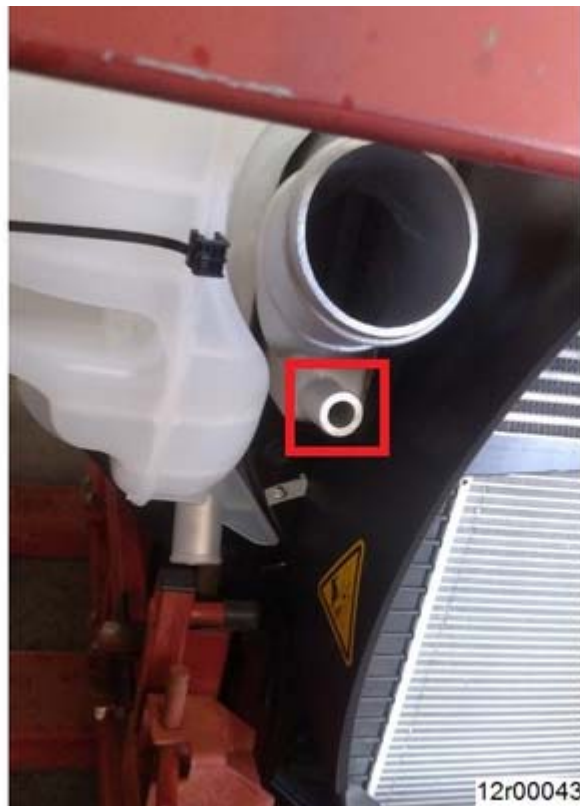
- Air compressor ingesting moisture from air compressor inlet tube supplied by Navistar. Air compressor inlet tube is connected at charge air cooler and condensation can collect at connection because of charge air cooler casting design.

Figure 1, Air Compressor Inlet Tube Port on Charge Air Cooler Causing Water Ingestion.

- For International® authorized repair locations, open a Navistar® Tech Support Case File for repair direction pertaining to malfunctioned parts on engine as well as for changing air compressor inlet tube configuration.
- If repair location is **not** authorized by International, please contact closest International® authorized repair location.

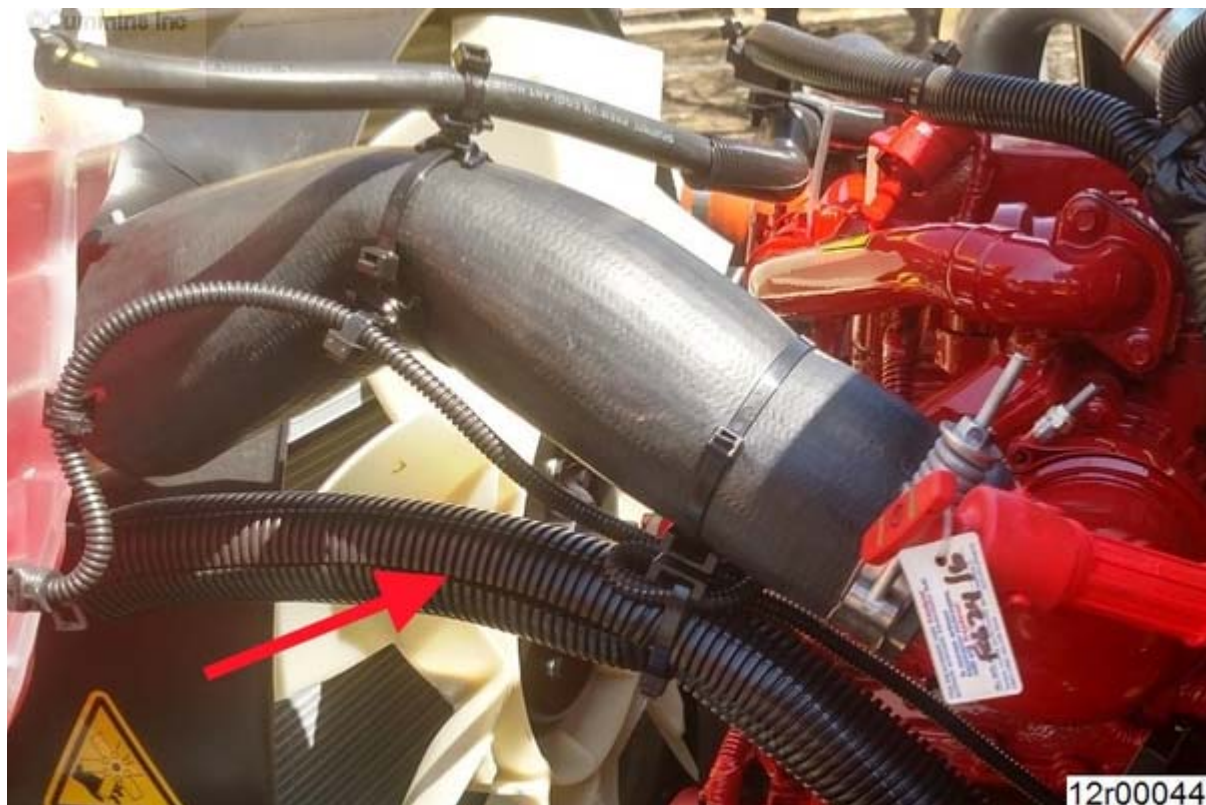
Figure 2, Air Compressor Inlet Tube from Charge Air Cooler to Air Compressor Inlet.

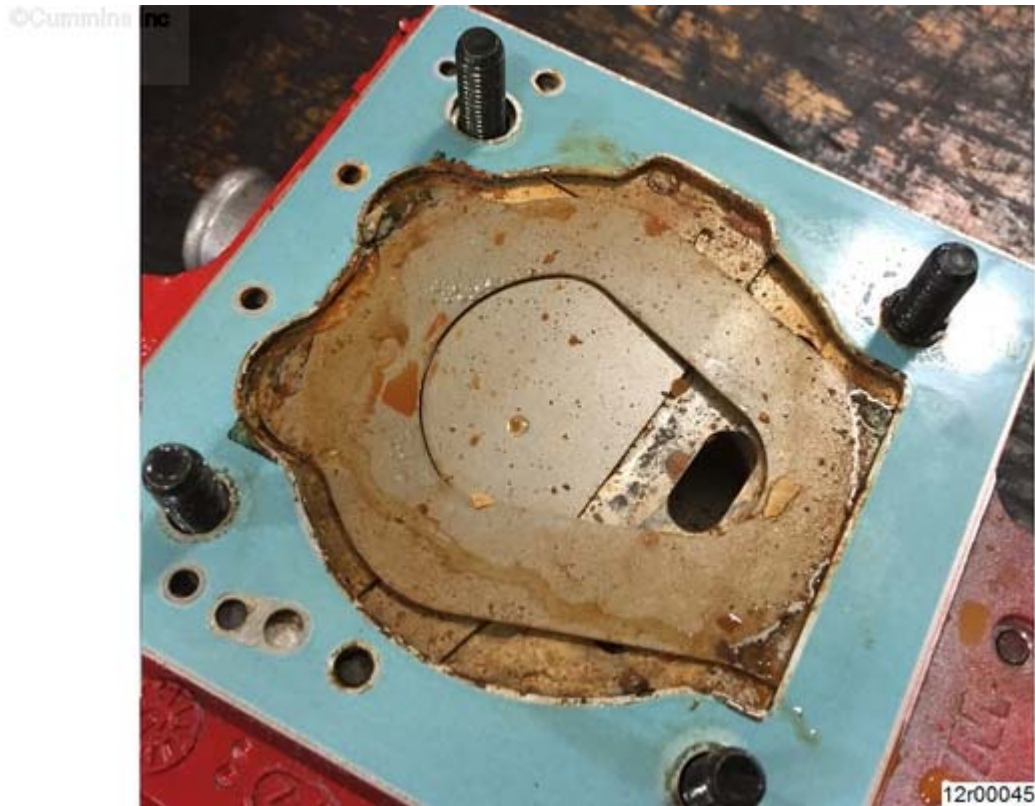
Figure 3, Corrosion Present On Air Compressor Unloader and Valve Assembly.

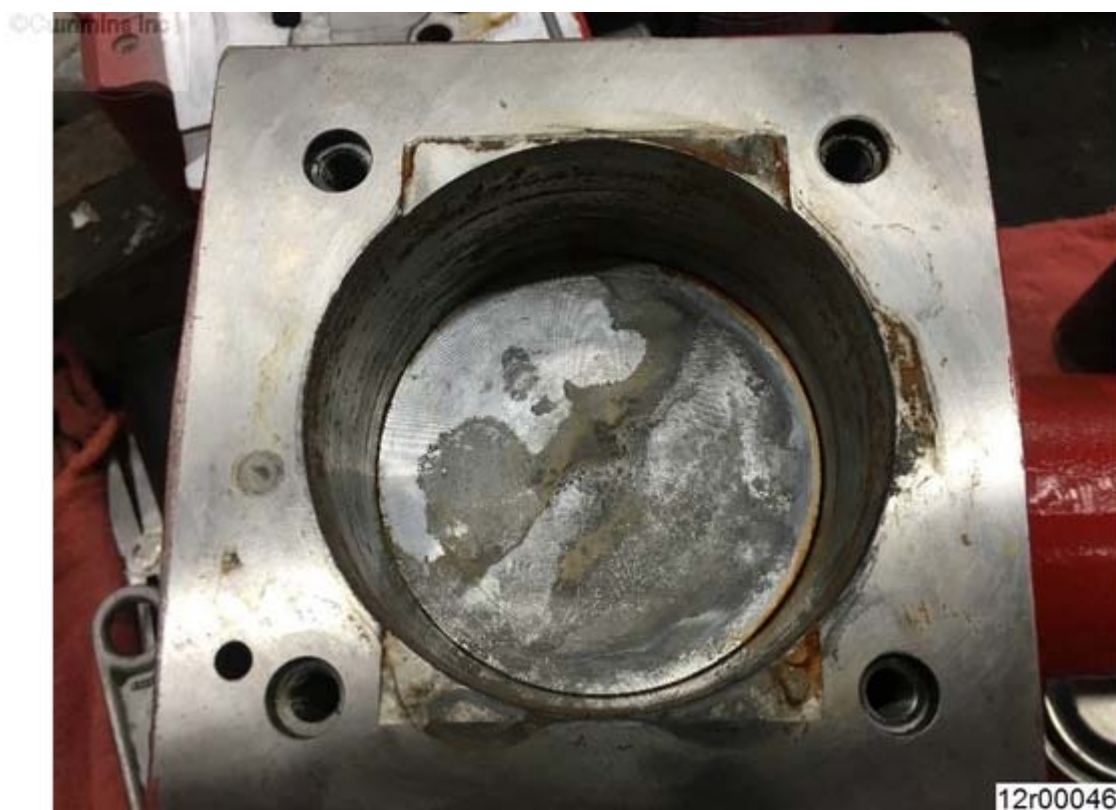
Figure 4, Corrosion Present in Air Compressor Cylinder.
