# SERVICE BULLETIN

**Service Bulletin No.:** 2017-0013

- AeroElite Ford 270 MY2010 – MY2016
- AeroElite Ford 290 MY2010 – MY2016
- AeroElite Ford 300 MY2010 – MY2016
- AeroElite Ford 320 MY2010 – MY2016

To repair cracks in the cab outer skin sheet metal.

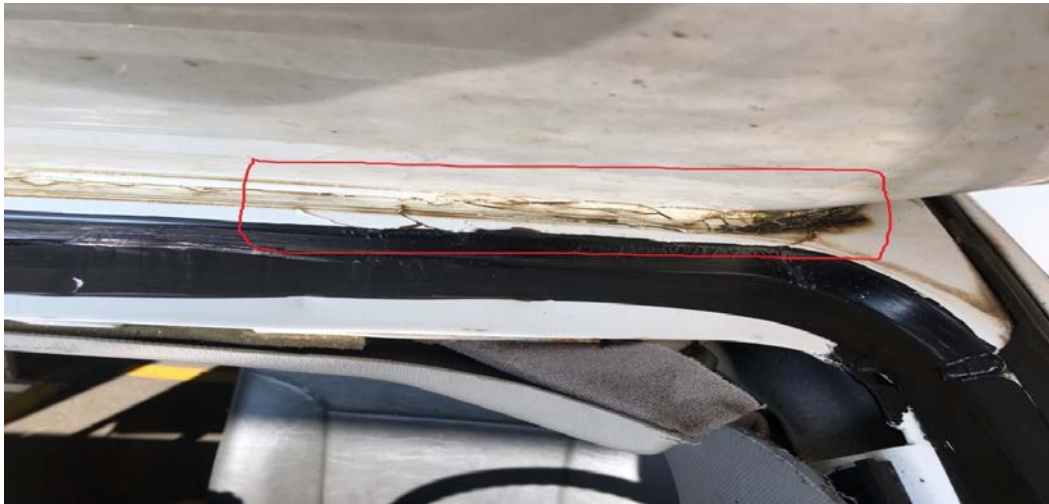
**Note:** The cracked area between the OEM cab area and the fiberglass cap will need to be accessed by scraping away the sealant.

Figure 1 The area inside the red box will need sealant removed.

**Step 2:** Scrape away or pull away dried sealant above the windshield area without damaging the fiberglass roof cap any further. Reference Figure 1.

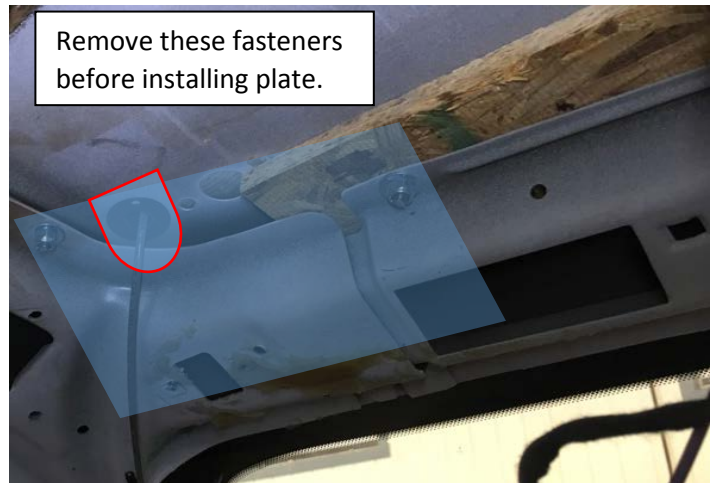
Figure 3 Roof reinforcement area with nuts that need removed.

**Step 1:** Remove the farthest left fastener over the windshield opening and the farthest forward fastener between the A-pillar and B-pillar (over the driver's door opening). Figure 3 represents both fasteners that need removed.

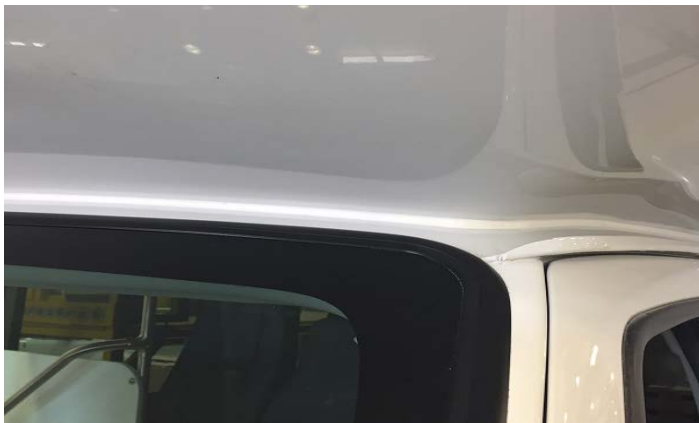
**Figure 5** Finished cap included for reference.
