## PRODUCT NOTICE

## PN630

Models Affected: TLM

SUBJECT: Load Chart

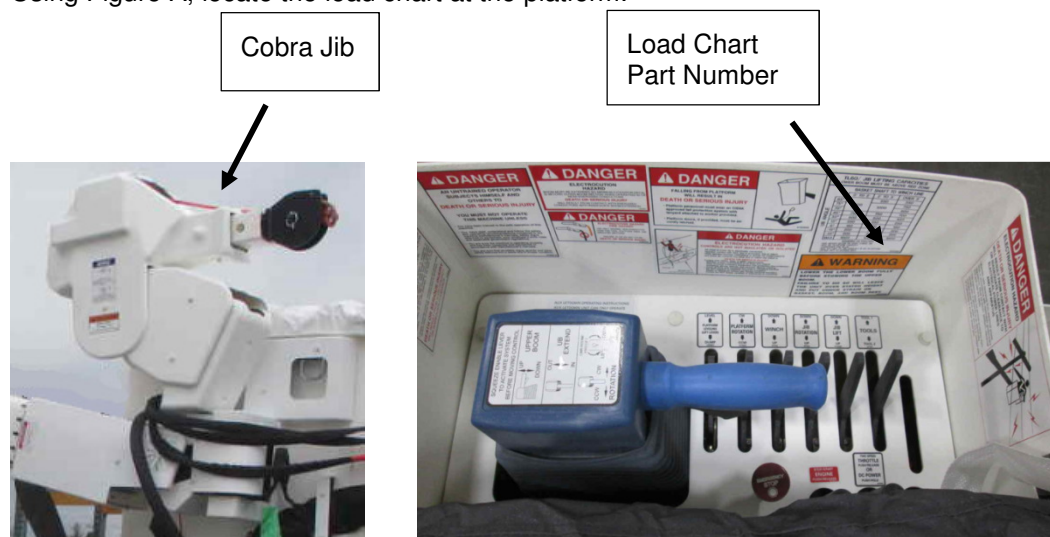
Figure A. Load Chart Location

Using Figure A, locate the load chart at the platform.

**Only TLM end mount platform units with a Cobra Jib and a load chart with the following part numbers are subject to this bulletin**

**Load chart part numbers: 492508, 493014, 494373, 495460, 499778, 604941, 605421, or 605530**

- 1) Immediately inspect the load chart according to the inspection procedure below to determine if your unit is subject to this bulletin.
- 2) Replace the load chart with the load chart supplied in the envelope and fill out the completion form if your unit is subject to this bulletin.
