| DOC # | PROCESS NAME | PAGE | REVISION | STATION | BY | DATE |
|---|---|---|---|---|---|---|
| <b>AR831</b> | <b>Front Pivot Mount Reinforcement</b> | <b>1 OF 2</b> | | <b>SER-E</b> | <b>C.WARD</b> | <b>12/2/2016</b> |

**Complaint:** Pivot Mounts 1306500-18 (RS) and 1306500-19 (CS) = bolts coming loose/shearing causing bracket failure

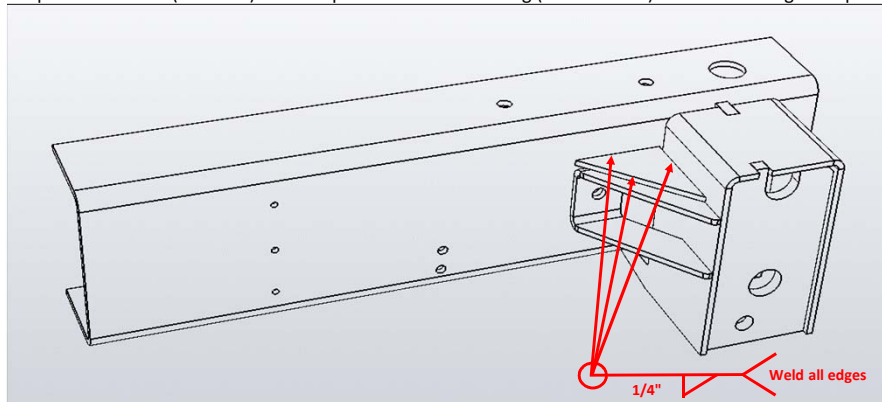
**Cause:** Inferior bracket support leading to bolt shearing and pivot mount movement

Step 7: Add Gusset (1310070) to the top side of the bracket leg (forward side) and weld all edges - repeat step for opposite side
