## Technical product information

| <b>Topic</b> | Luggage compartment lid power open function fails using key fob |

### Continental GT Convertible

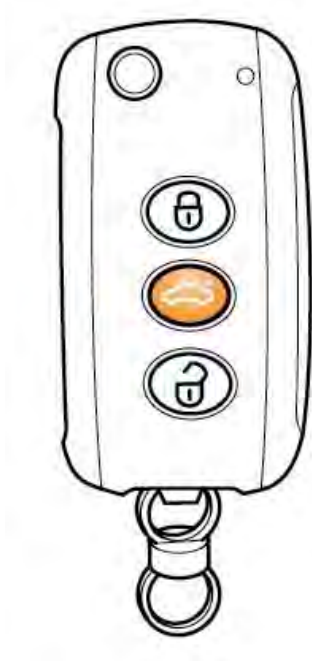
Figure 1

Boot lid control unit software error. Software 0804 may not always trigger a power open operation when initiated via the remote control key luggage compartment lid button (see Figure 1)

New boot lid control unit containing revised software. Software level 0805 or higher is good

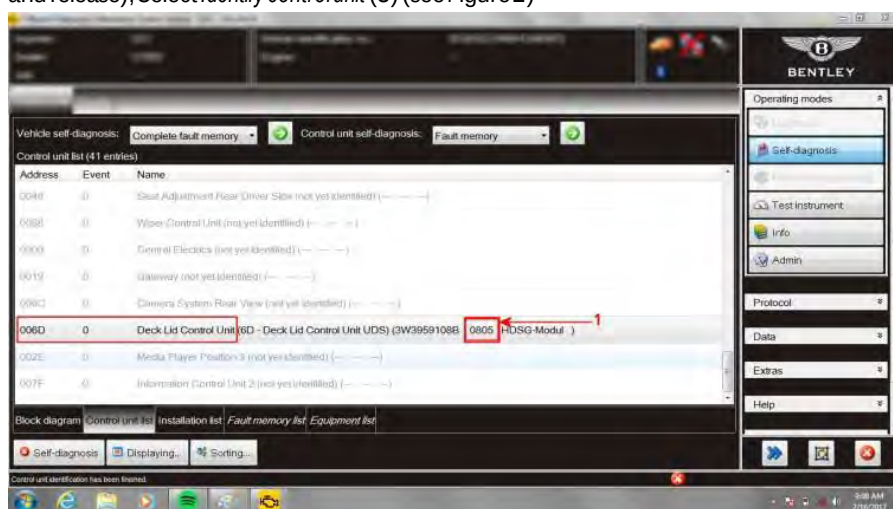
Figure 3

- With 006D Deck Lid Control Unit identified check the software level, data 1 in figure 3. If the software level shown is 0805 or higher the software has no error therefore this TPI is not relevant. If the software level shown is 0804 then replace the boot lid control unit. Refer to workshop manual Rep.Gr.97 Boot lid control unit (J605) – To remove and fit
