**HYUNDAI**NEW THINKING.
NEW POSSIBILITIES.**Technical Service Bulletin**GROUP
CAMPAIGNNUMBER
17-01-009-1DATE
**FEBRUARY
2017**MODEL(S)
**SANTA FE SPORT (AN)
SANTA FE (NC)****SUBJECT:****SANTA FE SPORT (AN), SANTA FE (NC)
REAR WHEEL SPEED SENSOR (SERVICE CAMPAIGN 949)*****THIS TSB SUPERSEDES 17-01-009 TO CLARIFY THE CONDITIONS FOR WSS COVER REPLACEMENT.*****★ IMPORTANT******* Dealer Stock and Retail Vehicles *****

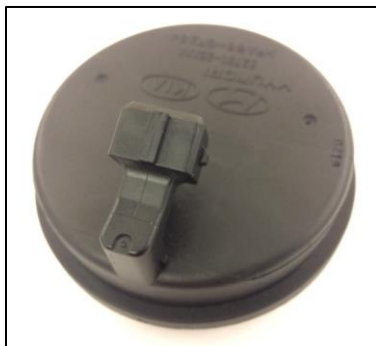
Description: If the rear wheel hub in the affected vehicles is submerged in salt water, salt water can enter the rear wheel speed sensor housing and may interrupt the rear wheel speed sensor signal and temporarily illuminate the ABS and/or ESC warning lights in the instrument cluster until the sensor dries. For these cases, replacement of the wheel speed sensor cap is required. If no ABS/ESC warning lamp is illuminated, applying a silicone spray to the sensor is required. This bulletin describes the service procedure for the rear wheel speed sensors.
