HYUNDAI NEW THINKING. NEW POSSIBILITIES. Technical Service Bulletin	GROUP CAMPAIGN	NUMBER 17-01-010-1
	DATE FEBRUARY 2017	MODEL(S) Santa Fe (NC) Tucson (TL)
SUBJECT: ELECTRONIC STABILITY CONTROL (ESC) MODULE LOT # INSPECTION AND REPAIR (SERVICE CAMPAIGN T1J)

This TSB supersedes 17-01-010 to clarify the tool type must be Torx Plus.

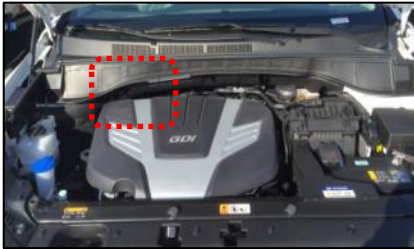
*ESC module is located on the passenger side firewall in the engine bay.

2. Check the first 3 digits of the LOT number. These digits indicate the part production date.

3.
 - If the first 3 digits of the LOT number are NOT found in the applicable tables below, no further action is required. Submit a claim using labor operation code **60C117R0**. Release the vehicle for retail sale if still in dealer stock.
 - If the first 3 digits of the LOT number are found in the applicable tables below, **continue to the next service procedure to inspect the bolts (page 5 for Santa Fe, page 14 for Tucson).**

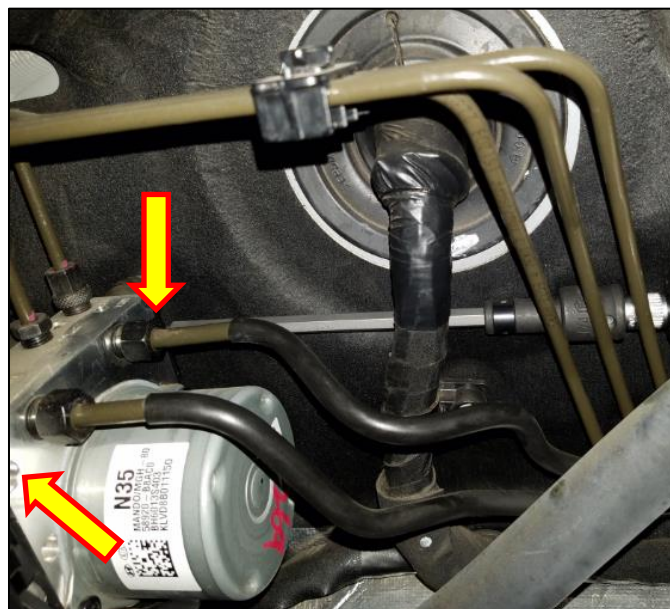
Upon removal, inspect the bolts for damage:

- If the bolt heads are damaged, replace the HECU continue to step 19.
- If the bolt heads are not damaged, replace the bolts with new ones and reassemble the vehicle in reverse order of removal to complete the service procedure. Use labor operation code **60C117R3**.

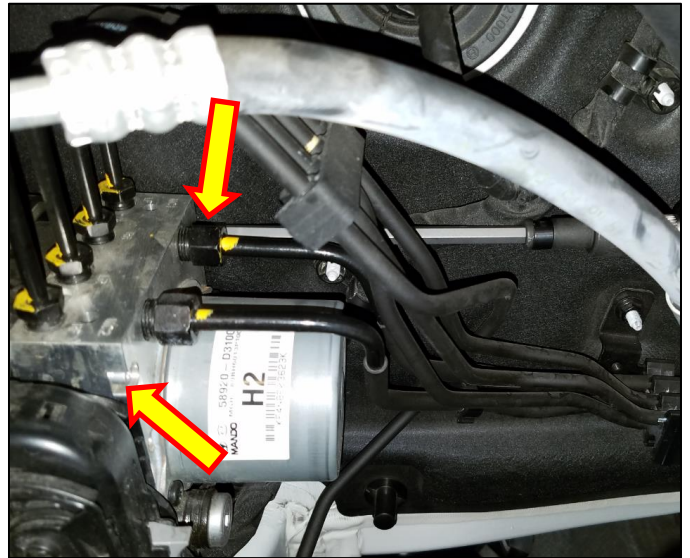
3. Upon removal, inspect the bolts for damage:

- If the bolt heads are damaged, replace the HECU continue to step 4.
- If the bolt heads are not damaged, replace the bolts with new ones to complete the service procedure. Use labor operation code **60C117R1**.
