Technical Service Bulletin

17-BE-002

Accent (MC)

SUBJECT: 2006-2011 ACCENT (MC) OCCUPANT CLASSIFICATION (OCS) SENSOR MAT WARRANTY EXTENSION (TXX6)

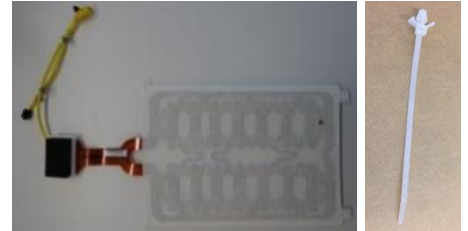
DTC	ACTIVE/HISTORY
B1447 – Occupant Classification System (OCS) – Passenger – ECU Defect.	Replace OCS Mat
B1448 – Occupant Classification System (OCS) – Passenger – Mat Defect.	Replace OCS Mat

With DTC B1447 and/or B1448 → Replace the OCS mat.
