**HYUNDAI**NEW THINKING.
NEW POSSIBILITIES.**Technical Service Bulletin**GROUP
CAMPAIGNNUMBER
17-01-009-2DATE
MARCH 2017MODEL(S)
**SANTA FE SPORT (AN)
SANTA FE (NC)****SUBJECT:****SANTA FE SPORT (AN), SANTA FE (NC)
REAR WHEEL SPEED SENSOR (SERVICE CAMPAIGN 949)*****THIS TSB SUPERSEDES 17-01-009-1 TO REVISE THE NUMBER OF SPRAY NOZZLES AND STRAWS THAT ARE INCLUDED WITH EACH SILICONE SPRAY PART NUMBER.*****★ IMPORTANT******* Dealer Stock and Retail Vehicles *****

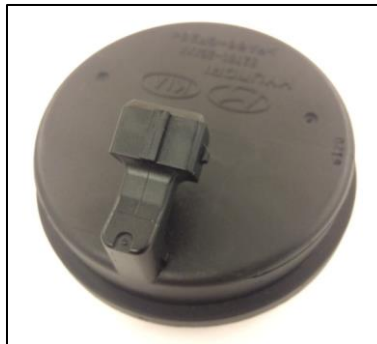
Description: If the rear wheel hub in the affected vehicles is submerged in salt water, salt water can enter the rear wheel speed sensor housing and may interrupt the rear wheel speed sensor signal and temporarily illuminate the ABS and/or ESC warning lights in the instrument cluster until the sensor dries. For these cases, replacement of the wheel speed sensor cap is required. If no ABS/ESC warning lamp is illuminated, applying a silicone spray to the sensor is required. This bulletin describes the service procedure for the rear wheel speed sensors.
