Technical Service Bulletin

Mazda North American Operations
Irvine, CA 92618-2922

Subject: KNOCKING / SQUEAKING NOISE FROM FRONT SHOCK ABSORBER, CREAKING NOISE FROM FRONT LOWER ARM BUSHING	Bulletin No.: 02-003/17
	Last Issued: 03/02/2017

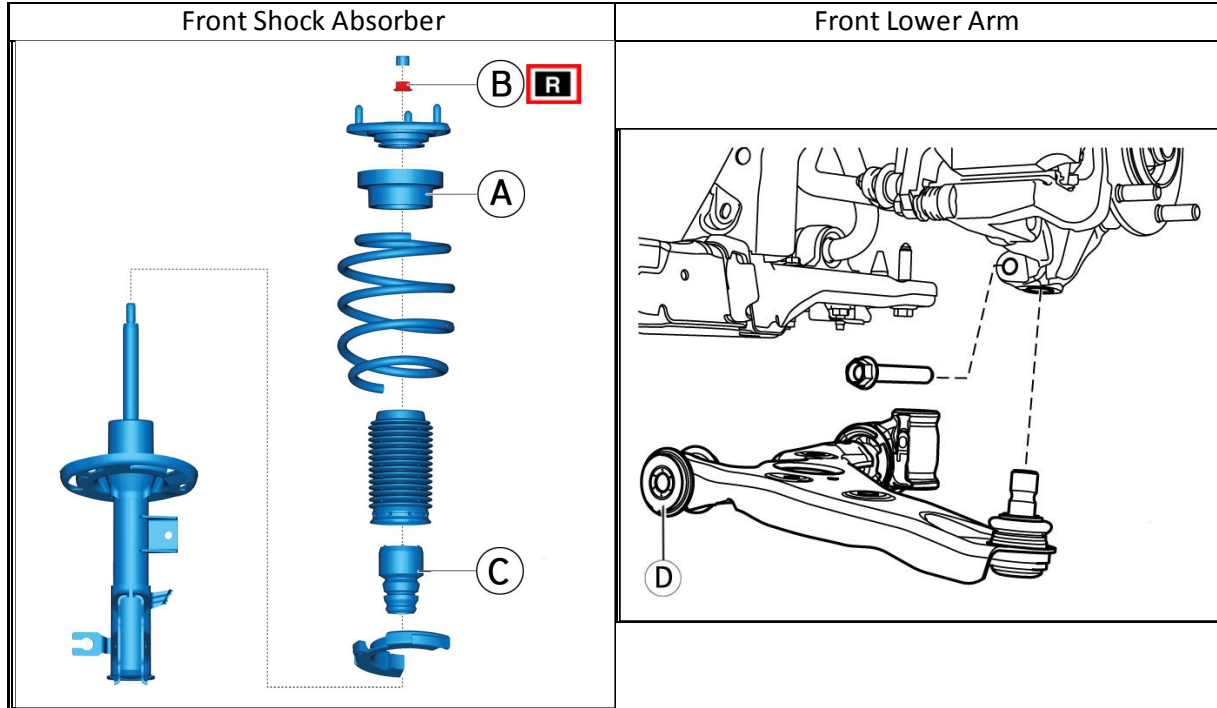
- upper front strut bearing (A) damage. (CX-5 and Mazda6)
- squeak type noise between the front strut bearing and coil spring. (CX-3, CX-5 and Mazda6)
- the bump stopper (C) may be contacting the strut bearing when the front shock absorber is compressed, causing a popping noise. (Mazda6 only)
- The front lower arm bushing (D) is making a **creak**type noise in wet road conditions. (CX-5, Mazda6 and CX-9).

1. The material and production method of the front strut bearing (A) has been changed. (CX-5 and Mazda6)
2. A protector has been installed onto the coil spring. (CX-5 and Mazda6)
3. The shape of the bump stopper (C) will be modified in the future. (Mazda6 only)
4. The shape of the coil spring has been changed. (CX-3 only)
5. Friction of the lower arm bushing has been reduced by adding a dry coating. (CX-5, Mazda6 and CX-9).
