Technical Service Bulletin

Mazda North American Operations
Irvine, CA 92618-2922

Subject: ALUMINUM WHEEL PAINT DAMAGE (BLACK SPOT, WHITE SPOT, FLAKING, DISCOLORED, BLACKENED)	Bulletin No.: 02-002/17
	Last Issued: 03/09/2017

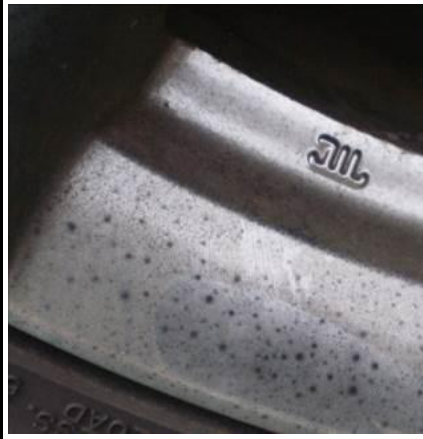
Some vehicles may exhibit an aluminum alloy type wheel(s) having one of the following paint damage conditions shown in the sample photos below. The damage extends to the front surface of the aluminum wheel partly or entirely.

Black Spot	White Spot	Flaking

1. Verify customer concern.
2. Is the **aluminum alloy type** wheel concern caused by an outside influence?
 - No - Go to step 3.
 - Yes - This service bulletin does not apply.
3. Replace the affected aluminum wheel(s). Refer to MS3 online Workshop Manual WHEEL BALANCE ADJUSTMENT (ALUMINUM ALLOY WHEEL).
4. Verify repair.

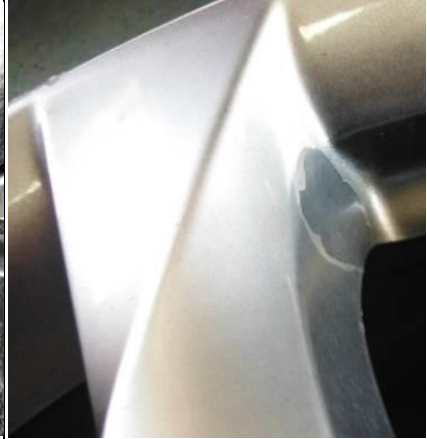
Discolored	Blackened
