Technical Service Bulletin

Subject: SMS (SHORT MESSAGE SERVICE) CANNOT BE READ OUT BY NAVIGATION UNIT	Bulletin No.: 09-009/17
	Last Issued: 03/13/2017

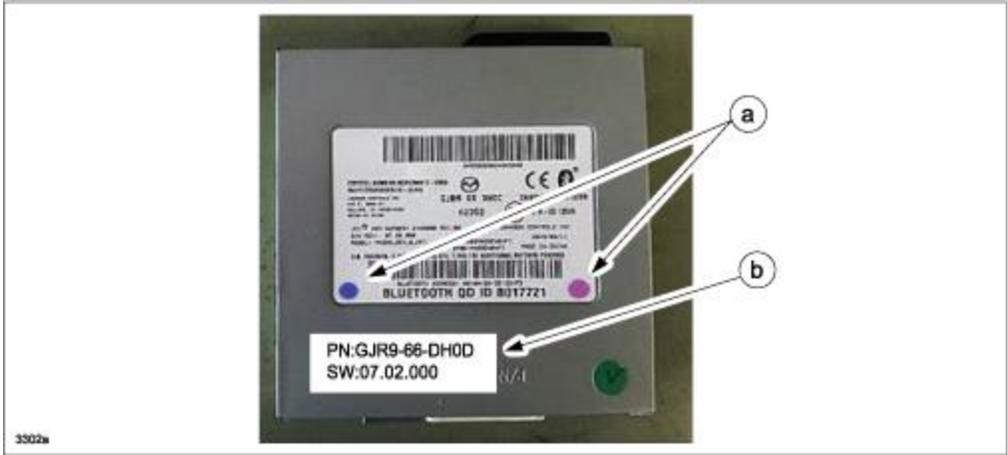
The rebuilt part has two markings (a) and a sticker (b), which show the new part number and the software number. The previous part information sticker (as shown below) may still be on the unit.

Order a rebuilt Telephone Adapter (Bluetooth unit) via United Radio (North America) and replace the defective part with an exchange part. Send the removed defective part back to United Radio.
