Technical Service Bulletin

Subject: BSM OFF INDICATOR ON WITH DTC U1A4B:97 OR U3000:97	Bulletin No.: 15-001/17
	Last Issued: 03/13/2017

2016 CX-3

2016 MX-5 vehicles with VINs lower than JM1ND*****104338 (produced before August 20, 2015)

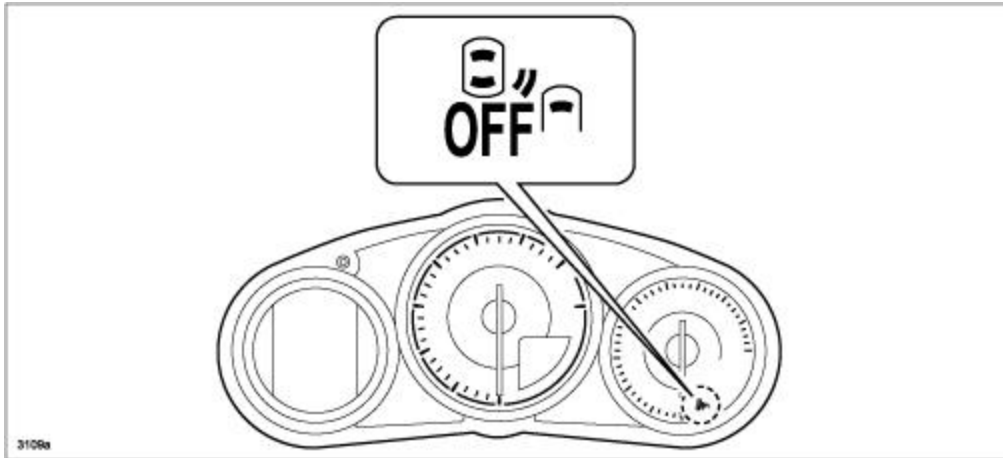
Some vehicles with Blind Spot Monitoring (BSM) may experience the following conditions (similar to when the BSM control modules detect dirt on the rear bumper surface):

- DTC U1A4B:97 - Radar sensor sensitivity temporarily decreases depending on various external and environmental factors (blind spot monitoring (BSM) control module (RH))
- DTC U3000:97 - Radar sensor sensitivity temporarily decreases depending on various external and environmental factors (blind spot monitoring (BSM) control module (LH))
- The BSM turns "OFF" and the BSM OFF indicator turns "ON" in the instrument cluster while driving
- The BSM will not turn on again during the drive cycle
- After cycling the ignition switch off and on again, the BSM operates normally
- DTC U1A4B:97 or U3000:97 is stored in memory

To correct this problem, the control logic of the BSM control modules has been changed.

1. Verify customer concern.
2. Replace both the BSM control modules. Refer to MGSSonline instructions:
 - **CX-3** -BLIND SPOT MONITORING (BSM) CONTROL MODULE REMOVAL/INSTALLATION.
 - **MX-5** - BLIND SPOT MONITORING (BSM) CONTROL MODULE REMOVAL/INSTALLATION.
3. Perform the blind spot monitoring (BSM) radar aiming. Refer to MGSSonline instructions:
 - **CX-3** -BLIND SPOT MONITORING (BSM) RADAR AIMING.
 - **MX-5** -BLIND SPOT MONITORING (BSM) RADAR AIMING.
