Subject: IMPROPER BLIND SPOT MONITORING (BSM) OPERATION	Bulletin No.: 15-002/17
	Last Issued: 03/13/2017

2016-2017 CX-3 vehicles equipped with Blind Spot Monitoring (BSM)

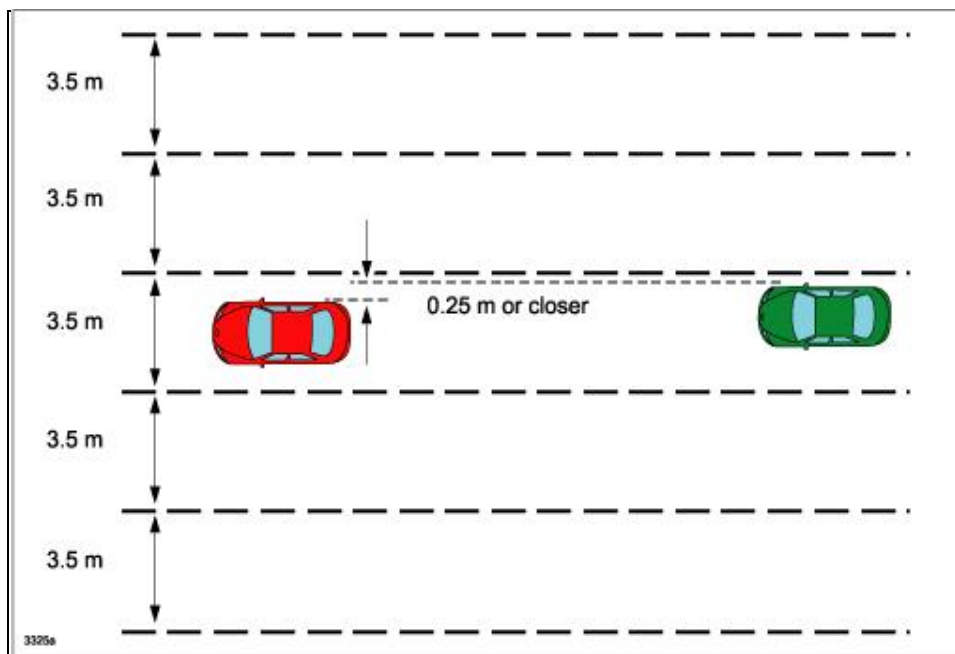
1. Even if there is no vehicle in the alert area, the BSM indicator light on the outer mirror glass illuminates.

This may be caused by a variation of the relative location between the radar emitted by the BSM unit and the rear bumper. An error may occur in the detection angle of the radar.

1. Verify the customer concern.
2. Replace both BSM control modules. Refer to MGSS online.
3. Perform BSM radar aiming. Refer to MGSS online .

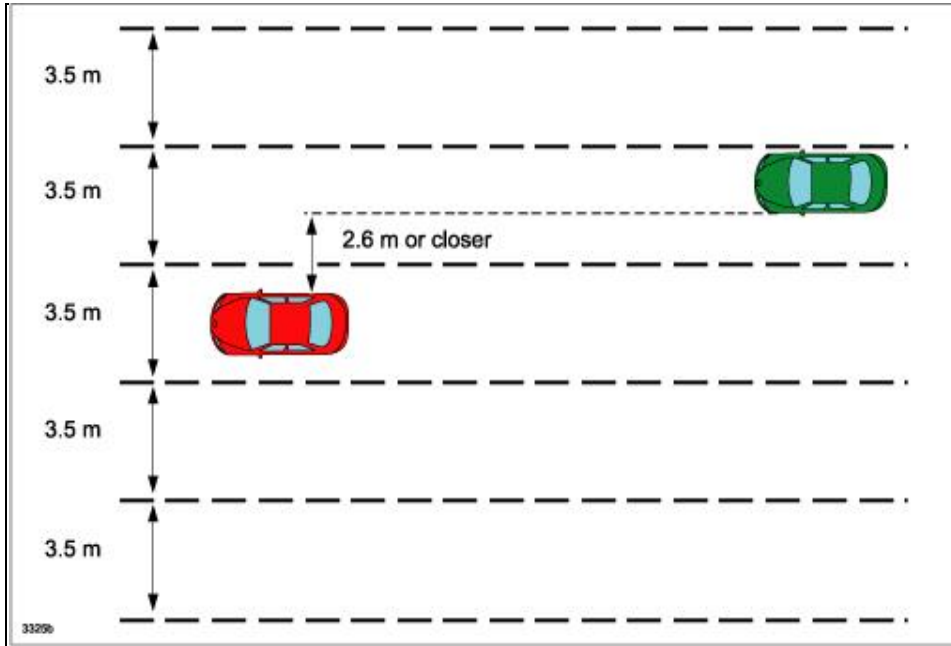
2. When a vehicle appears in the alert area, the BSM indicator light on the outer mirror glass illuminates later than expected.

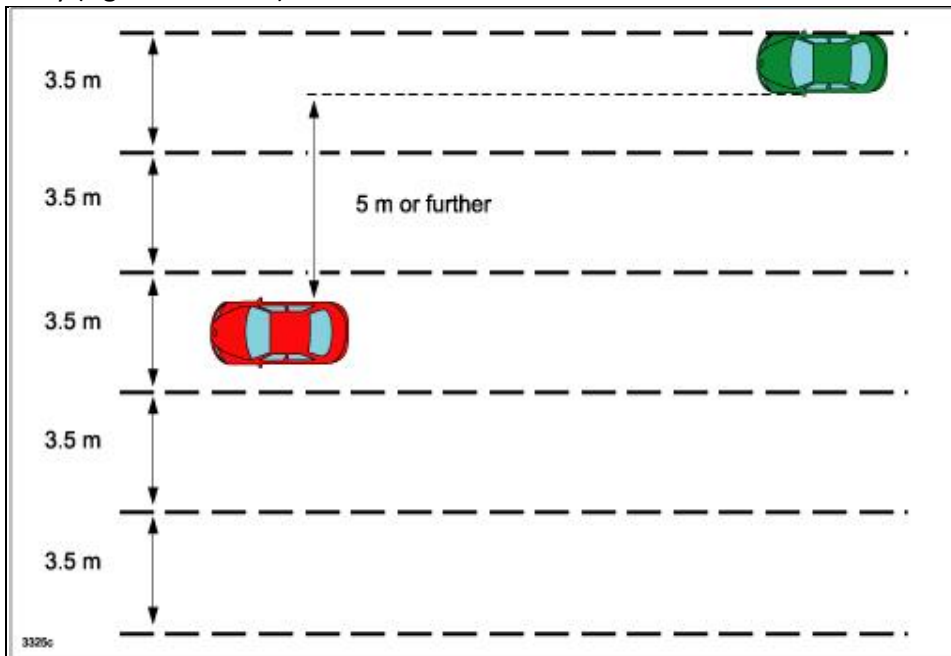
3. BSM indicator light on the outer mirror glass illuminates even when a vehicle is approaching two lanes away (right or left side).
