Technical Service Bulletin

Subject: REAR DOOR SUNSHADE TAB LEAVES DENT IN DOOR TRIM	Bulletin No.: 09-010/17
	Last Issued: 03/17/2017

APPLICABLE MODEL(S)/VINS

2016 CX-9 vehicles with VINs lower than JM3TC*****122316 (produced before September 29, 2016)

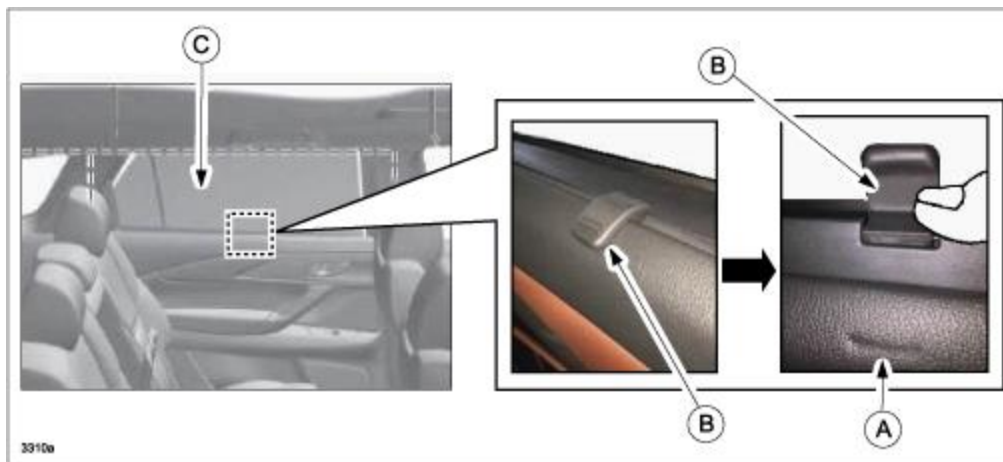
Some customers may complain about a dent (A) in the rear door trim, which is visible when the sunshade (C) is closed. The dent is caused by the sunshade tab (B) when the sunshade is opened. The tab contacts the door trim and leaves a dent.

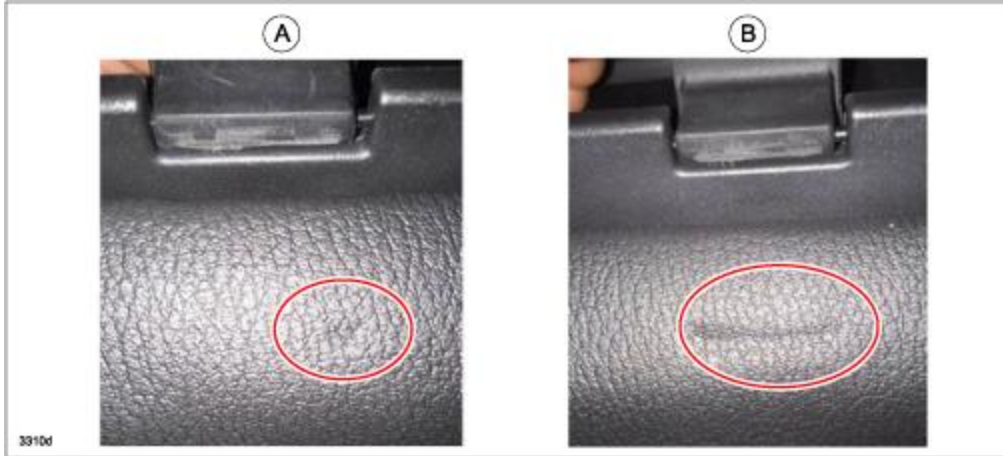
Dent size sample photos:

Small Dent (A)

A small size dent can be repairable using "Dent Repair Procedure" below.

Large Dent (B)

It is difficult to completely repair a large size dent using "Dent Repair Procedure". Door trim replacement may be required.
