Technical Service Bulletin

Subject: GRINDING NOISE FROM MANUAL TRANSMISSION IN 2ND AND/OR 3RD GEAR AND/OR HARD TO SHIFT INTO 2ND AND/OR 3RD GEAR	Bulletin No.: 05-001/17
	Last Issued: 03/17/2017

2016-2017 MX-5 vehicles with VINs lower than JM1ND****H*121392 (produced before September 6, 2016)

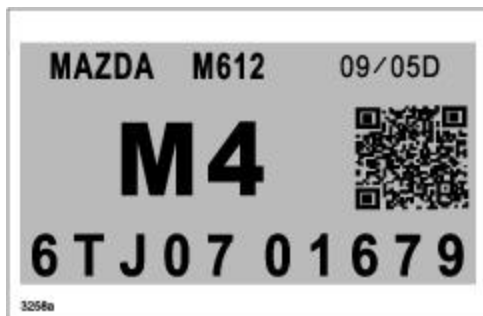
This may be caused by damage to 2nd and/or 3rd gears if the vehicle was driven with rapid acceleration and deceleration using frequent shift changes. To eliminate this concern, the configuration of the 2nd and 3rd gears has been changed to increase the rigidity.

NOTE: Transmissions with the serial No. "6TJ0701679" or higher are modified.

1. Verify the customer concern.
2. Replace the complete manual transmission with a modified one according to the instructions on MS3 (TRANSMISSION REMOVAL/INSTALLATION [M66M-D]).
3. Verify the repair.
