Technical Service Bulletin

Subject: CHECK ENGINE LIGHT ON WITH P0451:00 IN COLD WEATHER	Bulletin No.: 01-003/17
	Last Issued: 03/29/2017

2014-2016 Mazda3 vehicles with VINs starting with JM1

2014-2016 Mazda3 vehicles with VINs starting with 3MZ

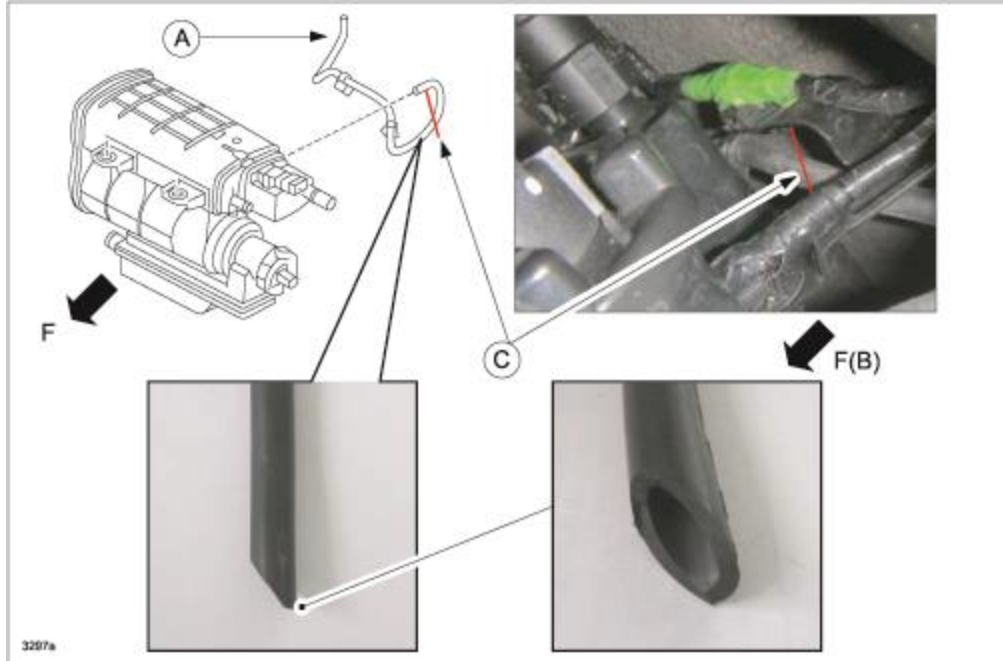
4. For 4-door sedan

When the engine is started for the first time after parking overnight in cold weather (below freezing), some vehicles may exhibit the check engine light on with DTC P0451:00 (Fuel tank pressure sensor: sensor characteristic malfunction) stored in memory. This concern may be caused by an increase in discharge resistance due to water accumulated and frozen in the canister vent hose.

a. Cut the Evaporative Hose No.1 (A) diagonally to enlarge the cross section as shown (C = cut point) to avoid water from accumulating and freezing. (F = vehicle front, F(B) = Vehicle front (view from bottom))

NOTE: Use of a utility knife or pliers with cutters is recommended to cut the hose.
