<b>Subject:</b>  <b>MULTI-MODEL - WINDSHIELD REPAIR CAUTION NEAR FORWARD SENSING CAMERA AND LASER SENSOR</b>	<b>Service Alert No.:</b> SA-058/17
	<b>Last Issued:</b> 07/06/2017

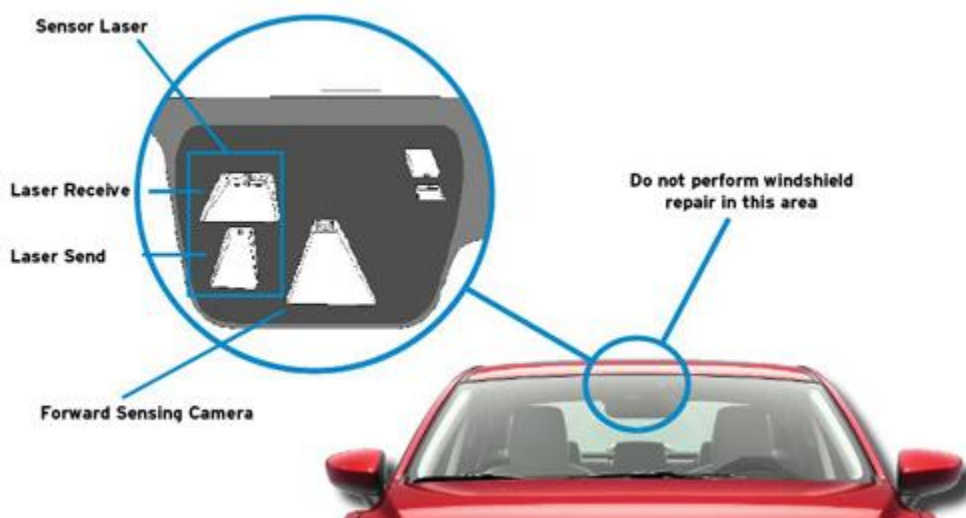
CAUTION: DO NOT attempt any repair of the windshield damaged by stone chipping/cracks at the area in front of the Forward Sensing Camera (FSC) and Laser Sensor. Replace the windshield with a new one instead.

If the windshield is repaired in this area, it may affect the performance of the Forward Sensing Camera and/or Laser Sensor. This may cause incorrect detection of objects and improper operation of i-ACTIVENSE system(s).
