Service Alert

SCBS, LDWS, HBC WARNING LIGHTS ON IN HOT WEATHER

Service Alert No.: SA-064/17

2017-2018 Mazda3 2017 Mazda6 2017 CX-5

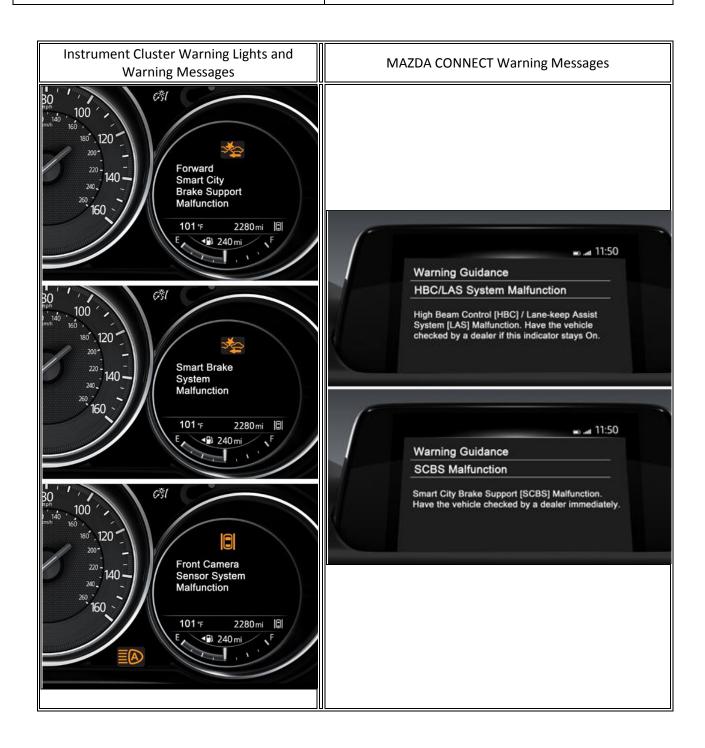
Some customers may complain about one or more warning lights on when they start the vehicle during hot weather. The combination of warning lights mentioned by the customer may include:

- SCBS
- LDWS
- HBC

Instrument Cluster Multi-Information Display warning messages may include:

- Forward Smart City Brake Support Malfunction
- Smart Brake System Malfunction
- Front Camera Sensor System Malfunction

MAZDA CONNECT center display warning messages may include:

- High Beam Control [HBC] / Lane-keep Assist System [LAS] Malfunction. Have the vehicle checked by a dealer if this indicator stays On.
- Smart City Brake Support [SCBS] Malfunction. Have the vehicle checked by a dealer immediately.

If you encounter a customer with a related concern, check for set DTC.

If DTC U3000:98 is set by itself or with U3000:04, advise the customer to park the vehicle in the shade as much as possible. If the light does not reset automatically as soon as the cabin cools, pull over to a safe location and turn the ignition off and then back on, this should reset the system.
Mazda is aware of this concern and is working on a repair. This notification will be updated once a repair is available.

2. If any DTC from the table below are set(except as noted in STEP 1), contact Hotline for further instructions.
