## WARRANTY EXTENSION

## CONDITION OF CONCERN

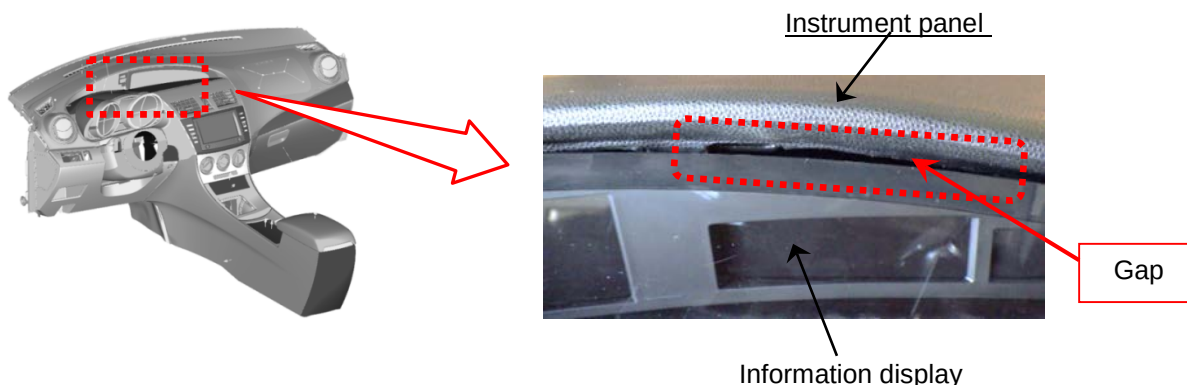
On certain 2010-2013 Mazda3 vehicles, the material of instrument panel surface may shrink and warp if exposed to heat under high ambient temperature. Also, the joint area between the instrument panel and information display may not have enough rigidity due to structural concern. With such conditions, the instrument panel just above the information display may warp, generating a gap between the instrument panel and information display, causing poor appearance.

The warranty coverage for instrument panel replacement due to warping or a gap is extended to 7 years (84 months) from the original warranty start date, with no mileage limitation.

Please replace the instrument panel according to the Workshop Manual.
