SERVICE BULLETIN

APPLICABILITY: 2013-2017MY Impreza
 2013-2017MY Crosstrek
 2012-2017MY Forester, NA and Turbo
 2015-2017MY WRX
 2013-2017MY BRZ

NUMBER: 02-166-17
DATE: 03/10/17

SUBJECT: Upper Oil Pan Assembly- Design Changes

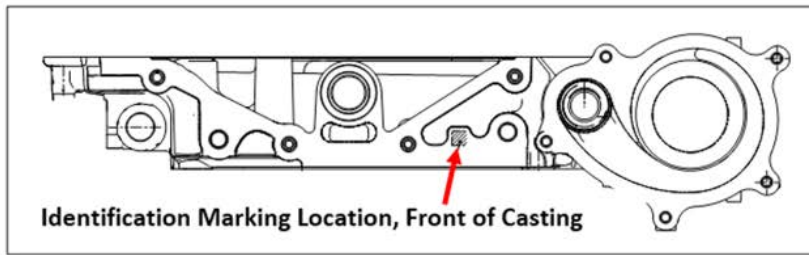
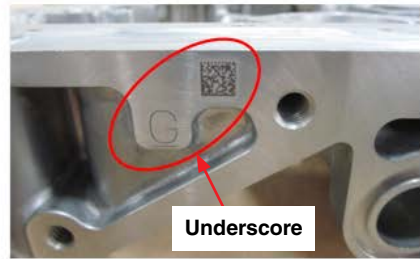
- An underscore has been added to the identification letter found on the front face next to the water pump cavity and QR code box.

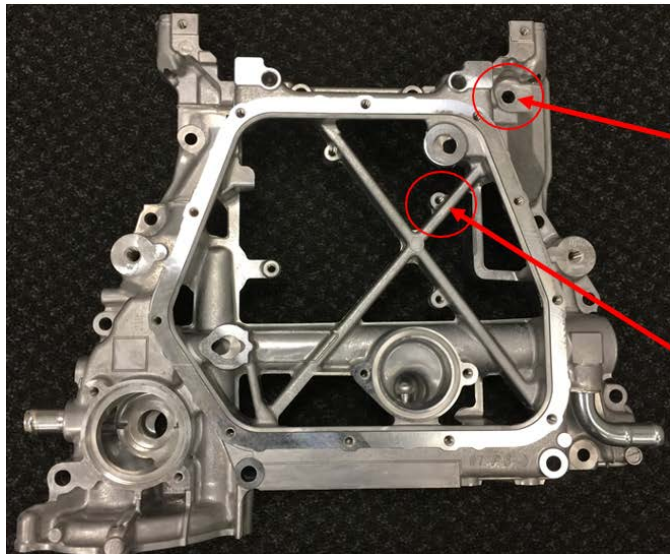
- Thicker casting and an additional mounting point for the baffle plate added to the internal ribbing.

Because the thickness of the casting has been increased by 5.5mm in this area, a new, longer socket-head cap screw, p.n. 800408250 is required replacing the original hex head bolt.

An additional mounting point / bolt hole has been incorporated here to improve retention of the baffle plate. Use hex bolt p.n. 808206010.
