**SERVICE BULLETIN**

**APPLICABILITY:** 2013-14MY BRZ

**NUMBER:** 12-200-16R

**SUBJECT:** Rear Combination Lamp and Related Enhancements

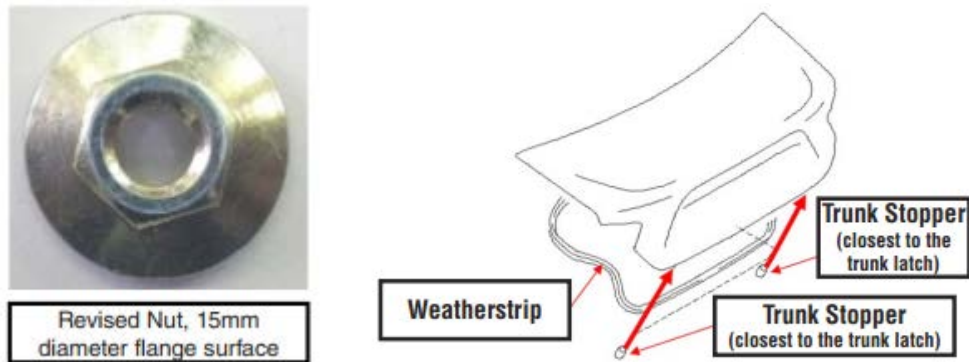
- Flange surface dimension of retaining nuts increased from 12mm to 15mm.
- Thickness of the combination lamp gaskets increased for improved sealing.
- The “height” of the trunk stoppers has been increased by 2.7mm and a liner added to the trunk weatherstrip intended to improve crush resistance and keep the trunk lid from contacting (and in a small number of cases, cracking) the tops of the combination lamps when closing.

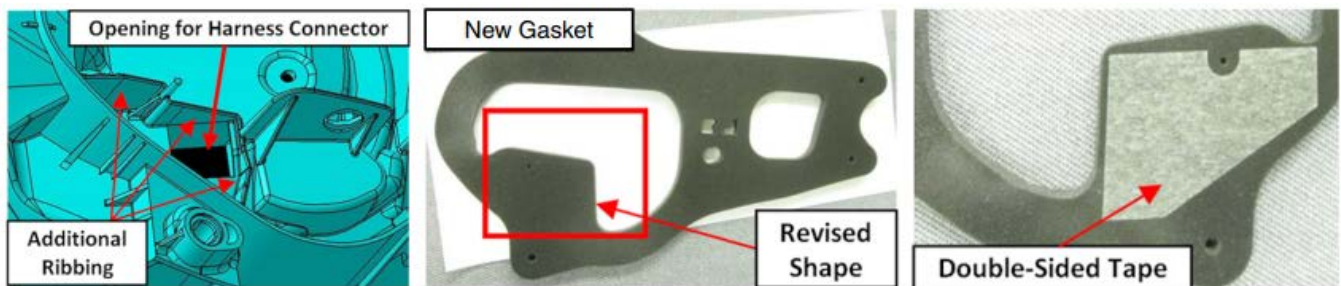
- Further revision of combination lamp assy. (additional ribbing) and further revision of the gasket shape along with addition of double-sided tape to the gasket for improved sealing.

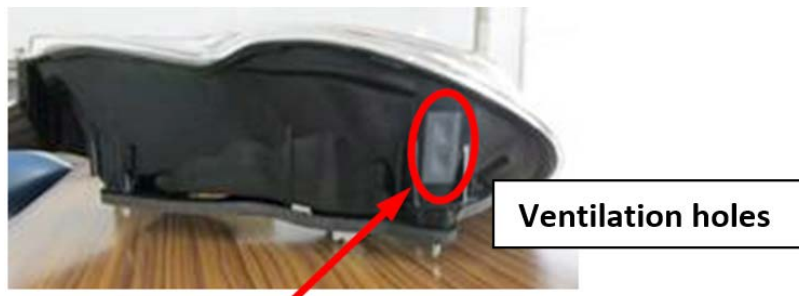
- Application of an anti-fog coating to the inside of the combination lamp lens at production to prevent “clouding”.
- Additional ventilation holes have been added to prevent condensation build-up.

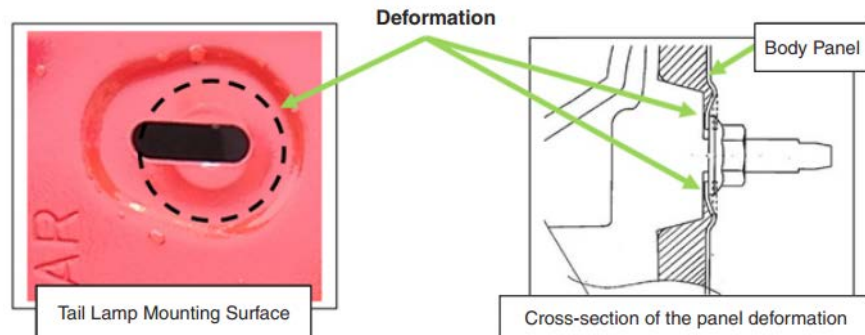
- Take out the 6 retaining clips from the trunk side liners then remove them to gain access to the combination lamp mounting nuts.
- After removing the 4 retaining nuts from each combination lamp, unplug and remove the assemblies.
- Before reinstalling any lamp assemblies, always inspect the rear body panel closely in the retaining nut areas for any deformation of the metal as shown in the illustrations below.

- If any deformation is found, **CAREFULLY** straighten the affected mounting area using a small body hammer and dolly.
- Another straightening method is to clamp the body panel using a bolt, flat washers and a nut as shown in the illustration below.

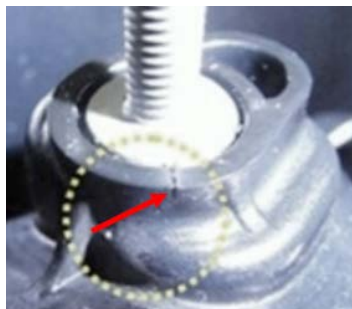
- Inspect the retaining stud boss areas of the housings for any cracking as shown below. If cracking is confirmed, the lamp assy. must be replaced.

**NOTE:** Unless the most recent combination lamp assemblies are already installed, when replacement is required, replace **BOTH** assemblies with the new parts.

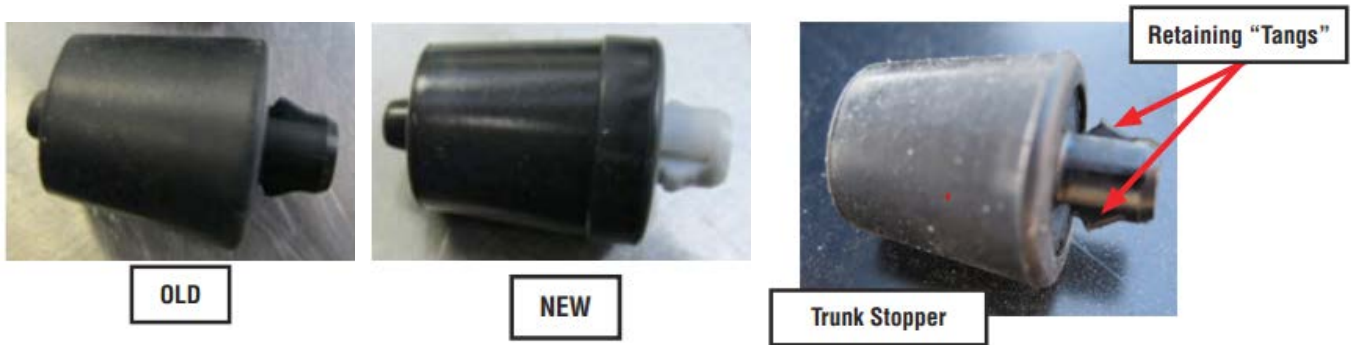
The photos below show the differences between the “OLD” and “NEW” trunk stoppers and the retaining tangs which secure them to the trunk lid.
