SERVICE BULLETIN

APPLICABILITY: 2015-2017MY Outback

NUMBER: 12-216-17

SUBJECT: Roof Rail Gapping- Design Change

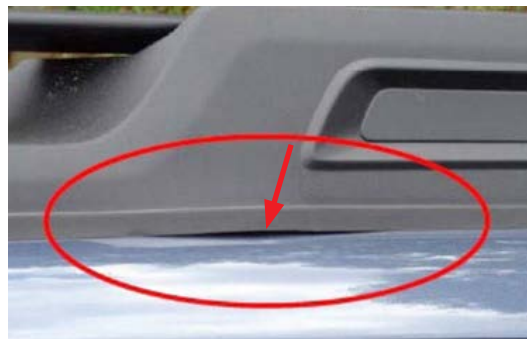
This bulletin announces a design change to the roof rail assemblies. This change has been made in response to isolated customer concerns of a visible gap between the base portion of the rail assembly and the roof panel as shown in the example photo below. The rail's retaining claws have been changed to optimize their holding force and eliminate any gapping.

After confirming the condition, replace the affected roof rail following the service procedure in the applicable Service Manual.
