SERVICE BULLETIN

APPLICABILITY: 2015-2017MY Legacy and Outback

NUMBER: 12-218-17

SUBJECT: Additional TIPS for Front Door Wind Rushing Sound Repair

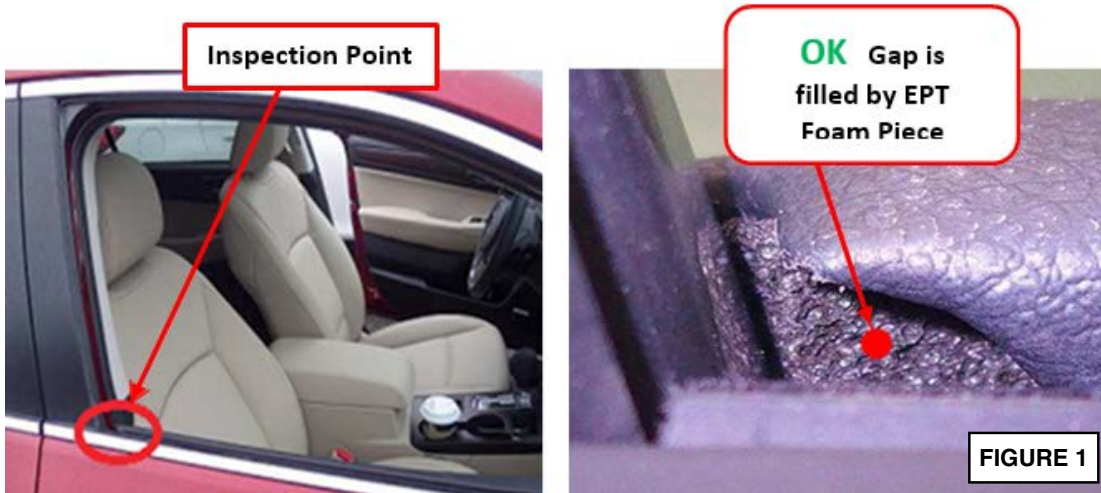
After road testing, confirming the condition and with the window all the way down (open), closely inspect the top rear corner of the door trim panel for any gap between the outer sash and door trim panel as shown below.

After the trim panel is reinstalled, verify there is no gap between it and the sash as shown in Figure 1 above.

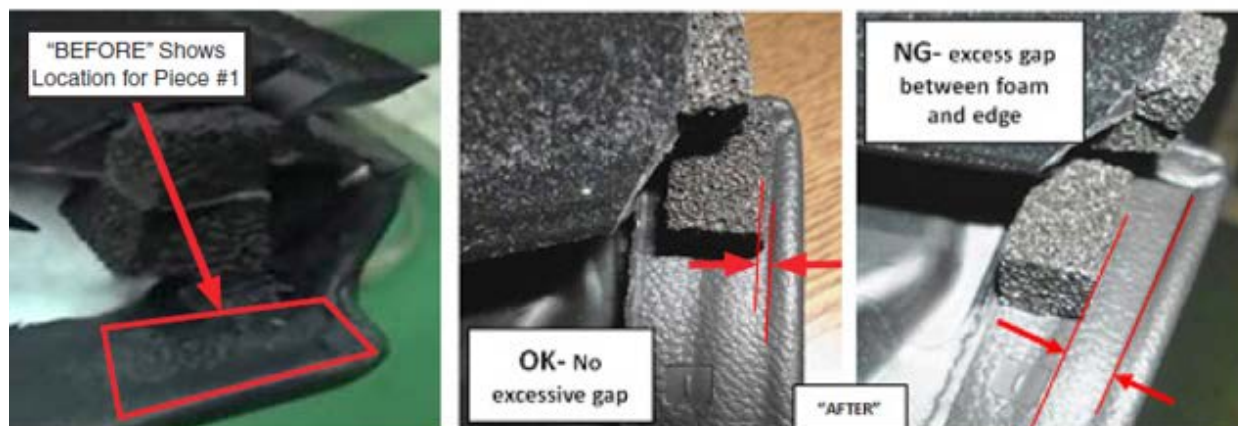
- **EPT Foam Piece #1** is applied to top **REAR** inside corner of the door trim panel where the trim material wraps around the back edge as shown in the “Before” and both the proper and improper installation “After” photos below. The NG photo shows an excessive gap between the foam and edge of the trim panel.

If the gapping condition (“NG”) shown in Figure 2 above is confirmed, **CAREFULLY** remove the affected door panel following the procedure outlined in the applicable Service Manual. Remove any residual EPT foam and / or adhesive with mild solvent on a clean shop cloth. Install a new EPT foam piece as described below.
