SERVICE INFORMATION BULLETIN

APPLICABILITY: 2015-2016MY Legacy and Outback
 2015-2016MY Impreza and XV Crosstrek
 2016-2017MY Forester
 2016-2017MY WRX

NUMBER: 15-205-16R

SUBJECT: Reprogramming File Availability to Address Operational Concerns with “Gen 2” Fujitsu-TEN (F10) Navigation and 7” Display Audio Units

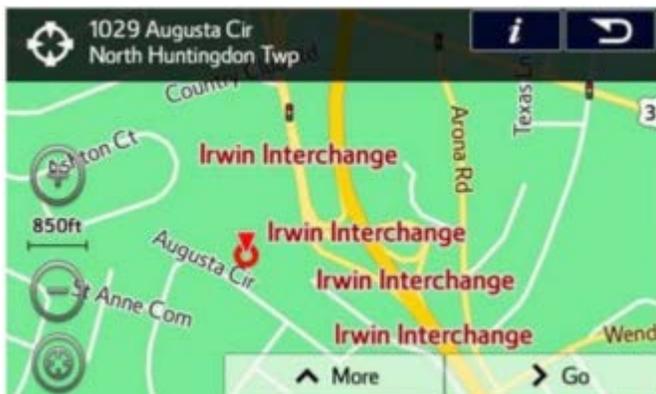
Symptom 6: Roads or interchanges have the same name displayed multiple times.

Change: Logic update to show only one road or interchange name at the same time.

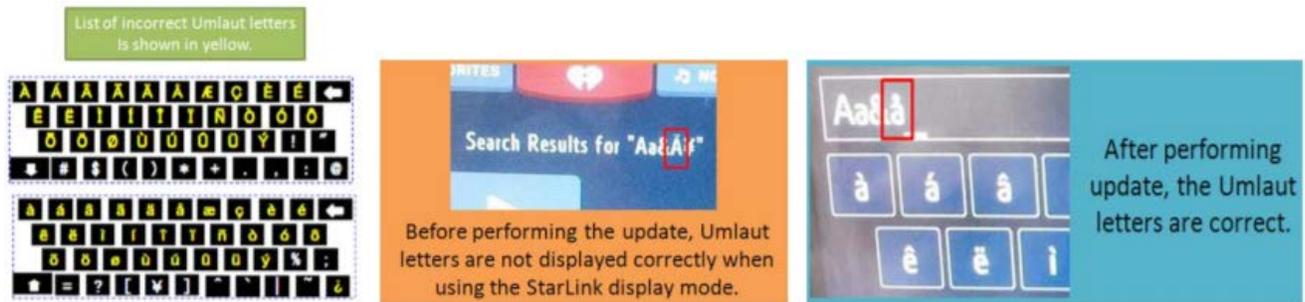
Symptom 11: Incorrect Umlaut characters are shown on StarLink display.

Change: Logic change to allow proper display of Umlaut letters.

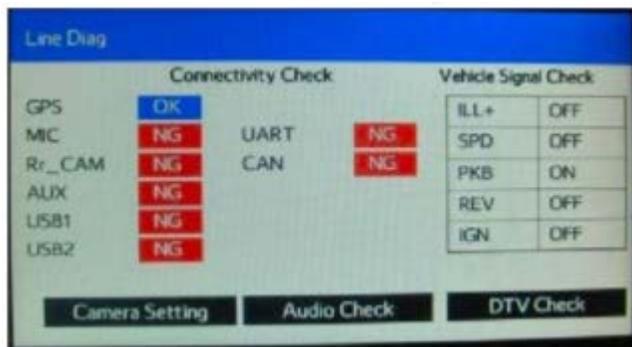
Symptom 14: “Line Diag” screen is intermittently displayed while driving.

Change: Logic change to prevent display of the “Line Diag” screen.

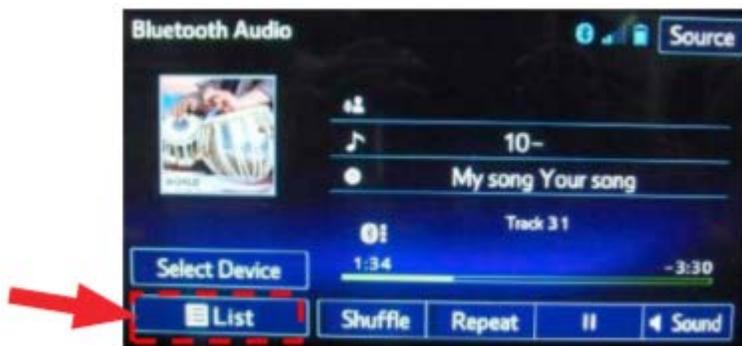
Symptom 15: “LIST” soft touch key is not displayed on Bluetooth Audio screen while using Bluetooth audio feature with an Apple device utilizing iOS8 software version.

Change: Logic change to enhance compatibility with iOS8 software.

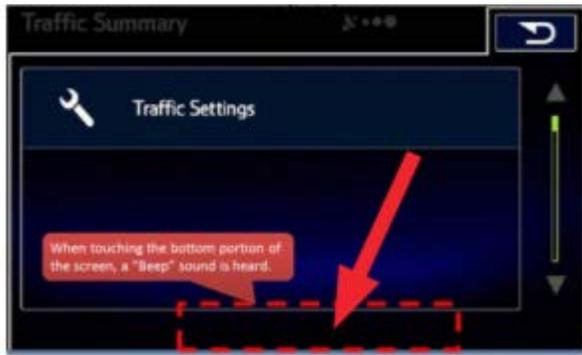
Symptom 16: “Beep” sound heard when touching the bottom of the display screen where no function soft touch keys are displayed.

Change: Logic change to eliminate beeping sound from inactive soft touch key screen areas.

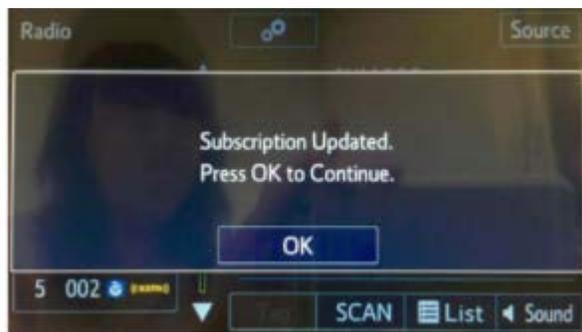
Symptom 17: Sirius/XM caution message screen is displayed in English even when French language operation settings are selected.

Change: Logic change to make all messages display in the selected operating language.

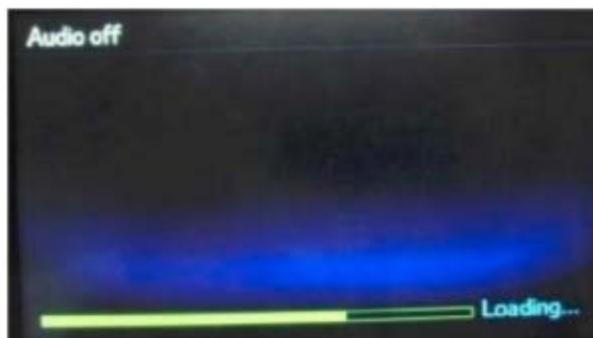
Loading Screen

Symptoms 18-22: The following symptoms are all related to the inability of the software to properly load. One or all of these 5 conditions may occur at the same time.

- Repeated display of the “Loading” screen at initial unit start-up
- Bluetooth device pairing failure
- Inoperative steering wheel (satellite) switches
- Voice recognition feature inoperative
- Sirius/XM radio feature inoperative.

Change: Logic updates included where applicable to address each of the following conditions:
