SERVICE BULLETIN

APPLICABILITY: 2015-2017MY Legacy / Outback 2.5 CVT Models **NUMBER:** 16-104-17R
 2015-2016MY Crosstrek Hybrid (HEV) **DATE:** 02/23/17
SUBJECT: “Bump” Feeling from CVT at Idle in Drive **REVISED:** 03/30/17

This bulletin provides a diagnostic procedure along with Transmission Control Module (TCM) reprogramming files to address isolated customer concerns of a “bump” feeling from the CVT. The bump feeling has been reported to occur after the CVT is fully up to operating temperature, in Drive and with the engine at idle.

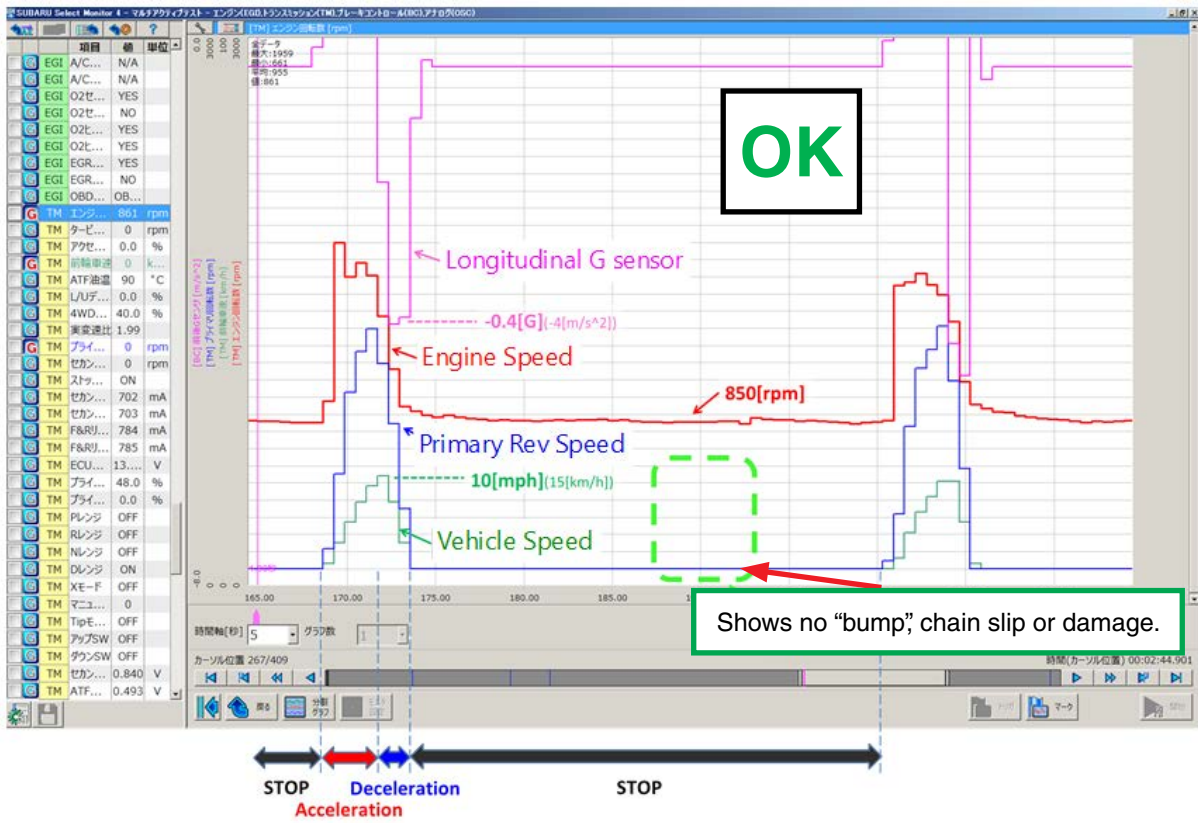
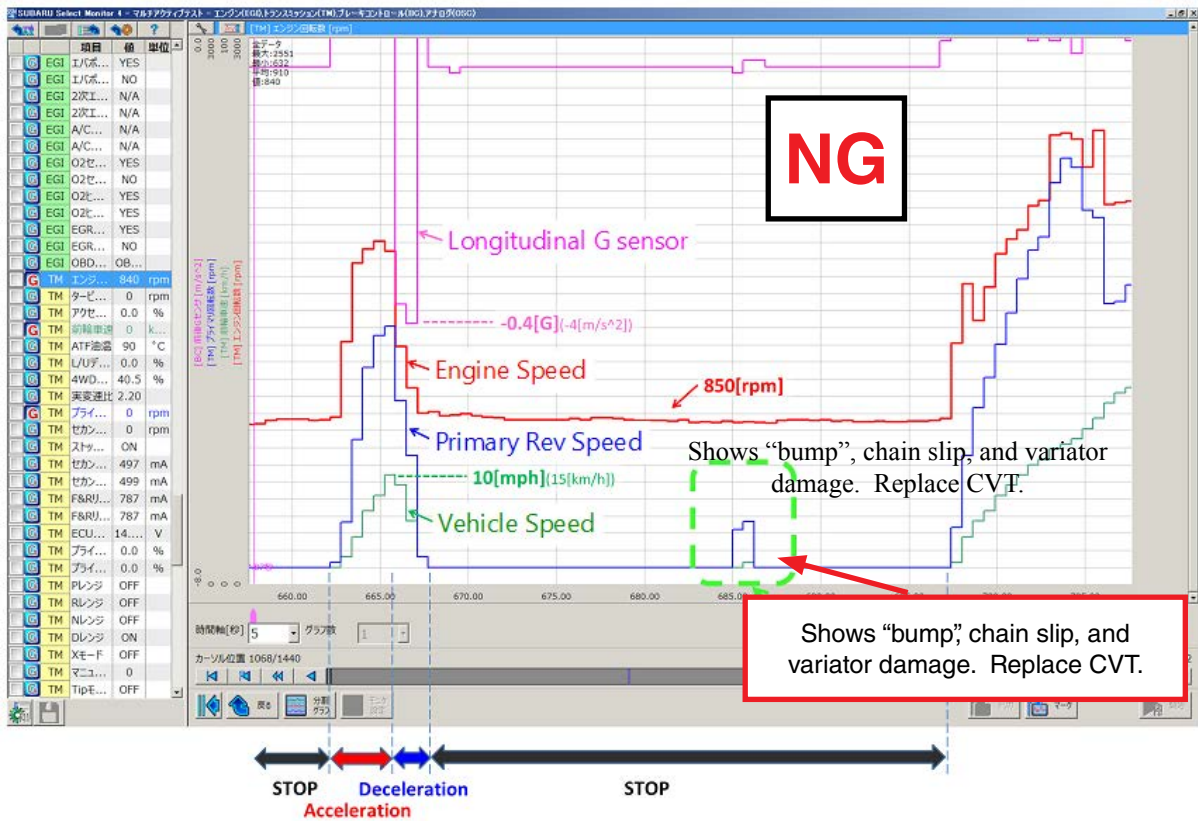
- While performing the testing above, determine if the “bump” condition can be confirmed and / or if the data graph shows any chain slippage. Examples of “OK” and “NG” graphs are supplied below for reference to help make a proper determination.

- If the bump condition is confirmed, there is most likely variator damage requiring CVT assembly replacement. Follow the service procedure in the applicable Service Manual when replacing the CVT assembly is required.

Regardless of whether or not the bump condition is confirmed, after testing or repairs are complete, the TCM **MUST** be reprogrammed following the procedure provided below before releasing the vehicle to the customer.
