SERVICE BULLETIN

APPLICABILITY: 2010-12MY Legacy and Outback 2.5L NA Models
 2015-2017 Legacy and Outback 3.6L Models
 2014-17MY Forester Turbo Models
 2015-17MY WRX
 All Above Models Equipped with TR690 CVT

NUMBER: 16-103-16R
DATE: 12/14/16
REVISED: 04/20/17

SUBJECT: Transmission Fluid Seepage

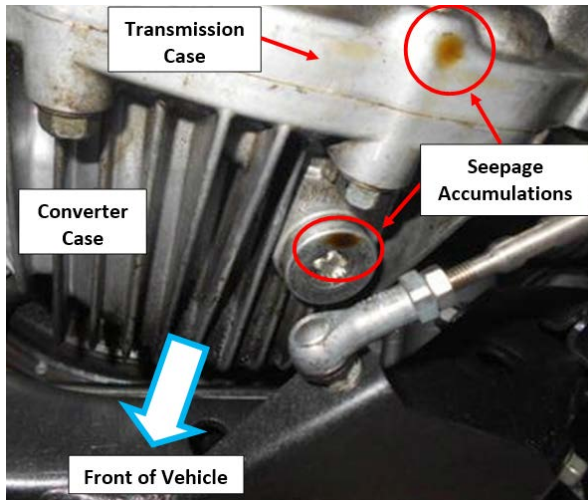
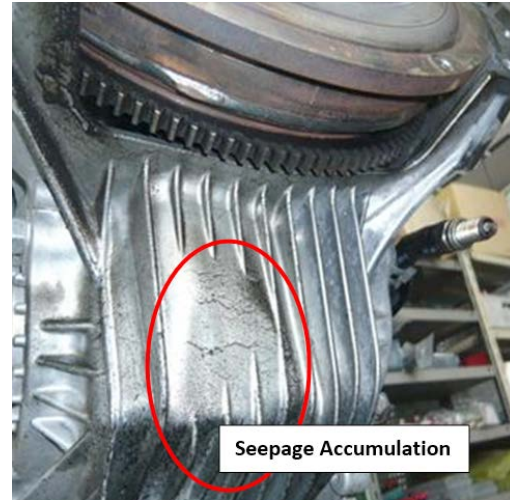
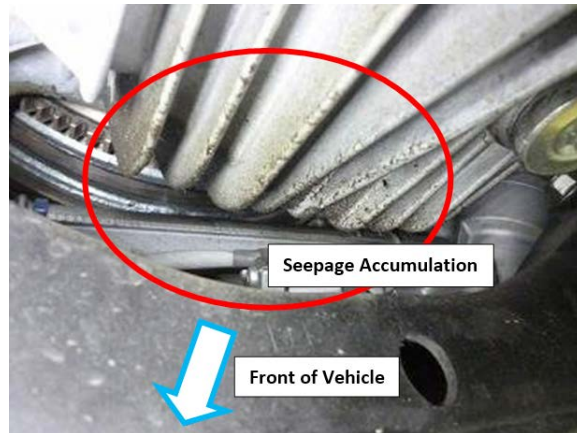
As a first step, during inspection of the customer’s concern, confirm the fluid found to be seeping is CVT fluid (CVTF) and not engine oil. The photos below are examples of where CVTF seepage may be evident.

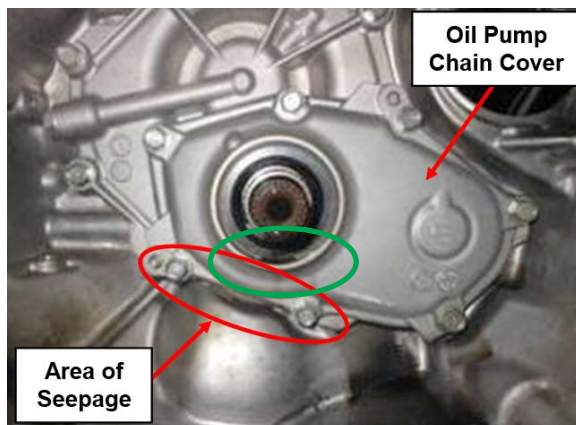
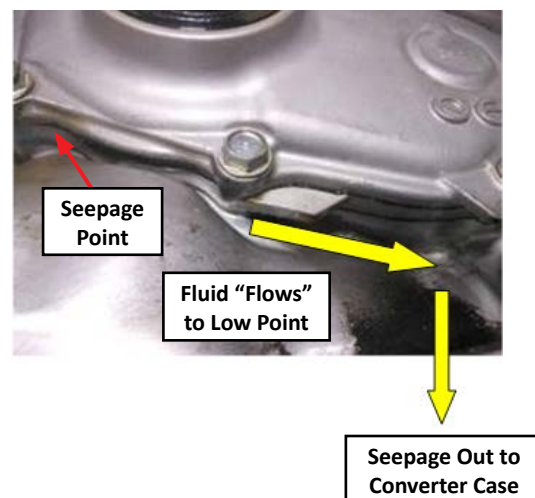
- Once the inspection has confirmed the seepage is CVTF, remove the CVT assembly following the procedure outlined in the applicable Service Manual.
- Remove the torque converter from the CVT and inspect the area of the oil pump chain cover as indicated in the photo below for any accumulation of CVTF and road dirt which may also have collected in the area.

NOTE: A small amount of fresh CVT fluid may appear near the 6:00 position of the seal area during removal of the torque converter (GREEN circle).

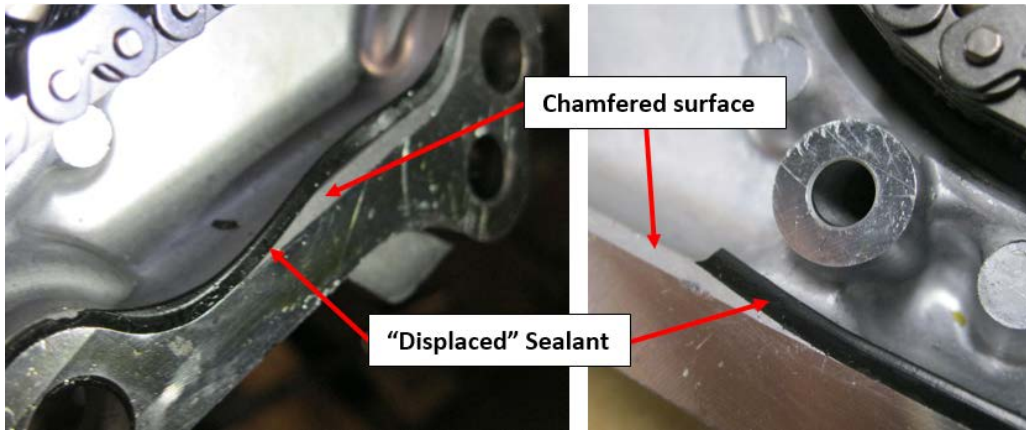
- Take note of how the sealant on the removed cover forms an additional “seal” when it becomes displaced into the chamfer around the inside edge of the case’s machined surface at assembly.

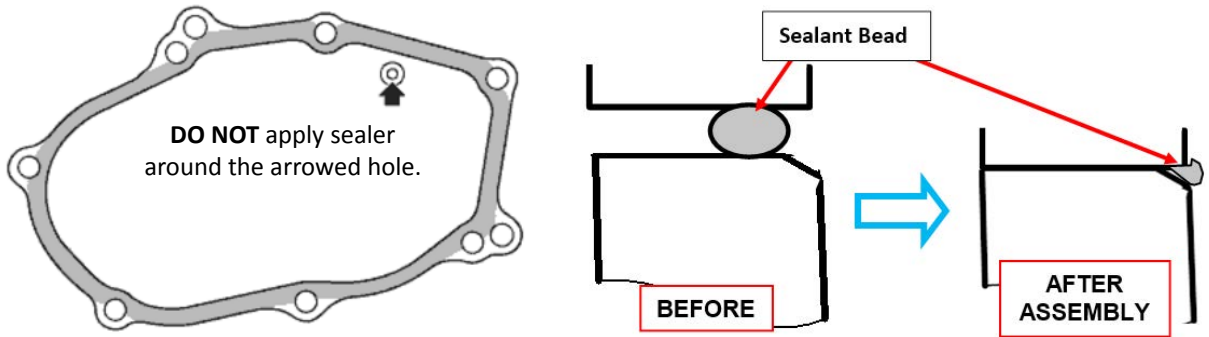
NOTE: As shown above, a properly applied, small bead of sealant will fill in the chamfered portion after the cover is installed. Do not use an excessive amount of sealant.
